Sample Drawing
 1234 Mock St
 Anywhere, CA 44444
 123-456-7890

Bay Area Retrofit
 Howard Cook, Contractor
 (510) 548-1111

August 25, 2010

Submitted to:
John Doe
San Francisco, CA
415-222-2222

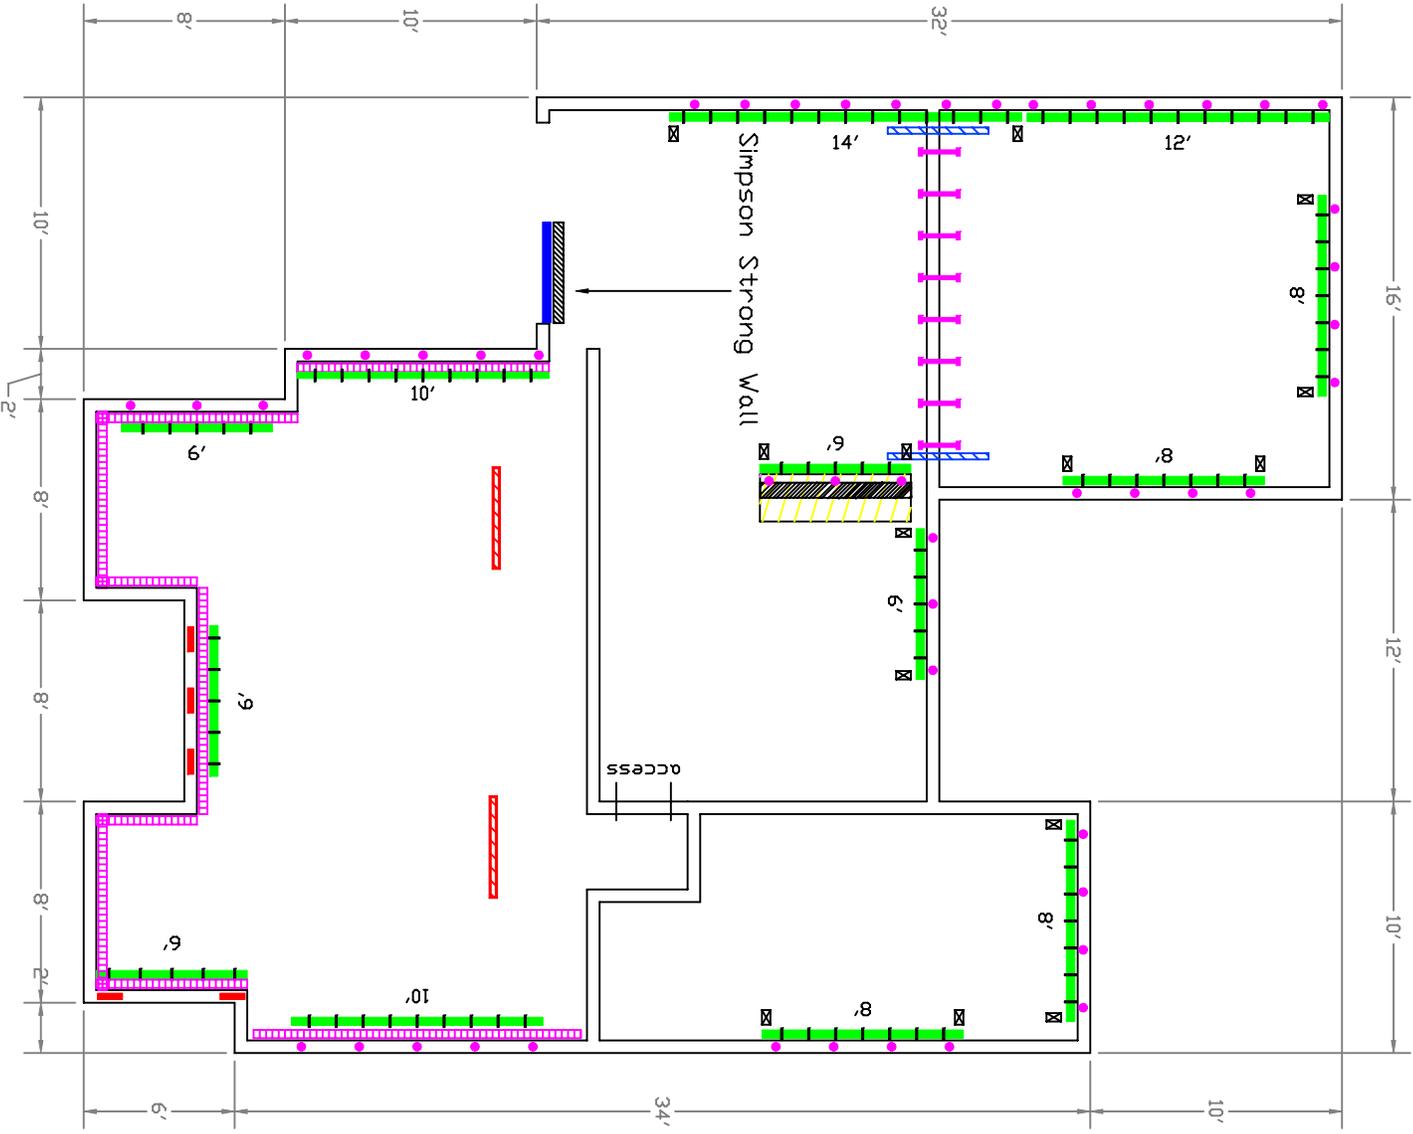
FINDING: **The cripple walls that support the floor are not bolted to the foundation.** The mudsill (the part of the house that rests directly on top of the concrete foundation) needs to be bolted to the foundation. The bolts we use have been tested and approved by the International Code Council Evaluation Service for retrofit applications.

FINDING: The cripple walls have inadequate lateral bracing to prevent collapse. This hazard can be corrected by bracing these walls with plywood. Our plywood is installed in accordance with information found in the American Plywood Association Research Report 154 for high capacity shear walls.

FINDING: The horizontal 2 by 4’s at the top of cripple wall on the north side of the house has a break in it. This break in the upper top plates means earthquake forces being generated on the northwest side of the house will not be restrained by the shear walls in the crawl space.

FINDING: The floor above the garage door opening is not attached to a foundation. This is because of the garage door opening located below this floor.

FINDING: The floor in the crawlspace needs to be attached to the new Simpson StrongWall. As of now the floor joist that extends from above the StrongWall into the crawl space is in two pieces butted together.

FINDING: The floor of the rear addition is not adequately attached to the floor of the main house. Earthquake forces will tend to tear the two floors apart. These two floors should be connected together so that they perform as one floor and transfer earthquake forces adequately to the earthquake resisting elements (bolts, plywood, etc.) located on the perimeter of the house.

FINDING: The floor of the rear addition is not attached adequately enough to the floor of the main house to prevent it from pulling away from the main house. Earthquake forces will pull the two floors apart.

RECOMMENDATION: Where shown on the enclosed drawing, bolt the mudsill to the foundation

RECOMMENDATION: Install Mudsill Plates on all bolts shown on the drawing.

RECOMMENDATION: Where shown on the enclosed drawing, install structural grade plywood manufactured specifically for shear wall construction.

Where shown on the drawing, install hold-downs on shear wall to help keep the wall from tipping over.

RECOMMENDATION: Install new segments of foundation as shown on attached plans so that the shear wall at this location can be lengthened. Foundation segment to be designed by a structural engineer.

RECOMMENDATION: Install Simpson StrongWall at the location shown on the drawing.

RECOMMENDATION: As shown on the drawing, join these two lengths of floor framing together with a large steel strap called a continuity tie.
