**Bay Area Retrofit**  
 Howard Cook, Contractor  
 (510) 548-1111

**Submitted to:**  
John Doe  
San Francisco, CA  
415-222-2222

My examination of your home showed a need for the following structural modifications:

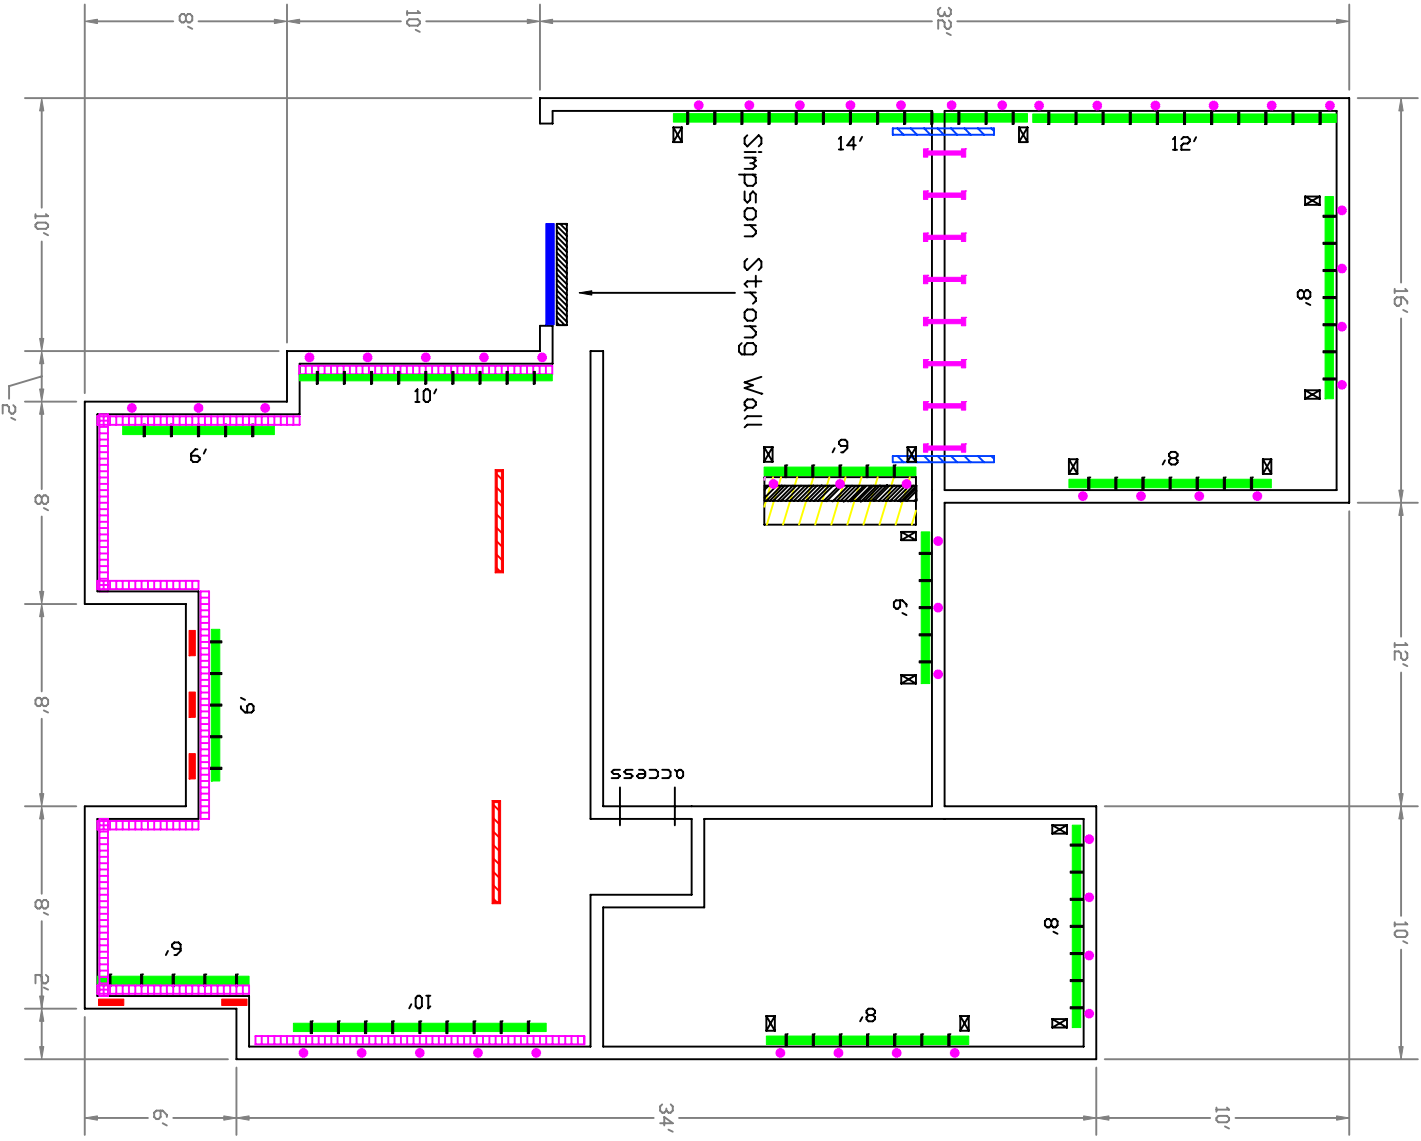
Sample Drawing  
 1234 Mock St  
 Anywhere, CA 44444  
 123-456-7890

**FINDING:** **The cripple walls that support the floor are not bolted to the foundation.** The mudsill (the part of the house that rests directly on top of the concrete foundation) needs to be bolted to the foundation. The bolts we use have been tested and approved by the International Code Council Evaluation Service for retrofit applications.

**FINDING: Mudsills tend to split if the wood to bolt connection is not strengthened with Mudsill Plates.** These were developed after the Northridge earthquake when it was observed that a large number of mudsills split. In addition mudsill plates can increase the strength of the bolt from 59% to 200%.

**FINDING: The cripple walls have inadequate lateral bracing to prevent collapse.** This hazard can be corrected by bracing these walls with plywood. Our plywood is installed in accordance with information found in the American Plywood Association Research Report 154 for high capacity shear walls.

**FINDING:** The horizontal 2 by 4’s at the top of the floor cripple walls, (known as the top plate) are not joined together. Instead they are made of several unconnected pieces that are butted together.

**FINDING:** The horizontal 2 by 4’s at the top of cripple wall on the north side of the house has a break in it. This break in the upper top plates means earthquake forces being generated on the northwest side of the house will not be restrained by the shear walls in the crawl space.

**FINDING:** The shear walls need hold-downs to resist overturning (or tipping over) forces at specific shear wall locations. The lateral forces of an earthquake pushing against the top of a shear wall cause to tip over, much as a tall chest of drawers will tilt up and overturn if you try and slide it across the floor by pushing it from the top.

**FINDING:** The effectiveness of the proposed shear wall to the left of the west facing window in the basement can be increased by increasing its length and install a new segment of foundation.

**FINDING:** The floor above the garage door opening is not attached to a foundation. This is because of the garage door opening located below this floor.

**FINDING:** The floor in the crawlspace needs to be attached to the new Simpson StrongWall. As of now the floor joist that extends from above the StrongWall into the crawl space is in two pieces butted together.

**RECOMMENDATION:** Where shown on the enclosed drawing, bolt the mudsill to the foundation

**RECOMMENDATION:** Install Mudsill Plates on all bolts shown on the drawing.

**RECOMMENDATION:** Where shown on the enclosed drawing, install structural grade plywood manufactured specifically for shear wall construction.

**RECOMMENDATION:** Remove stucco at probable top plate break location and connect the two upper top plates together with a large steel strap.

Where shown on the drawing, install hold-downs on shear wall to help keep the wall from tipping over.

**RECOMMENDATION:** Install new segments of foundation as shown on attached plans so that the shear wall at this location can be lengthened. Foundation segment to be designed by a structural engineer.

**RECOMMENDATION:** Install Simpson StrongWall at the location shown on the drawing.

**RECOMMENDATION:** As shown on the drawing, join these two lengths of floor framing together with a large steel strap called a continuity tie.

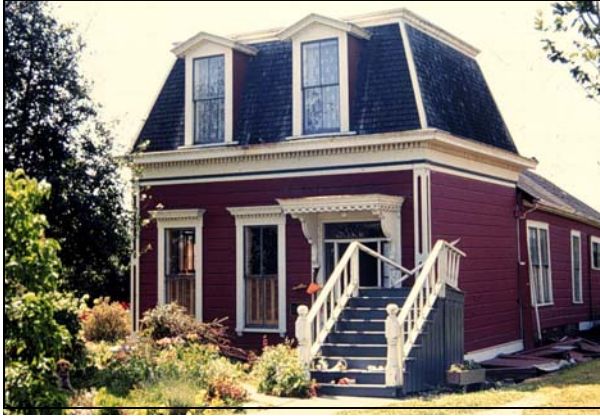
**Example 1:** Cripple wall failure; notice the location of the steps relative to the floor.

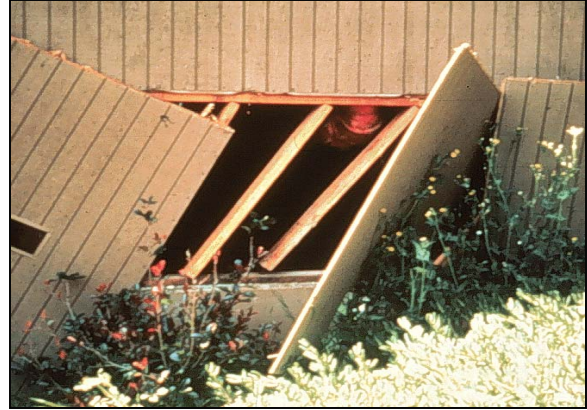
**Example 2:** Cripple wall failure where the floor shifted to the right..

The house on the left has fallen from its foundation but is otherwise intact. This small house in Ferndale California cost over \$150,000 to repair and was unlivable for six months. This damage would have been avoided if it had been retrofitted.

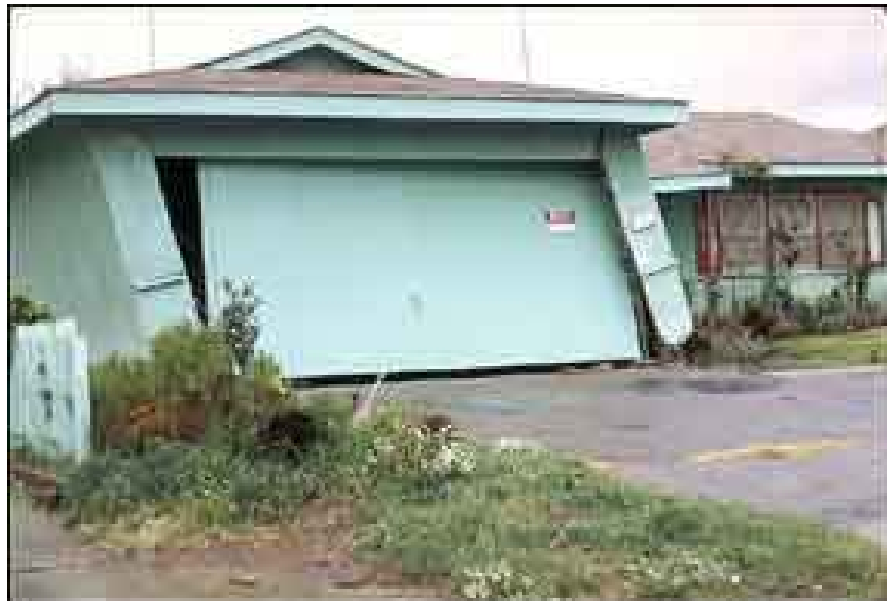
Shear walls on either side of a garage with overturning damage

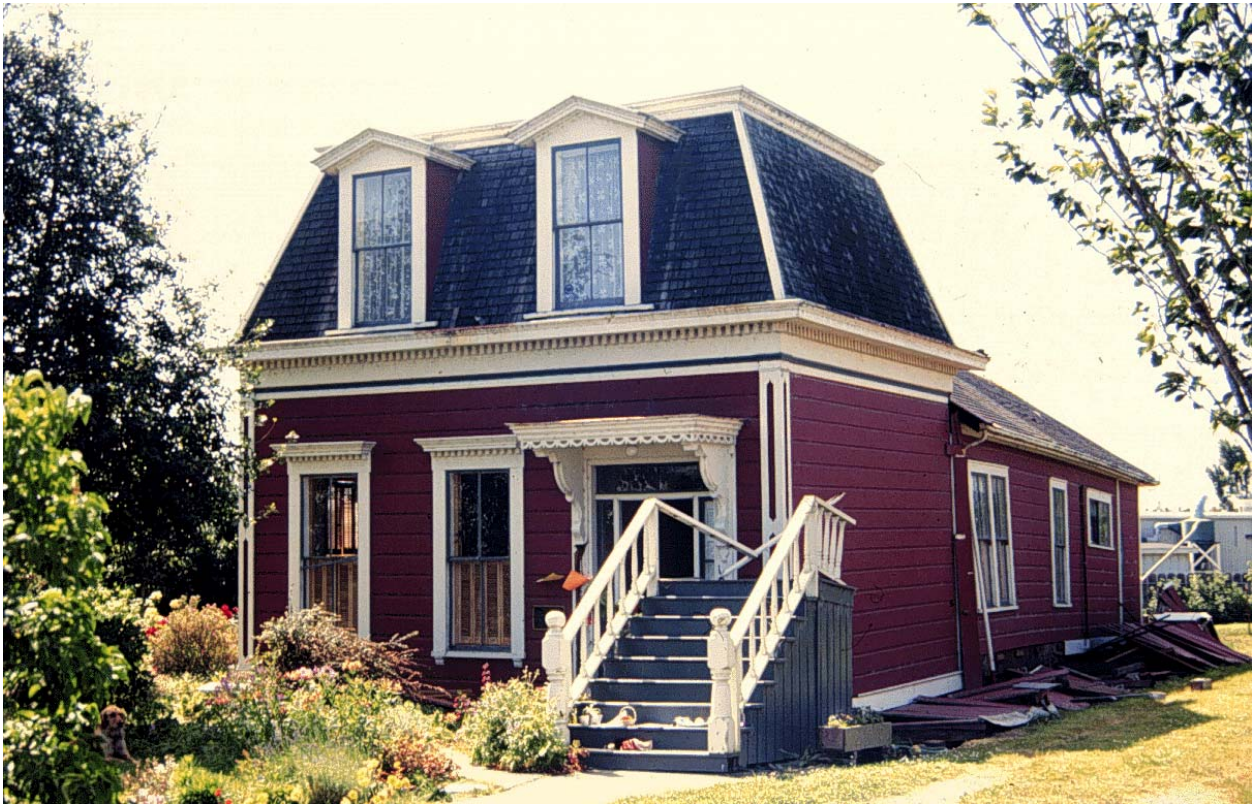
Notice the top of the stairs of this home relative to the position of the floor. This home fell six feet in a 7.1 earthquake in Ferndale California. None of the windows are not cracked and the house is fully intact in every way except the damage to the interior was so extensive it needed to be torn down. The damage to this home would have been quite minimal if it had been retrofitted and not fallen off its foundation.
