Shear Wall Repair missing topplate, plywood to next joist

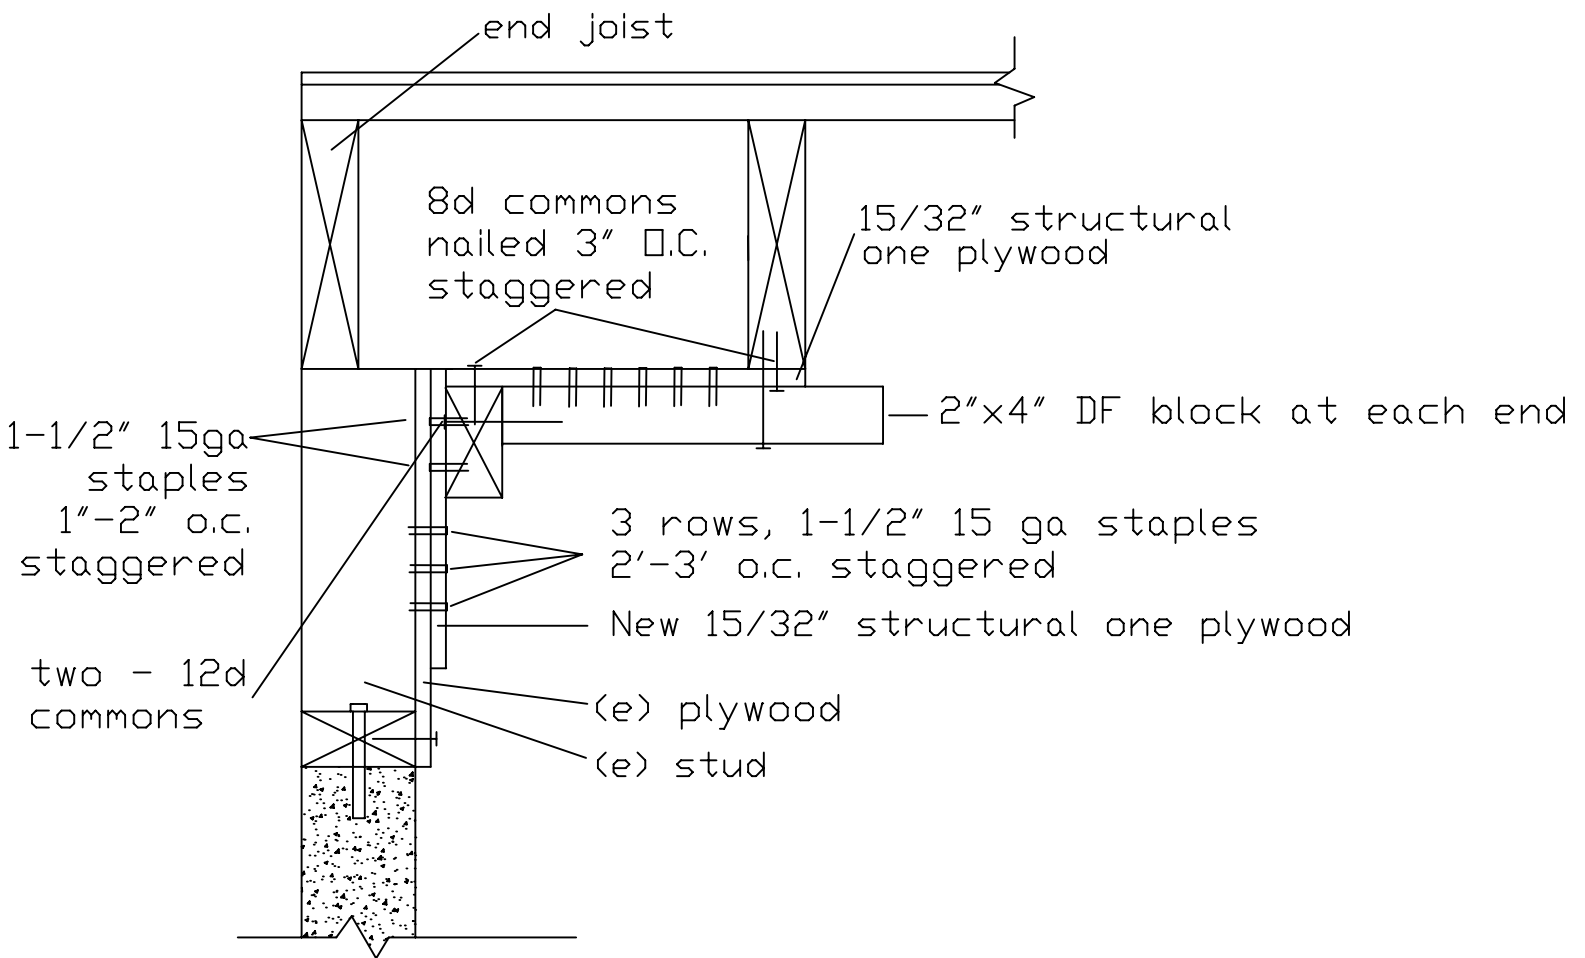
Used when end joist is difficult to access or distance between end joist and first joist makes installing a topplate impossible.
