Foundation Capping

Uses, Limitations and Risks of Foundation Capping

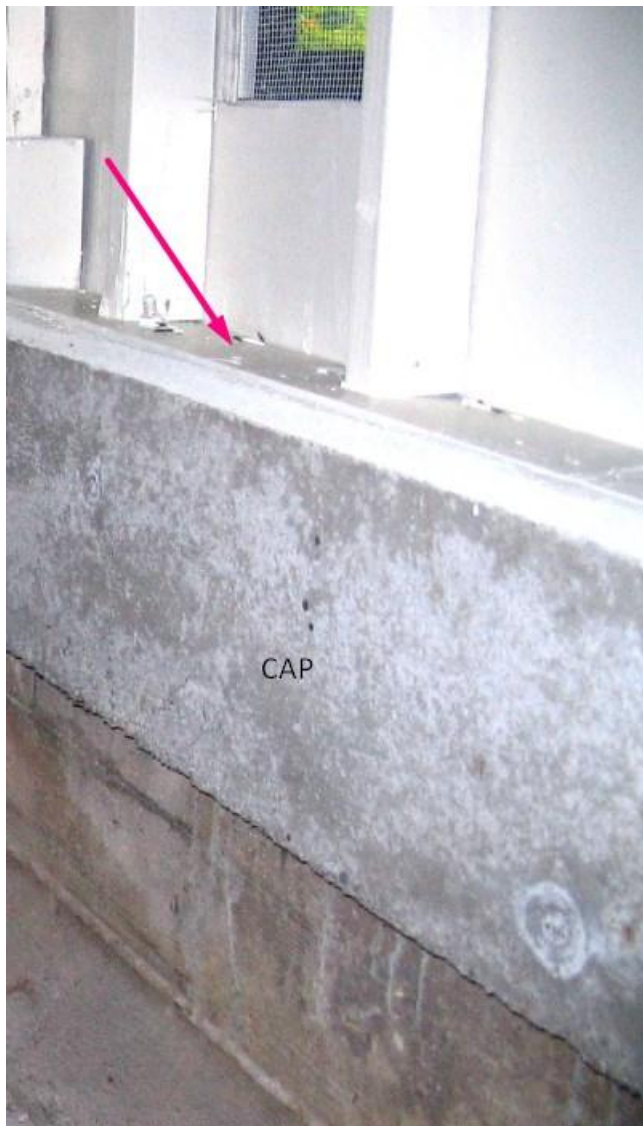
“Capping” of an existing un-reinforced masonry foundation refers to the addition of concrete (or shotcrete or gunitite) on the top of, on one side of, or on the top and both sides of an existing foundation. This usually makes retrofitting very difficult because the mudsill becomes embedded in concrete such that the edge of the plywood cannot be nailed to it. The red arrow points to the mudsill which has been embedded in concrete.

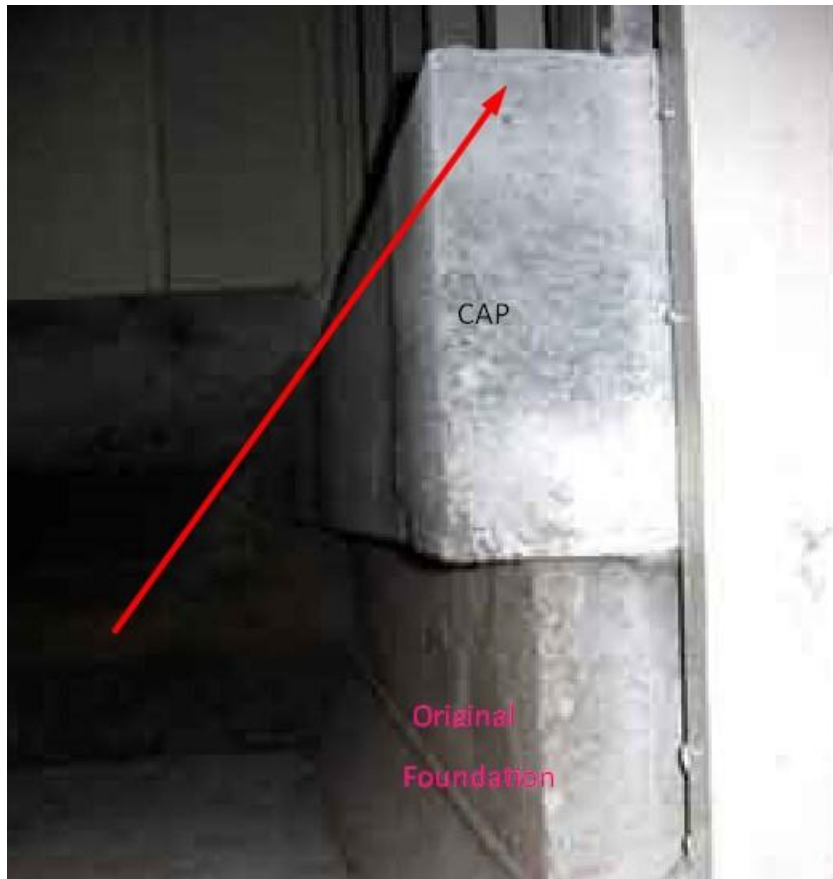
Another example: This is from the side. The red arrow point at where the end of the mudsill is supposed to be.

The concrete should have some reinforcing connecting the cap to the existing foundation but there is really no way to know.
