Shearwall Repair no blocking-flushcut repair

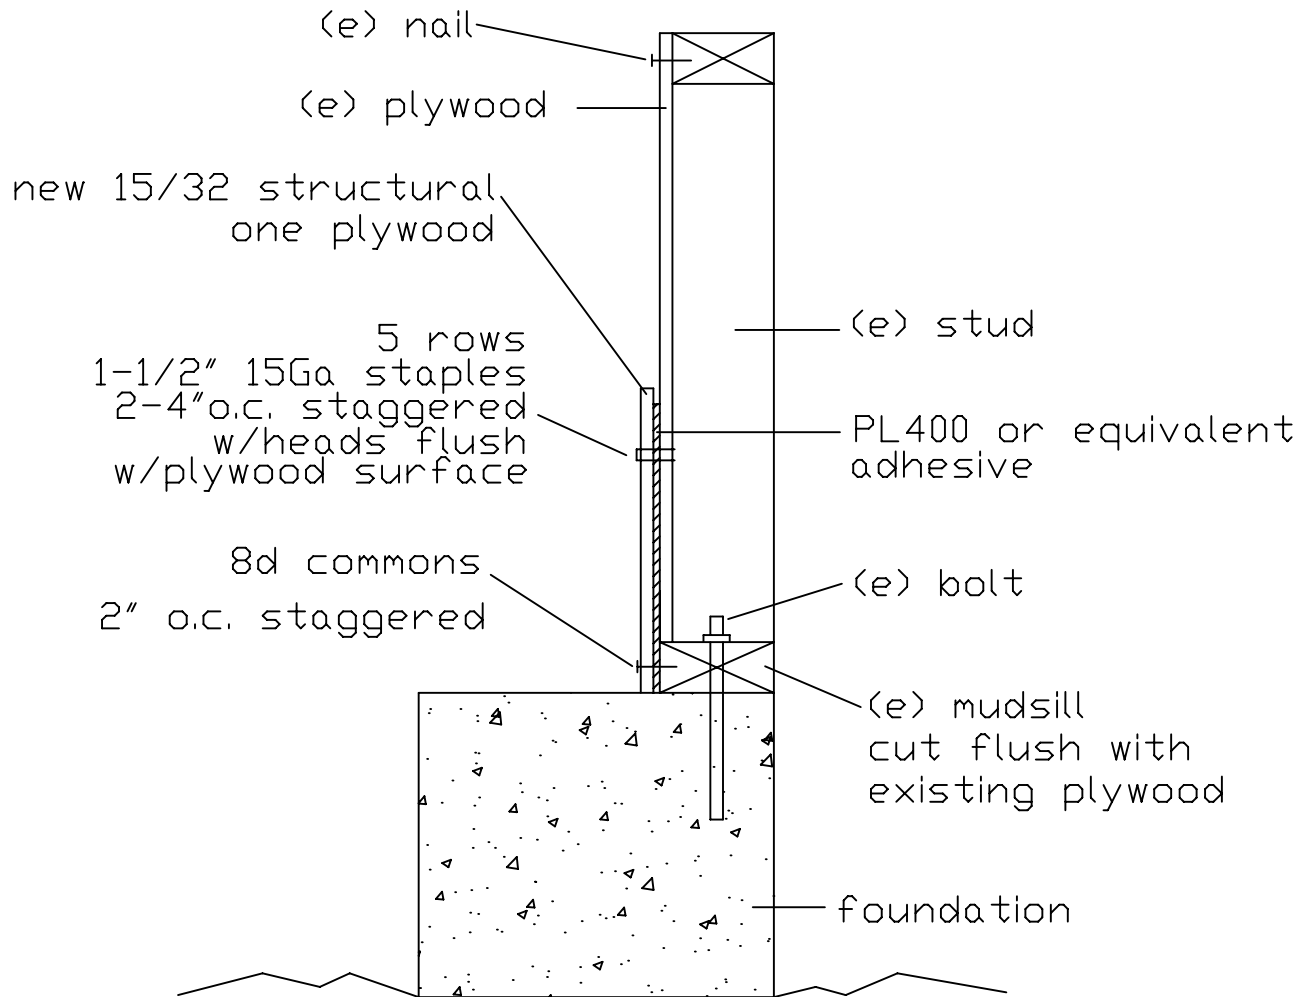
This is a repair to attach existing shear panel to mudsill when original contractor neglected to install blocks on top of mudsill.
