Earthquake Damage Assessment and Repair Guidelines for Residential Wood-Frame Buildings

Volume 2 | ENGINEERING GUIDELINES

CEA-EDA-02 2020

Earthquake Damage Assessment and Repair Guidelines for Residential Wood-Frame Buildings, Volume 2 – Engineering Guidelines

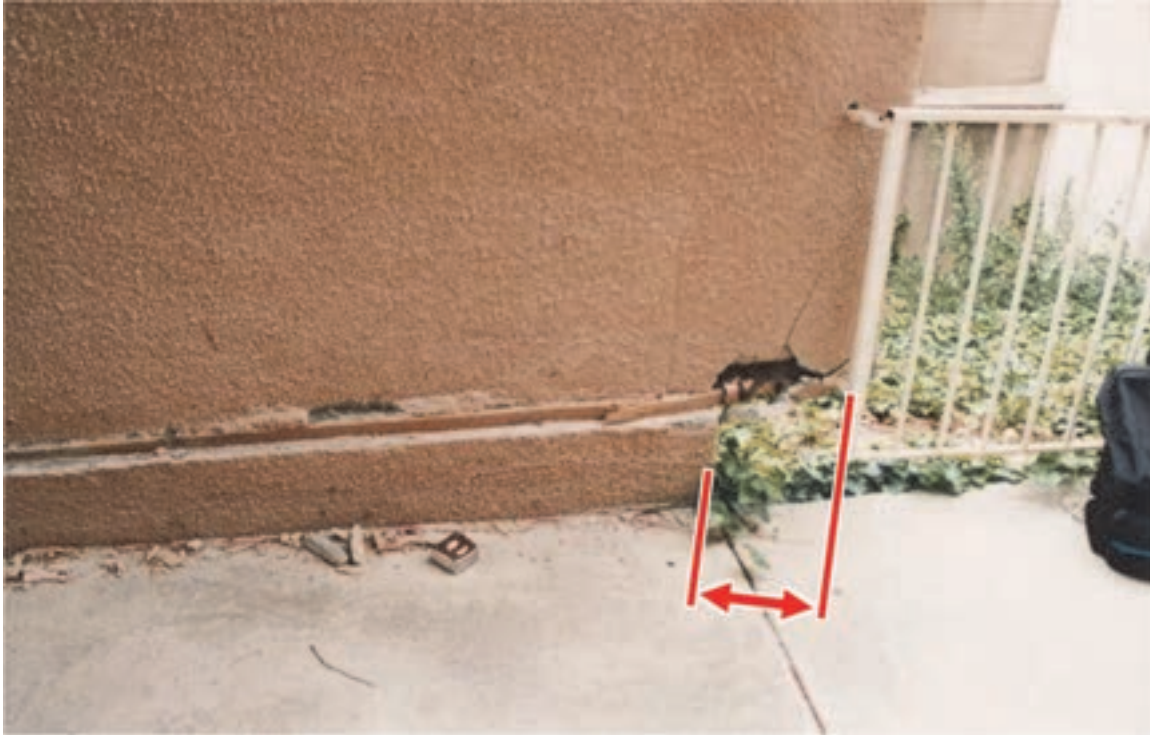
Figure 2-1 Earthquake-caused sliding of superstructure at foundation. The wall has shifted to the right several inches relative to the foundation, stucco wall finishes have cracked and spalled along the sill plate, and the sill plate is fractured near the right end of the wall (photo credit: Exponent).

Figure 2-1 shows substantial sliding, readily observed, with fracture of the sill plate and conspicuous damage to the wall finishes along the sill plate. Figure 2-2 shows less obvious sliding, initially noticed only because of inoperable doors within the affected wall line.

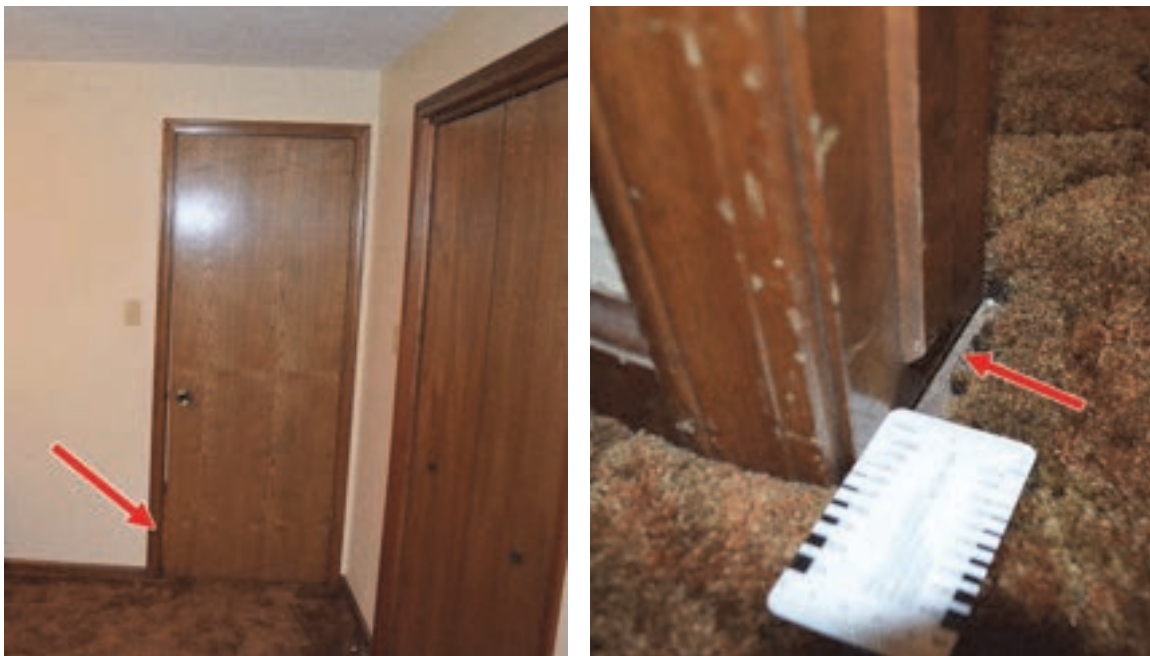
Figure 2-2 Earthquake-caused sliding of superstructure at floor slab. The wall has shifted less than 1 inch to the left, as evidenced in the left photo by the tapered gap between the left side of the door and doorjamb and in the right photo by the gap between the carpet and doorjamb (photo credit: Exponent).

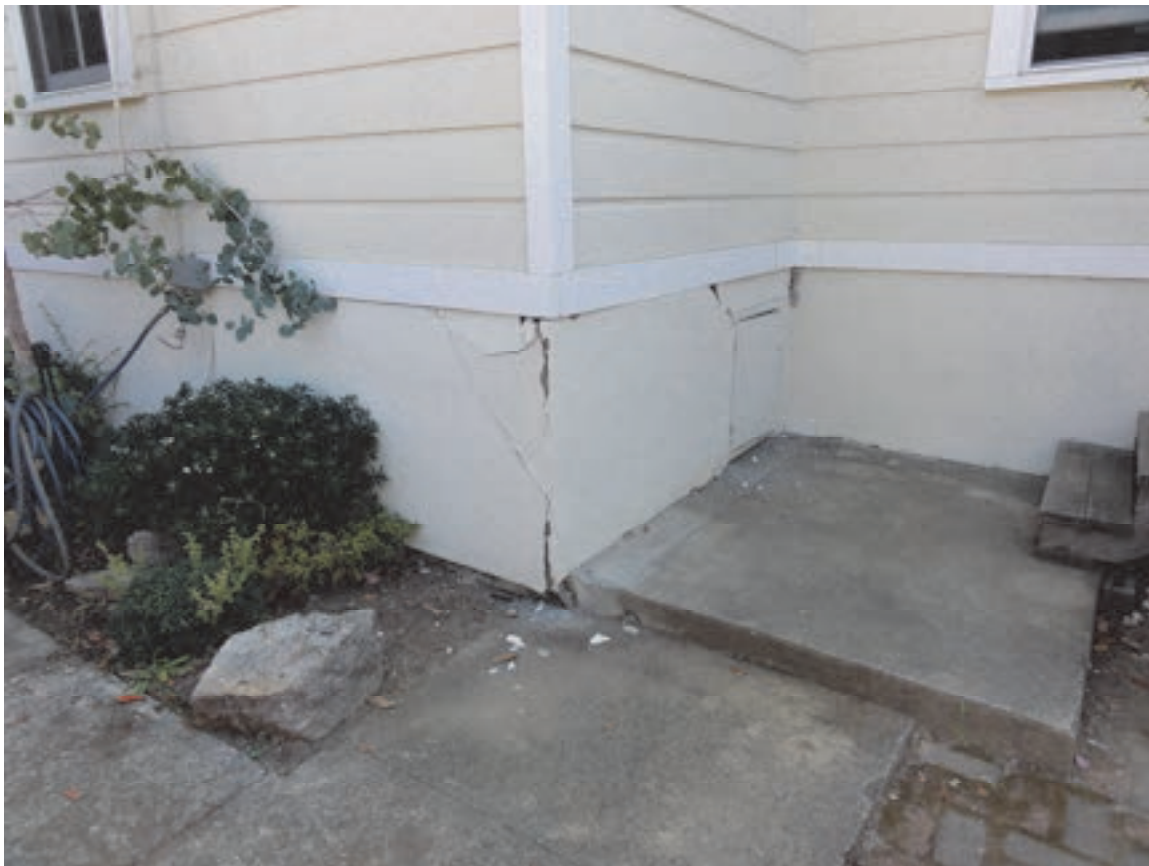
Figure 2-3 Damage to cripple wall finishes caused by the 2014 South Napa, California earthquake (photo credit: Exponent).

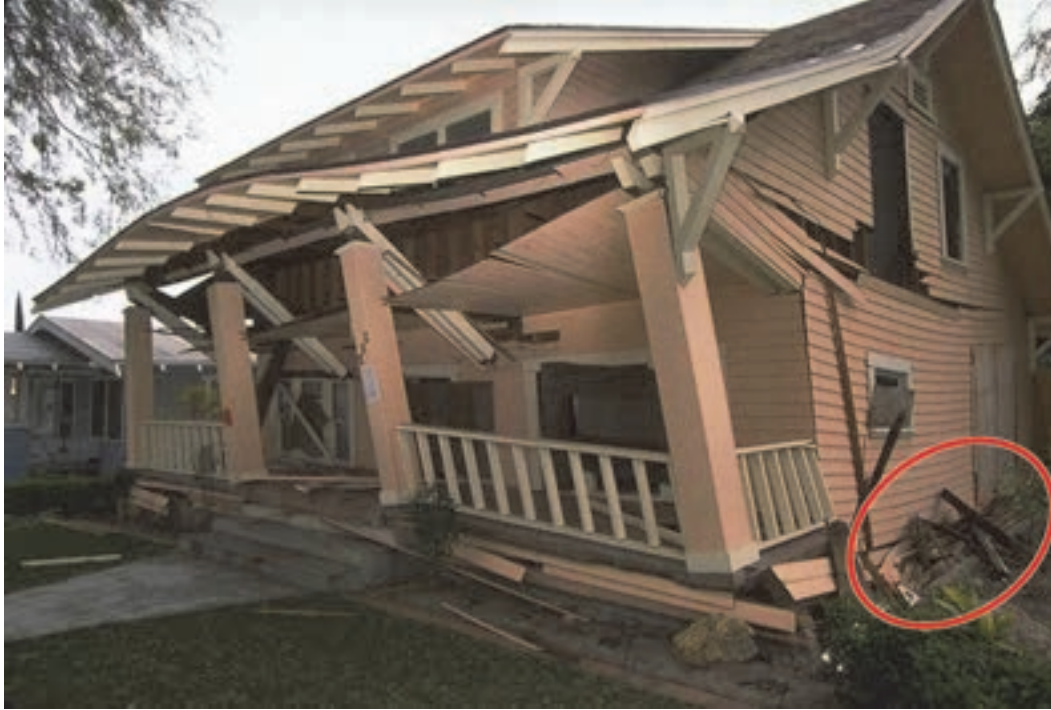
Figure 2-4 Cripple wall collapse caused by the 1994 Northridge, California earthquake resulting in widespread related damage in upper-story framing and relative movement between the main house and the covered porch (photo credit: Federal Emergency Management Agency, or FEMA).

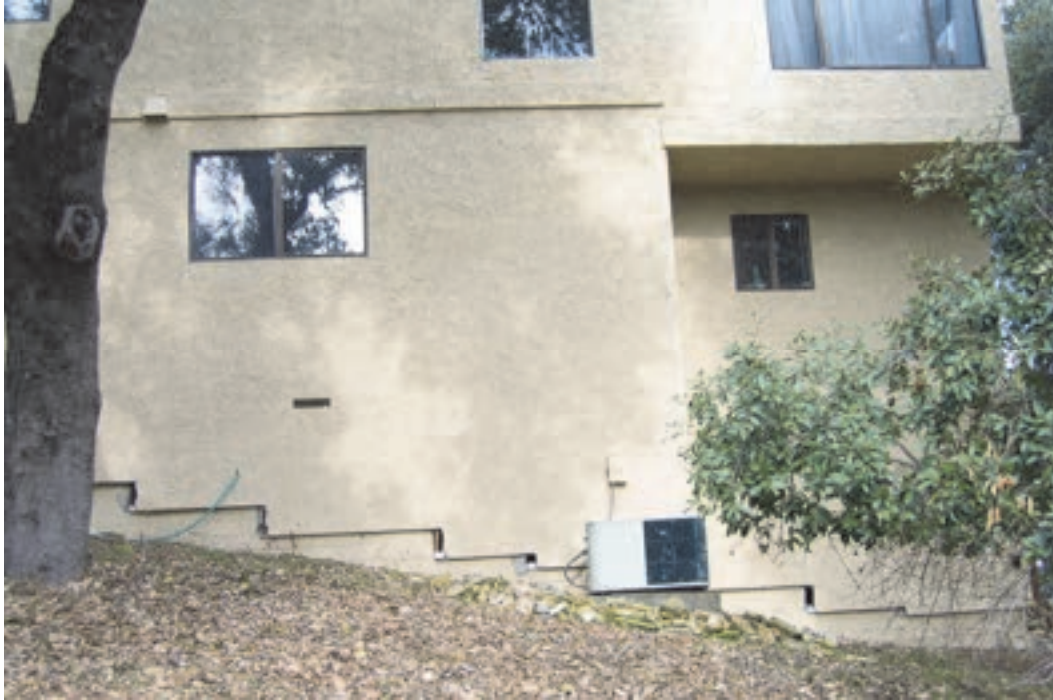
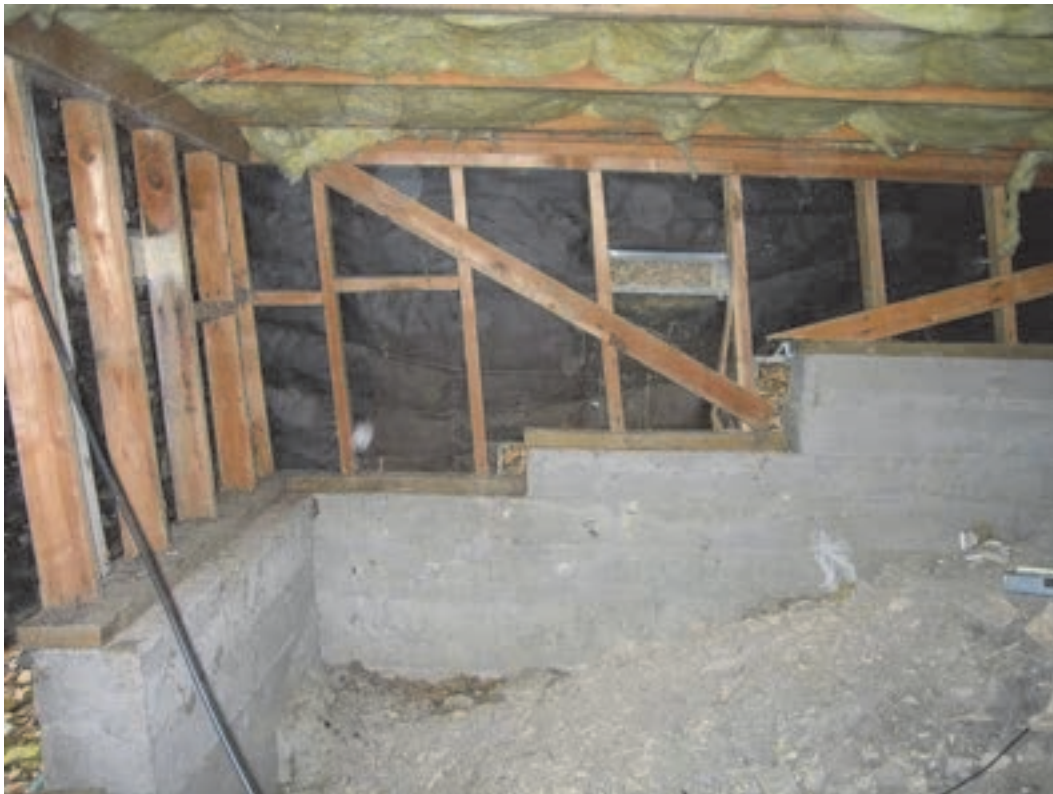
Figure 2-5 Damaged framing enclosing the underfloor area of a hillside house caused by the 2003 San Simeon, California earthquake. The damage includes detachment of the stucco from the wall framing and both in-plane racking and out-of-plane leaning of the wood-frame walls (photo credit: Exponent).

Hillside houses typically incorporate stepped or sloped perimeter foundations (or stemwalls) along their sides (Figure 2-5). Posts or wood-frame walls enclosing the underfloor area along these lines may range in height from twenty or more feet at the downhill end to effectively zero at the uphill end, where the floor framing is typically attached to the uphill foundation with a sill plate or ledger. The tall posts or walls, if inadequately braced, may allow excessive deformation at the downhill end, causing torsional response and increasing demands on the uphill framing-to-foundation connections. This damage mechanism typically includes framing deformation and damage (Figure 2-5), and in the worst cases, localized loss of support for floor framing at the uphill end (Figure 2-6) or complete separation of the house from the uphill foundation, resulting in collapse. Hillside houses with no sidewalls, or only short sidewalls at the uphill end, are particularly prone to this damage mechanism. In addition to structural damage, MEP components located below the house may also be damaged.

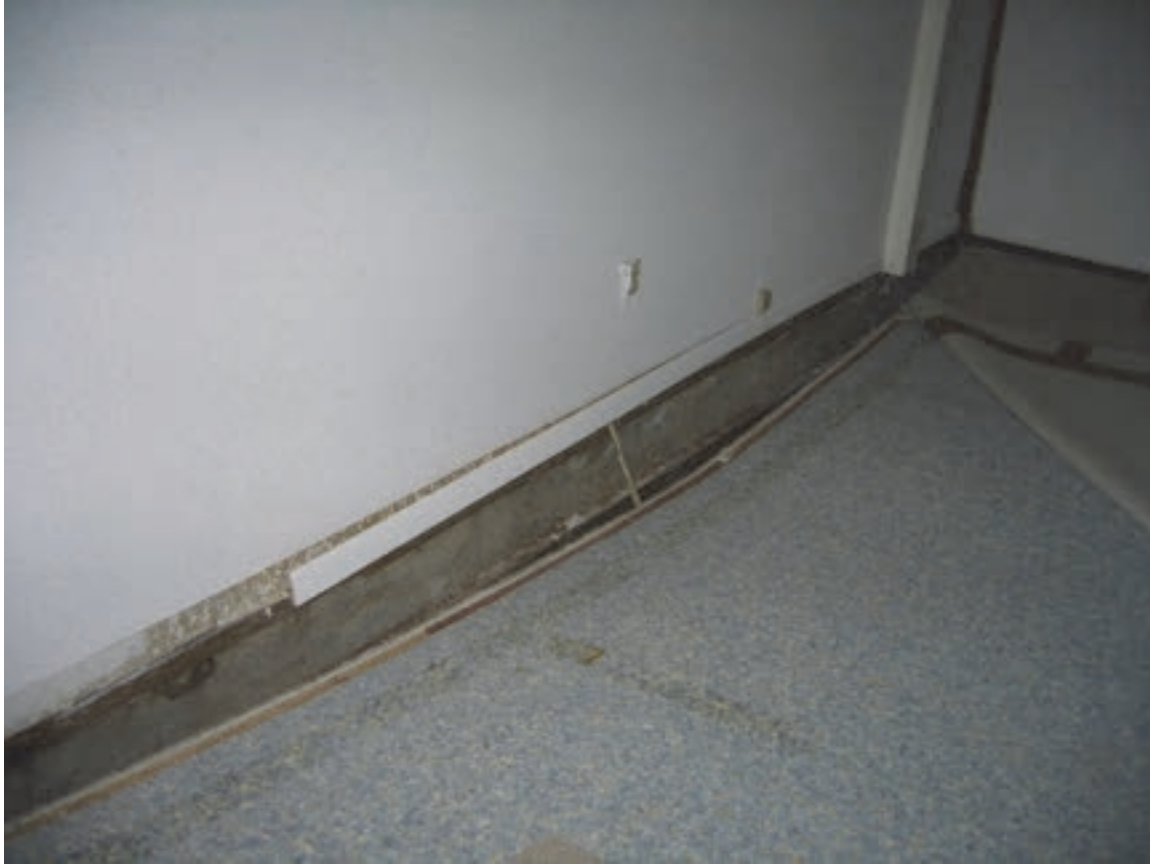
Figure 2-6 Damage at uphill end of a hillside house caused by the 2003 San Simeon, California earthquake. The floor framing detached and pulled away from the uphill foundation, causing the floor to sag (photo credit: Exponent).

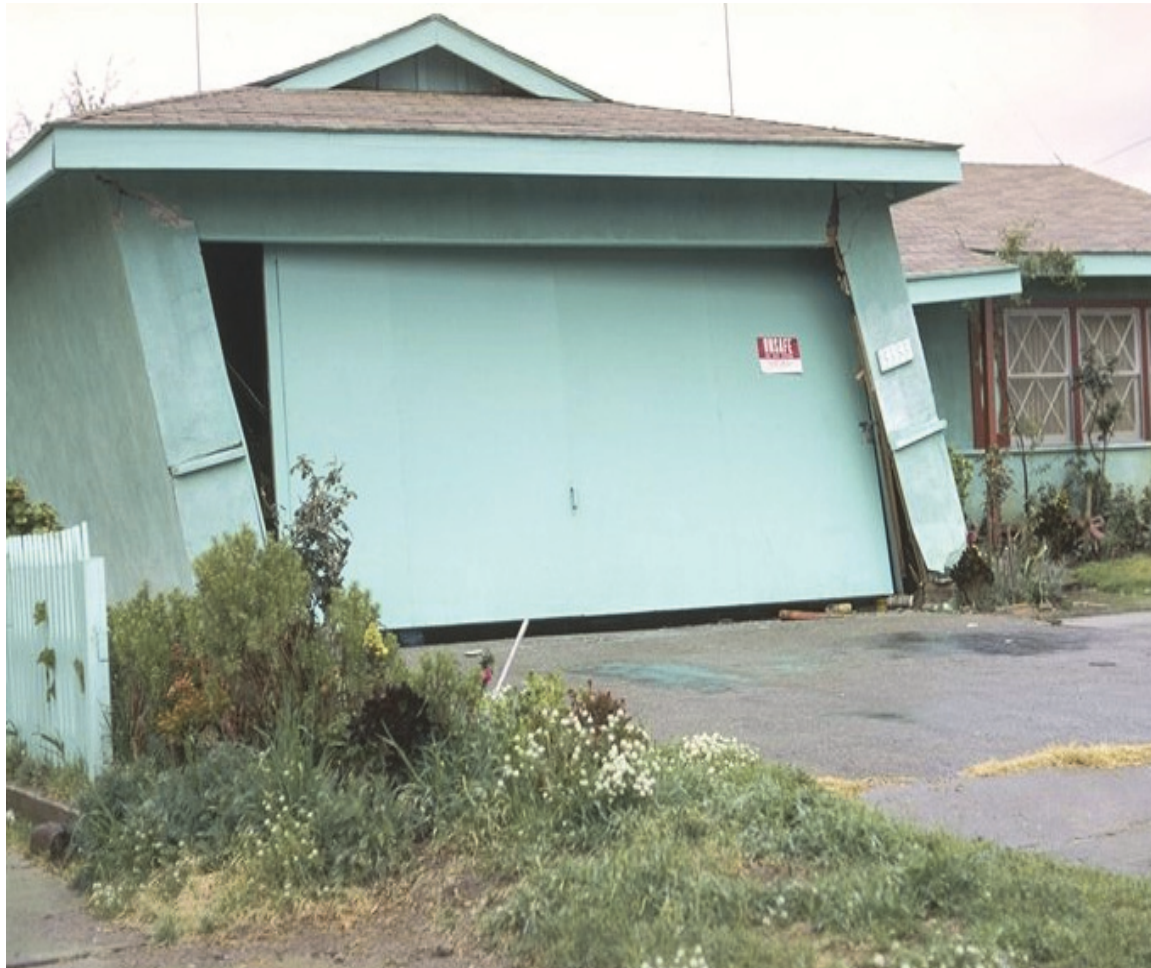
Figure 2-7 Large in-plane drift of narrow wall piers at garage door opening caused by the 1971 San Fernando, California earthquake (photo credit: National Information Service for Earthquake Engineering, or NISEE).

Where window and door openings leave only narrow wall segments to resist earthquake forces, wall lines can be prone to excessive in-plane drift (Figure 2-7) and possibly collapse. Where wider wall segments are not possible, newer houses avoid this vulnerability by using portal frame systems, proprietary engineered wall piers, or even structural steel elements. This mechanism can result in damage to wall pier finishes and sheathing, damage to wall pier framing, damage to connections at the tops and bottoms of wall piers, and inoperability of doors and windows within racked wall lines.

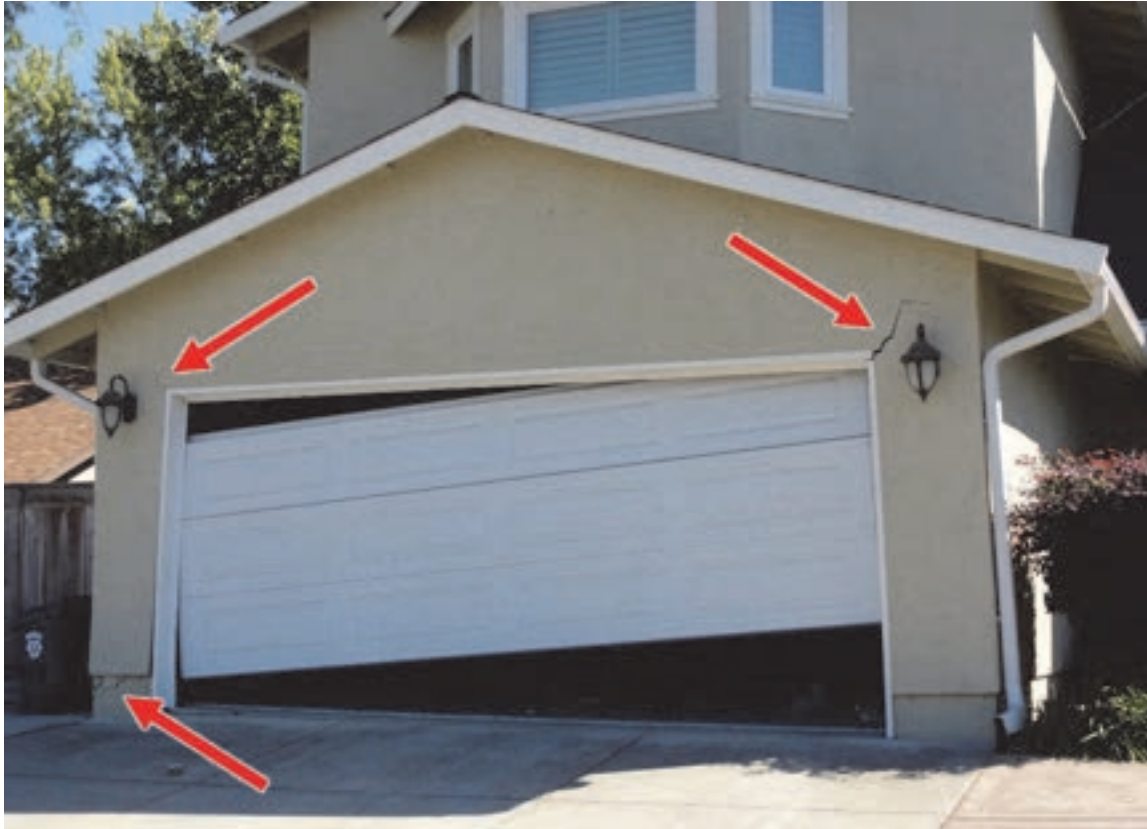
Figure 2-8 Damage related to living space over garage caused by the 2014 South Napa, California earthquake. In-plane racking of the front wall line of the garage caused cracking and possible framing damage in the narrow wall segments on either side of the garage door (photo credit: Exponent).

Multi-story houses with attached garages often have living spaces directly over relatively open garage areas. Where only narrow wall segments are provided on either side of a wide garage door, the additional weight of the upper story can make an already weak condition even more prone to excessive drift (Figure 2-8) and possibly collapse.

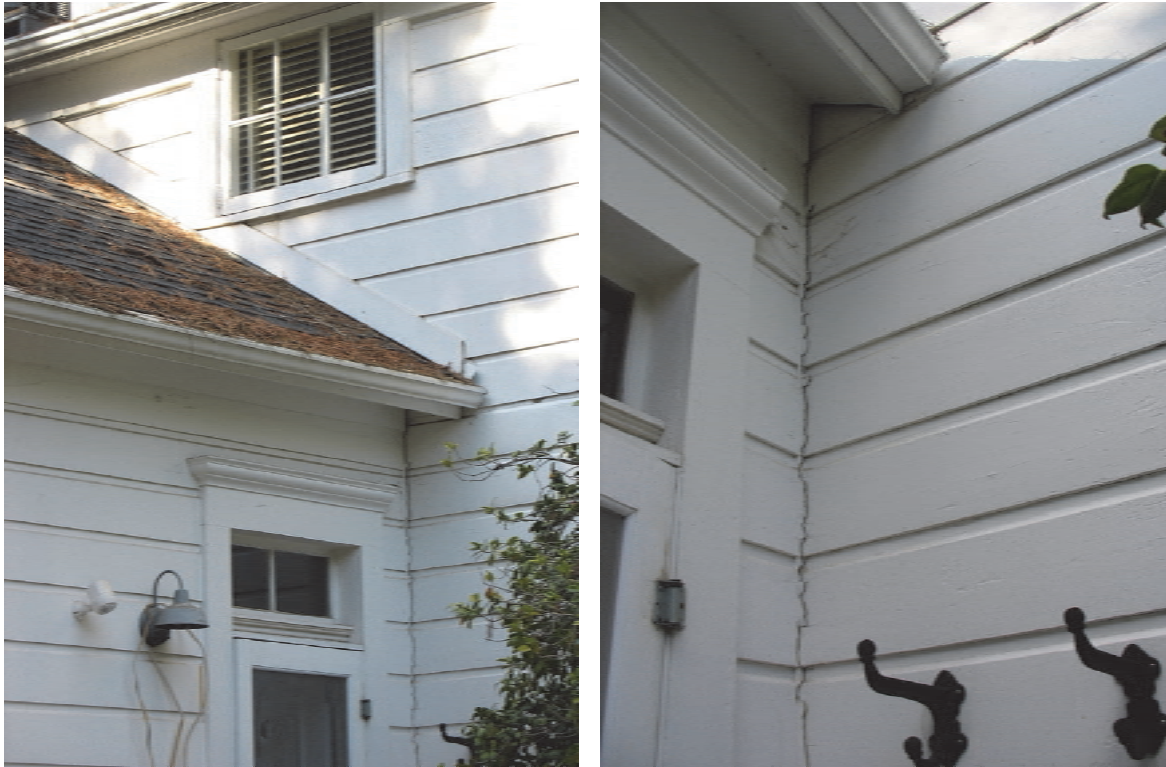
Figure 2-9 Left: Adjoining wings of a house create a framing discontinuity. Right: Separation of wood siding at intersection of adjoining wings caused by the 2014 South Napa, California earthquake. The separation was not structurally significant because there was no continuous framing or structural connection between the wings (photo credit: D. Bonowitz).

Earthquake damage is often concentrated where structural framing is discontinuous from one story to the next or between wings of a house in plan. Earthquake damage associated with these framing discontinuities includes concentrated damage to finishes, residual separations, and framing damage. In split-level houses, where the floor or roof framing is discontinuous between the one-story and two-story portions, differential movement and lack of effective connection between the portions can lead to damage. Where the common wall between the portions provides support for the lower-story floor or roof, the separation can result in local collapse. Where two wings of a house join, relative movement between the wings can lead to damage along the intersection (Figure 2-9).

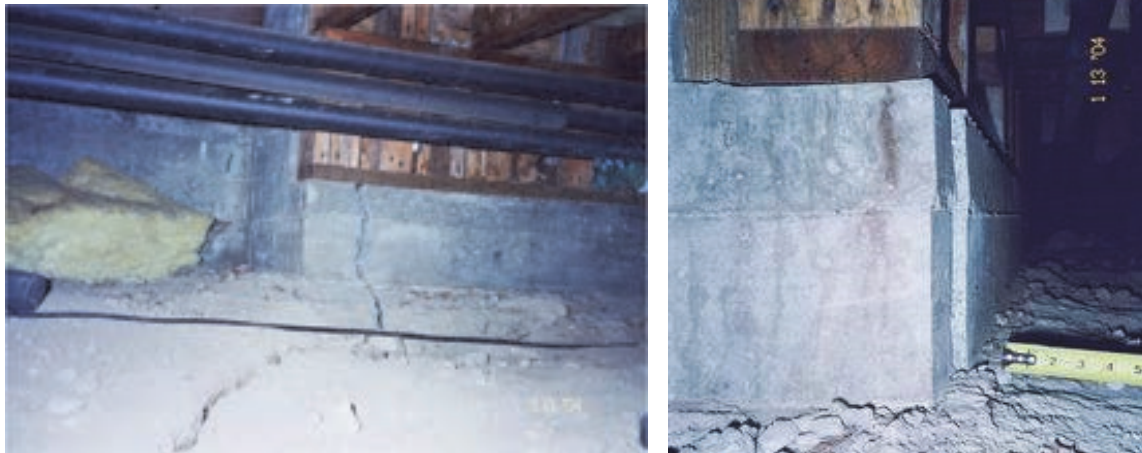
Figure 2-11 Cracking of concrete stemwall in-line with ground crack resulting from the 2003 San Simeon, California earthquake (left). The offset across the crack is revealed in the photograph on the right (photo credit: Exponent).

Earthquake damage to concrete footings and stemwalls is almost always caused by permanent ground deformation due to one or more of the mechanisms discussed in Chapter 5. This damage typically takes the form of fresh-appearing cracks with offsets (vertical or horizontal) (see Figure 2-11) or sloping across cracks and joints. In cases of significant ground deformation, a concrete stemwall may tilt or slope.

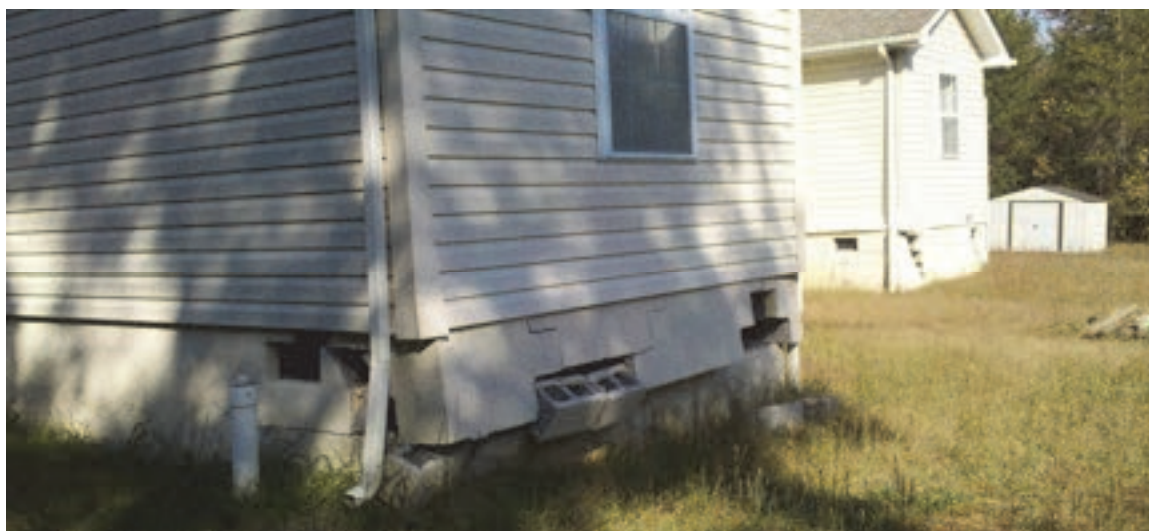
Figure 2-12 Damage of unreinforced, ungrouted masonry stemwalls caused by the 2011 Virginia earthquake (photo credit: M. Mahoney).

Continuous brick strip footings or brick stemwalls were used in older houses, and these foundations are almost never reinforced. Stemwalls constructed of concrete masonry units and supported by concrete footings are used in some newer houses and may or may not have grouted cells or steel reinforcing. Earthquake damage patterns for these foundation elements are similar to those of concrete footings and stemwalls, except that offsets between masonry units can occur, particularly in the case of unreinforced foundations (see Figure 2-12).

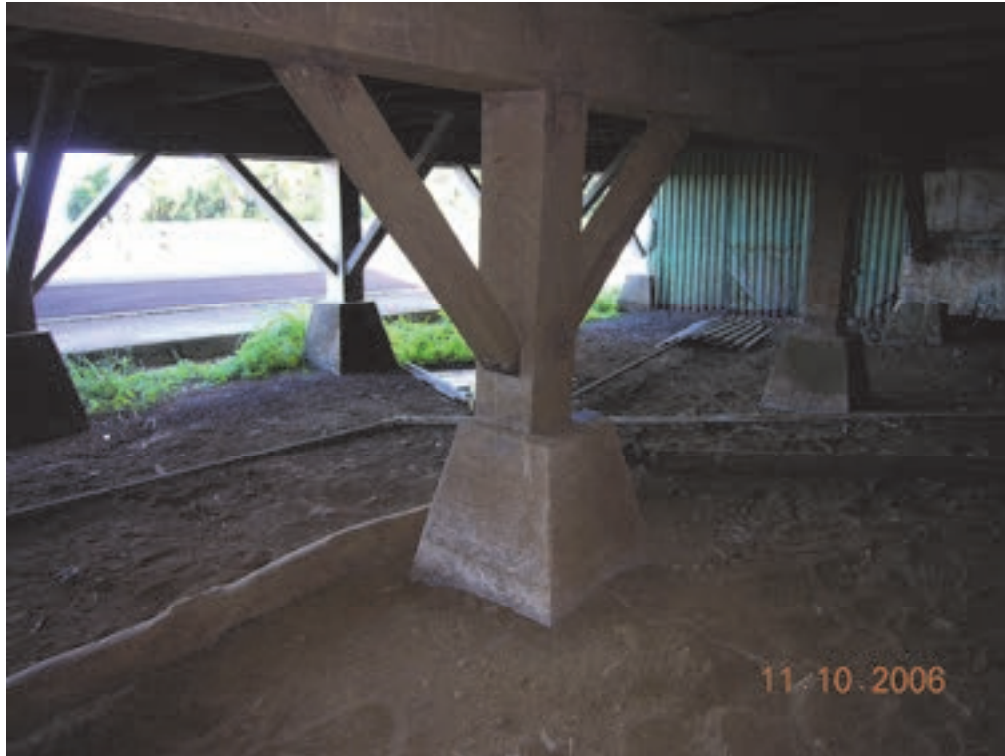
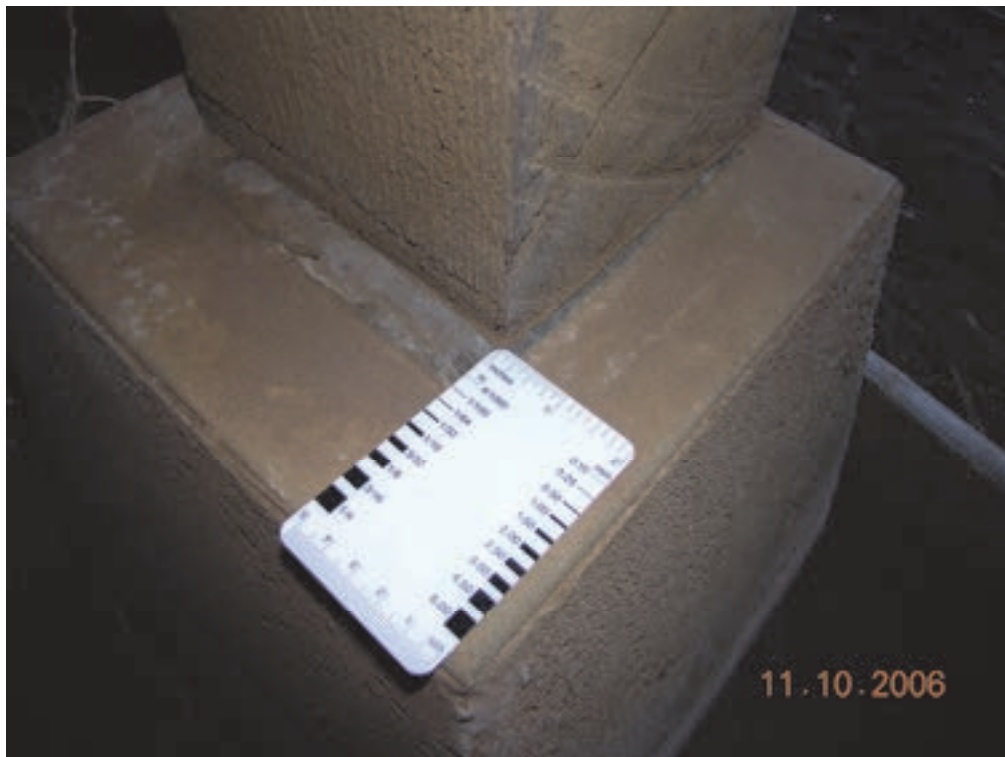
Figure 2-13 Shifting of an unattached wood post along the top of the concrete pier due to the 2006 Kiholo Bay, Hawaii earthquake. There was no continuous perimeter foundation around the building (photo credit: Exponent).

Earthquake damage to concrete piers is almost always caused by permanent ground deformation due to one or more of the mechanisms discussed in Chapter 5. This damage can take the form of cracking or rotation of piers due to movement of the ground. Unattached wood posts can move relative to the floor beams or piers (Figure 2-13) or become dislodged and fall as a result of earthquakes. If posts are attached to both the floor beams and piers, the wood posts or connections can become damaged (Figure 2-14).

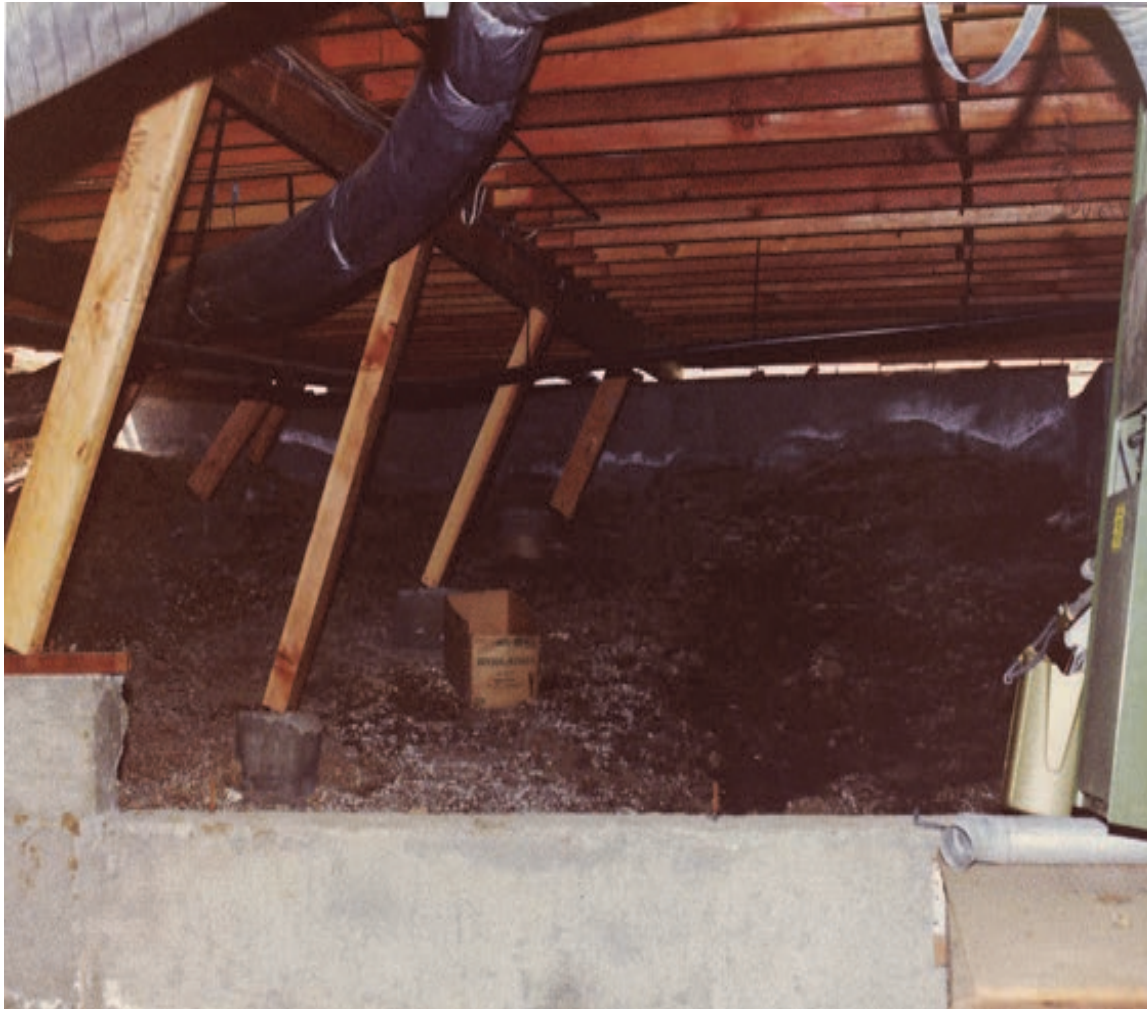
Figure 2-14 Leaning posts within the interior of the house plan. The house had a perimeter foundation with inadequate anchorage between the superstructure and the foundation (photo credit: R. Gallagher).

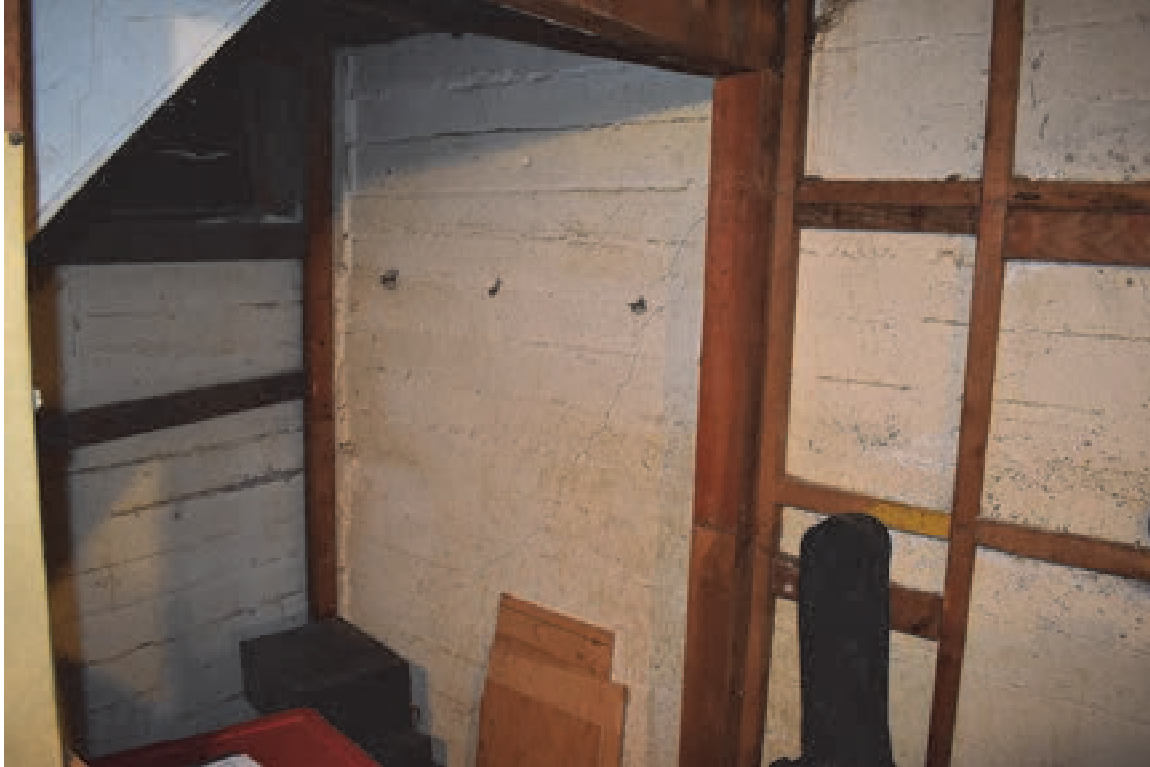
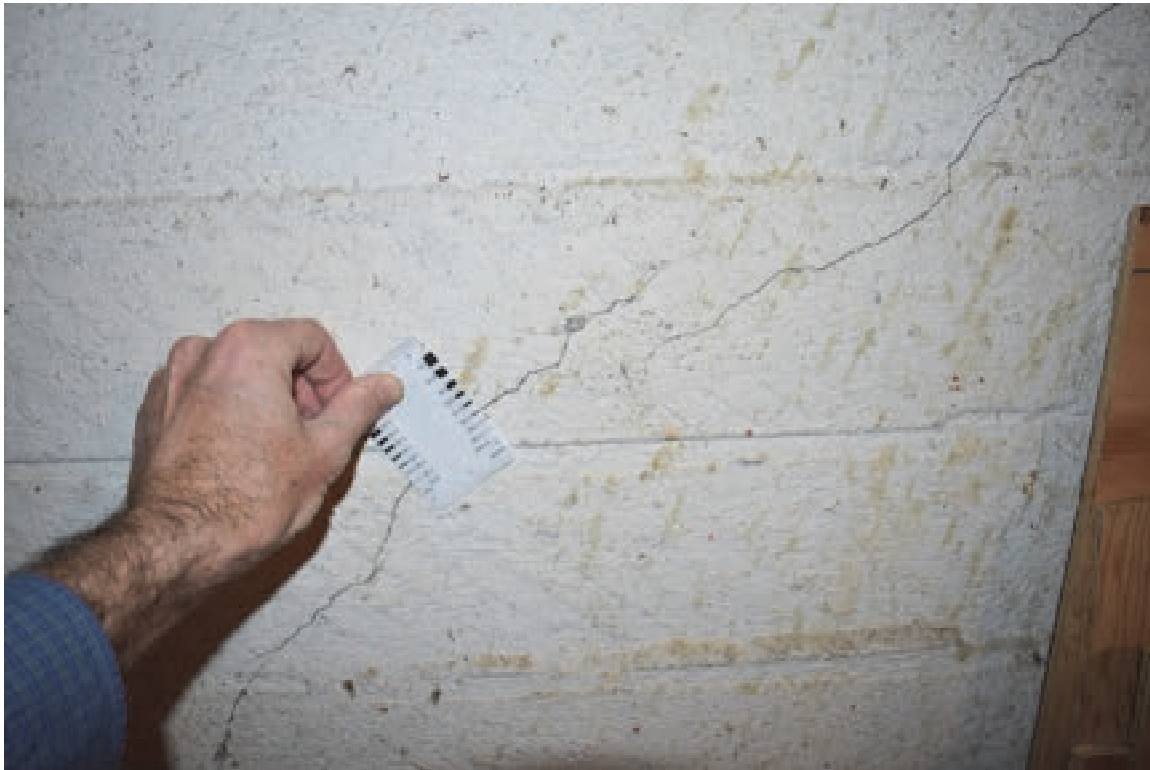
Figure 2-15 Typical non-earthquake-related cracking of concrete California basement wall (photo credit: Exponent).

Full basements are rare in warm locales where the frost line depth is only a few inches from the ground surface. In these cases, the most common basements are effectively below-grade closets just large enough to house a boiler or water heater (the so-called California basement) or are built into a sloping site so that the basement walls also retain several feet of soil at the uphill end. In the latter case, the basement “room” is actually a below-grade garage accessed by a sloped driveway. In most cases, concrete basement walls have minimal reinforcing steel and no construction joints, so they are prone to cracking (Figure 2-15).

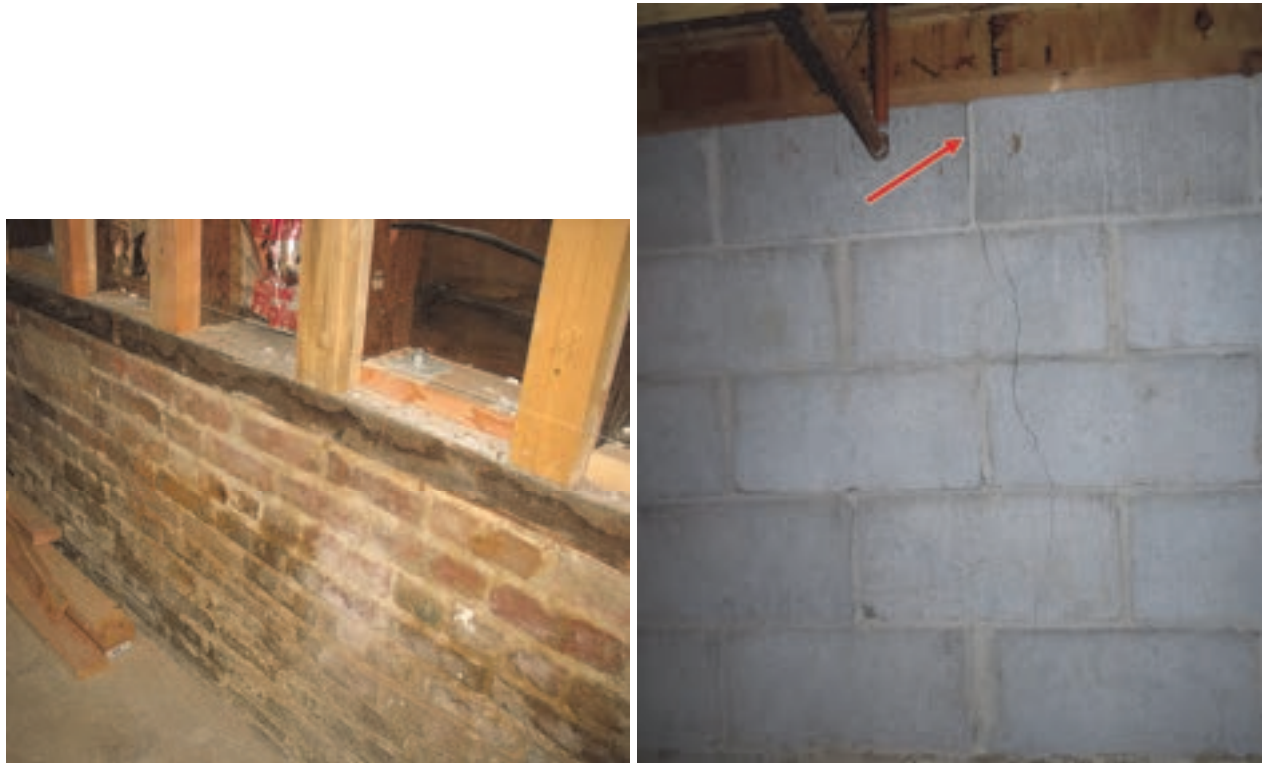
Figure 2-16 Typical brick masonry (left) and CMU (right) basement wall configurations, where cracking in the right photo was caused by the 2018 Anchorage, Alaska earthquake (photo credits: D. Bonowitz, left, and Z. Stutts, right).

See the discussion of concrete basement walls above. Earthquake damage to masonry basement walls can be similar to that associated with masonry stemwalls (discussed above) or retaining walls (see Chapter 5). Typical brick masonry and concrete masonry unit (CMU) basement wall configurations are depicted in Figure 2-16.

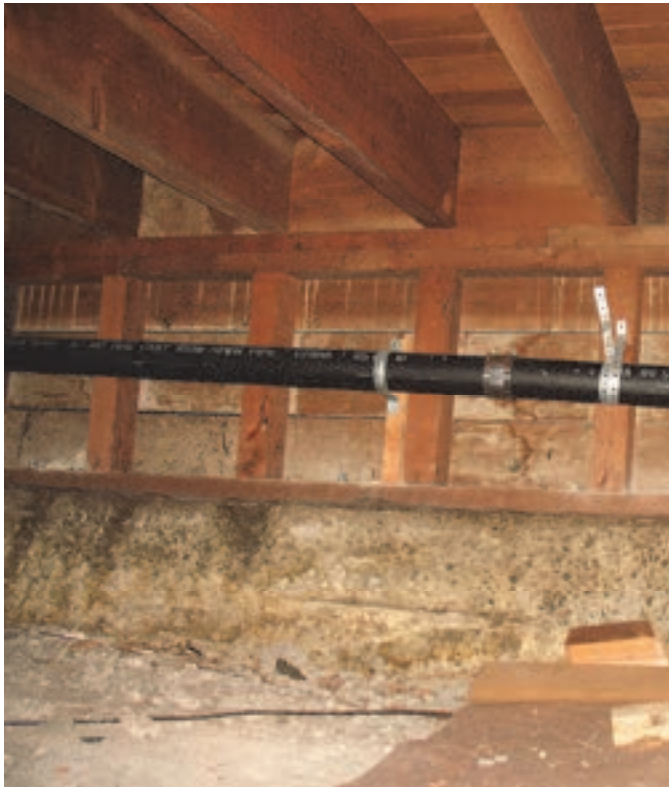
Figure 2-17 Sill plate below cripple wall framing of older house with steel post-installed anchor bolts attaching the sill plate to the foundation (photo credit: D. Bonowitz).

Wood-frame houses with continuous concrete or masonry foundations have wood sill plates (sometimes referred to as foundation sill plates or mudsills) that bear on the foundations and provide bases for wood wall studs or floor joists (see Figure 2-17). Sill plates in newer houses, particularly along perimeter wall lines, are almost always attached to the foundations with steel anchor bolts embedded into the concrete or masonry. Sill plates in older houses may not have steel anchors but may have been set into the wet concrete to provide some nominal attachment. In urban areas of California, it is rare to find a sill plate lying directly on a concrete footing with no attachment at all.

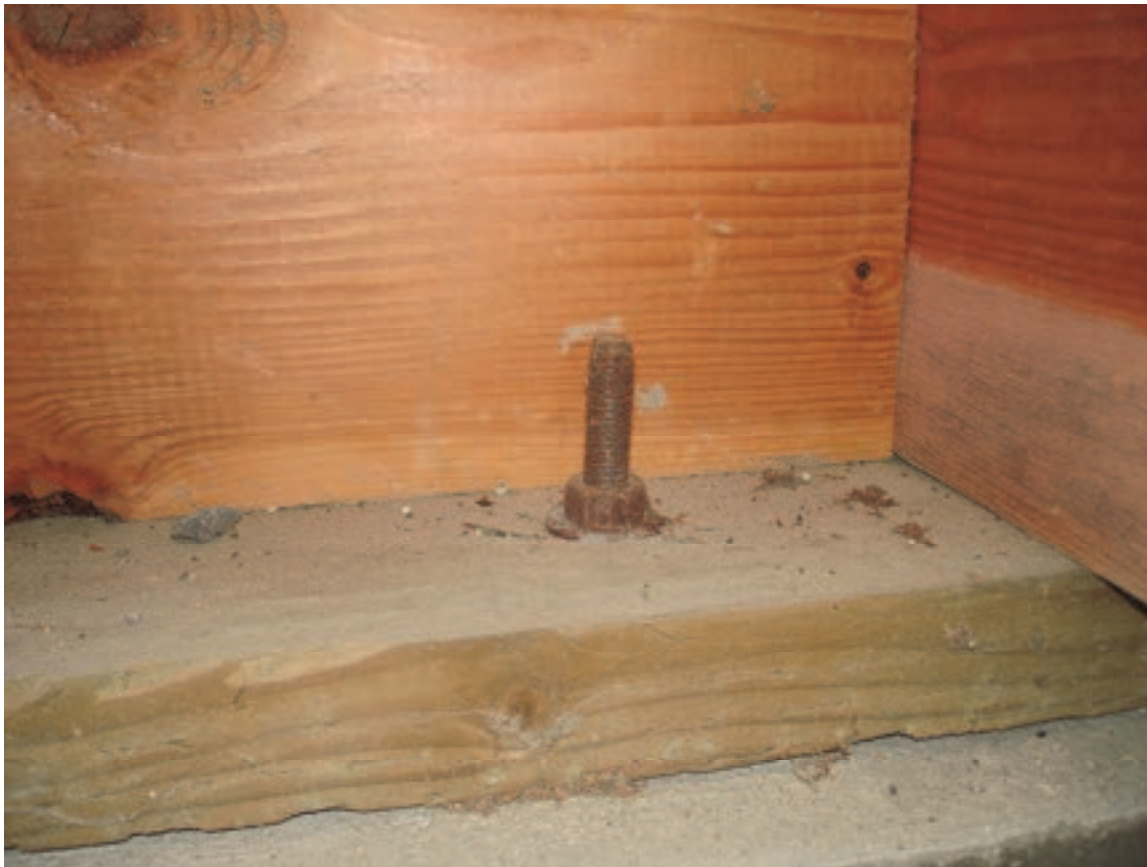
Figure 2-18 Typical steel cast-in-place anchor bolt attaching sill plate to concrete foundation (photo credit: E. Mikailian).

As discussed above, wood sill plates in all but the oldest houses are typically attached to foundations with embedded, or cast-in-place, steel anchor bolts (see Figure 2-18). Earthquake damage associated with steel cast-in-place anchor bolts can include splitting of the wood sill plates, deformation or fracture of the steel anchors, or damage to the concrete or grout surrounding the anchors (localized crushing of a sill plate around a washer can be caused by over-tightening of a nut or an under-sized washer). Fracture of steel anchors is rare and would typically be accompanied by damage patterns associated with sliding of the sill plates, as discussed in Section 2.2.1. Damage to the concrete or grout is typically in the form of fresh cracking or spalling of the concrete or grout around the anchor bolts and is most often associated with anchors installed with inadequate end or edge distances.

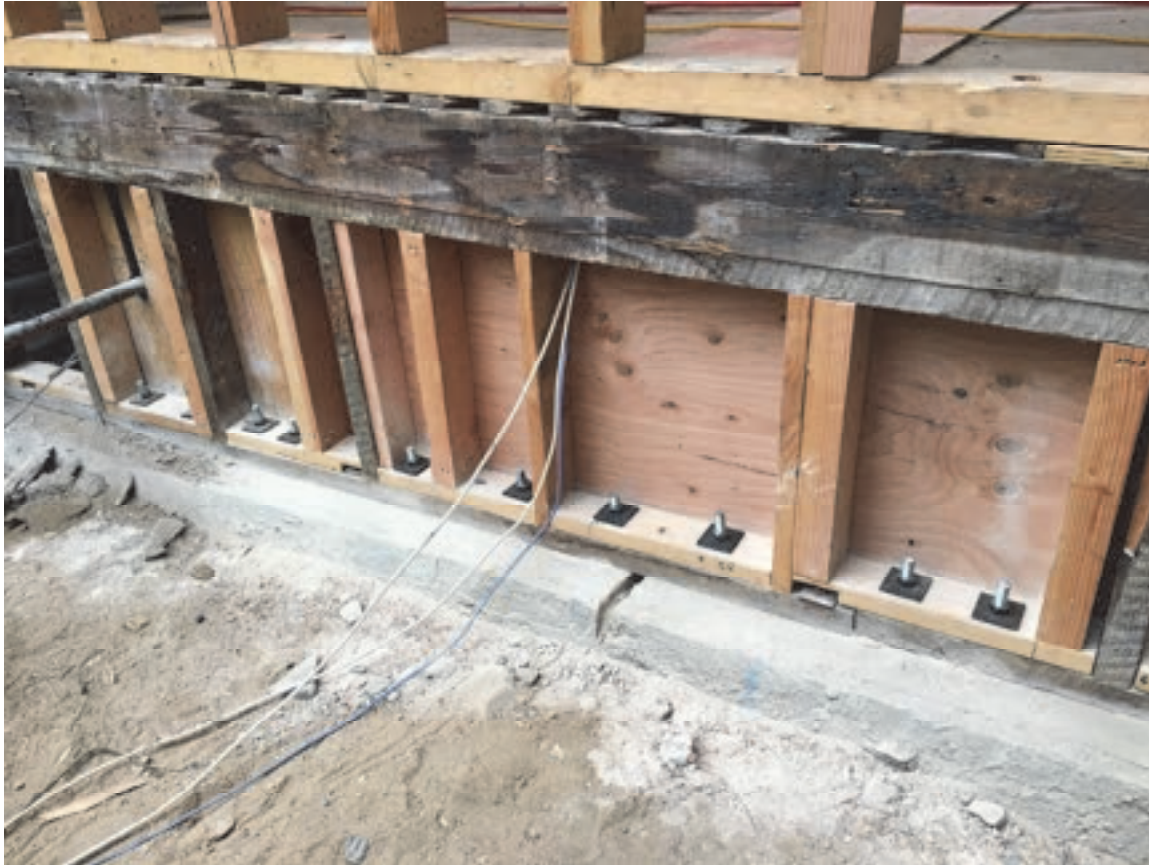
Figure 2-19 Steel post-installed anchor bolts associated with modifications to a house. These are adhesive anchors attached to an existing concrete foundation (photo credit: E. Mikailian).

Steel anchor bolts may be installed into hardened concrete or grout. Usually, such an installation is part of a seismic retrofit or other alteration made after original construction (Figure 2-19). The bolts can be expansion-type anchors or adhesive anchors. Earthquake damage patterns associated with steel anchor bolts installed into hardened concrete or grout are similar to those for steel cast-in-place anchors. These anchors can be more prone to pull-out failure if not adequately attached to the concrete or masonry.

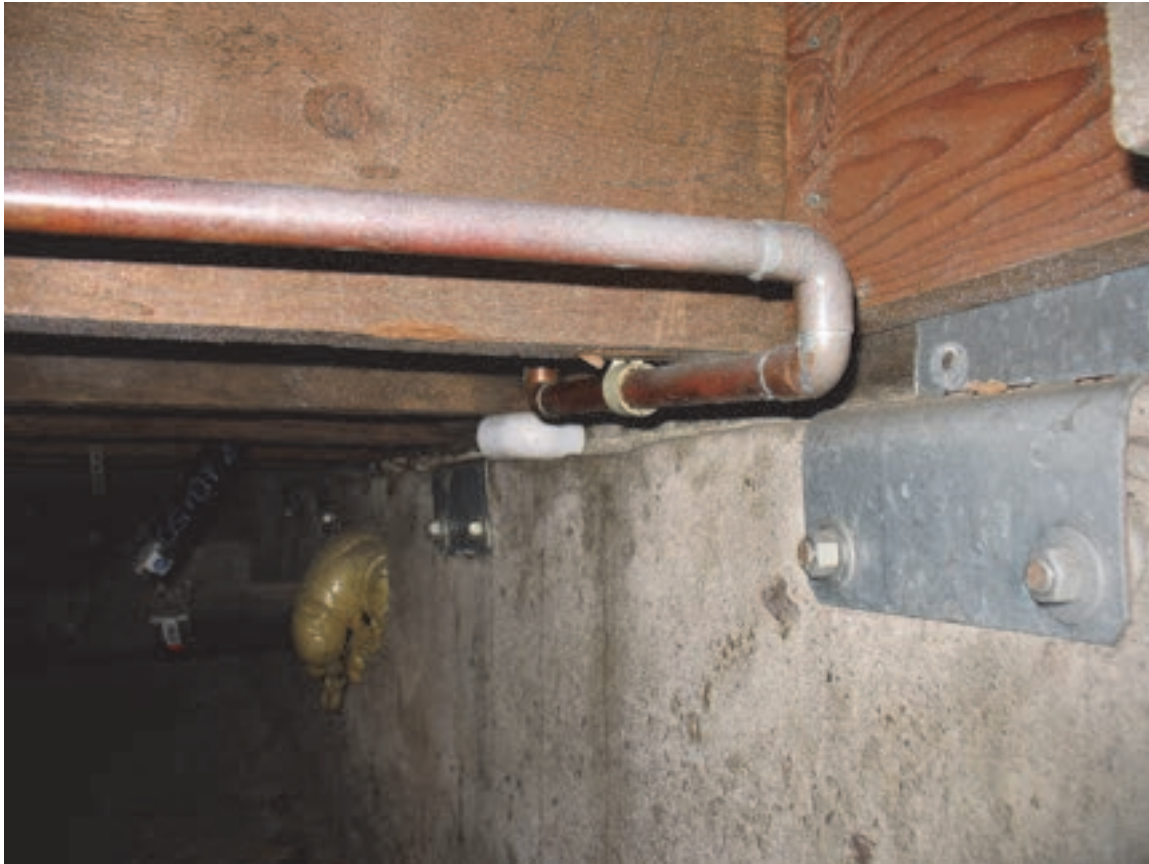
Figure 2-20 Steel post-installed plate connectors attaching a wood sill plate to a concrete stemwall. The connectors were installed as part of a seismic retrofit (photo credit: D. Bonowitz).

Steel plate connectors (sometimes referred to as retrofit plates) serve the same purpose as post-installed bolt anchors but are used where installation of bolt anchors is difficult. The steel plates are attached to the sides of sill plates with wood screws and attached to the concrete or masonry stemwalls with steel post-installed bolt anchors (Figure 2-20); the plates typically contain pre-drilled holes for inserting these fasteners into the sill plates and foundations. Earthquake damage associated with steel post-installed plate connectors is most likely to include splitting of the wood sill plates, deformation or fracture of the wood screws, or damage to the steel post-installed bolt anchors (see discussion above). Although unlikely, damage can also include deformation or fracture of the steel plates.
