Earthquake Damage Assessment and Repair Guidelines for Residential Wood-Frame Buildings

Volume 2 | ENGINEERING GUIDELINES

CEA-EDA-02 2020

Earthquake Damage Assessment and Repair Guidelines for Residential Wood-Frame Buildings, Volume 2 – Engineering Guidelines

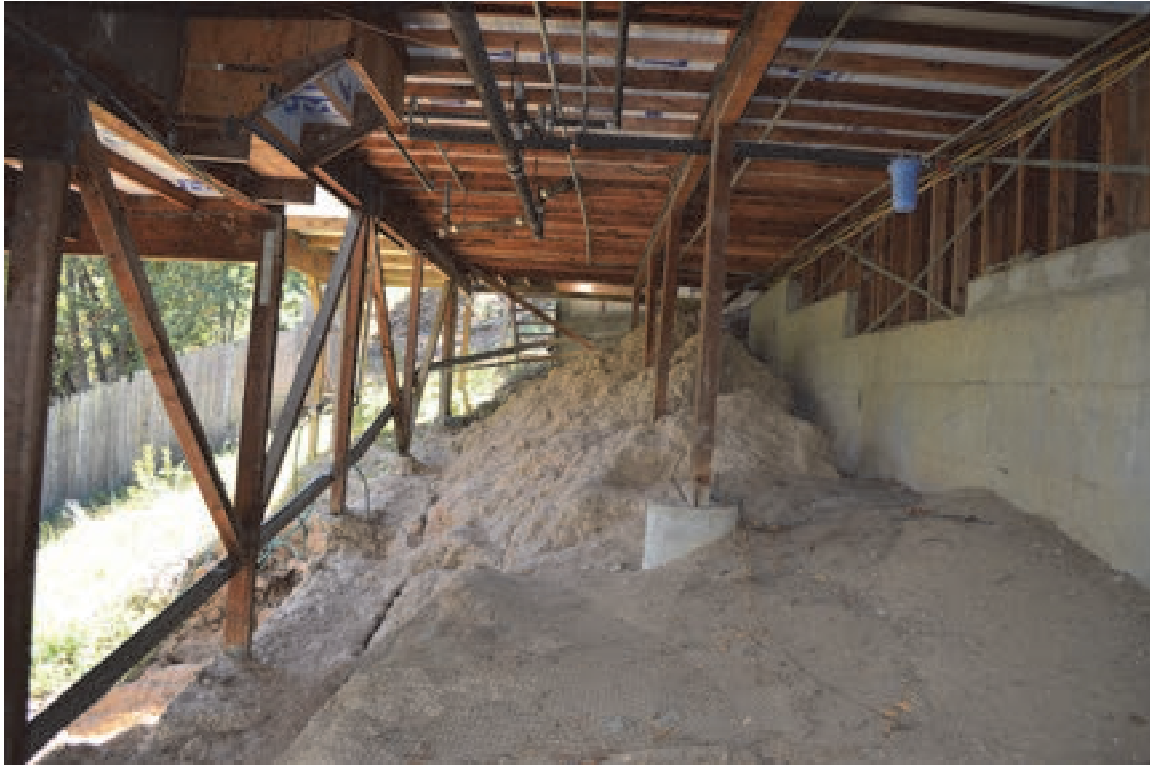
Figure 2-21 View of the framing connections to the uphill foundation (at right side of the photograph) at a hillside house (photo credit: Exponent).

The framing-to-foundation connections at the uphill end of a hillside house (Figure 2-21) can be prone to earthquake damage. These connection details can vary significantly, so earthquake damage can involve wood ledgers, wood sill plates, steel anchors, or other connection assemblies. If the connection is severed completely, the damage can manifest as loss of bearing for the floor joists, with associated damage to floor finishes and adjacent wall finishes.

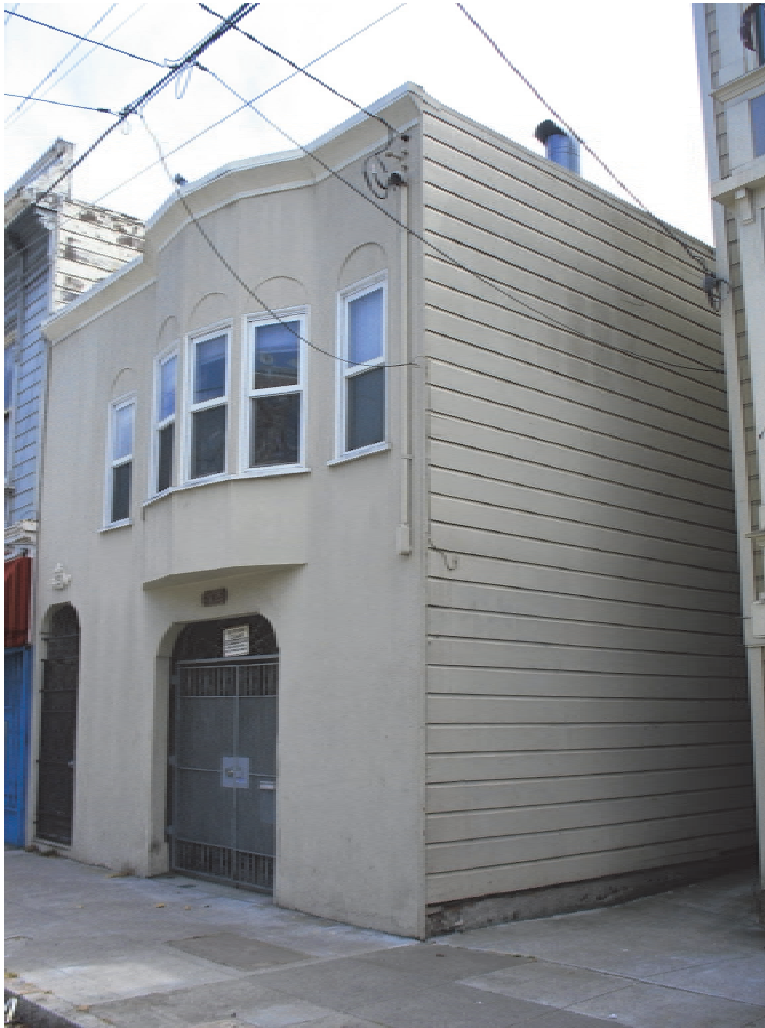
Figure 2-22 Horizontal wood siding (shiplap) on the side wall and stucco on the front face of a house with a living-space-over-garage condition (photo credit: D. Bonowitz).

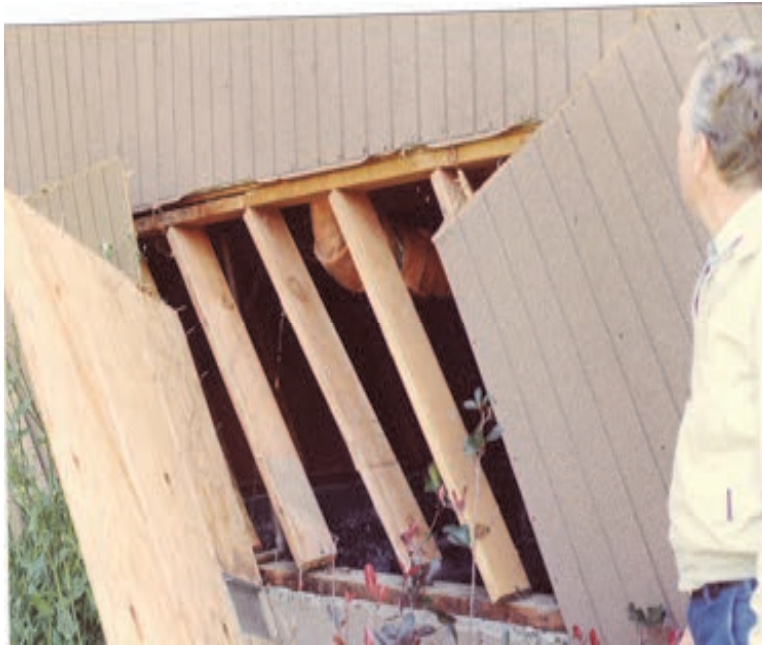
Figure 2-23 Plywood panel siding detached from cripple wall framing at a hillside house (photo credit: R. Gallagher).

Plywood is commonly used as an exterior wall finish material in houses, typically in the form of panels with decorative vertical grooves. Although these panels may not be considered structural sheathing, their earthquake damage patterns are similar to those of wood structural panels described below (Figure 2-23). Plywood panel siding that is edge nailed at all edges of each panel can effectively function as a shear wall. It is more common, however, to find edge nailing along only one of the two vertical panel edges. When installed in this manner, plywood panel siding retains some bracing capacity but much less than if the edges were fully nailed, and additional panel and framing deformation, as well as more frequent nail tear-out at panel edges, can occur with this installation.

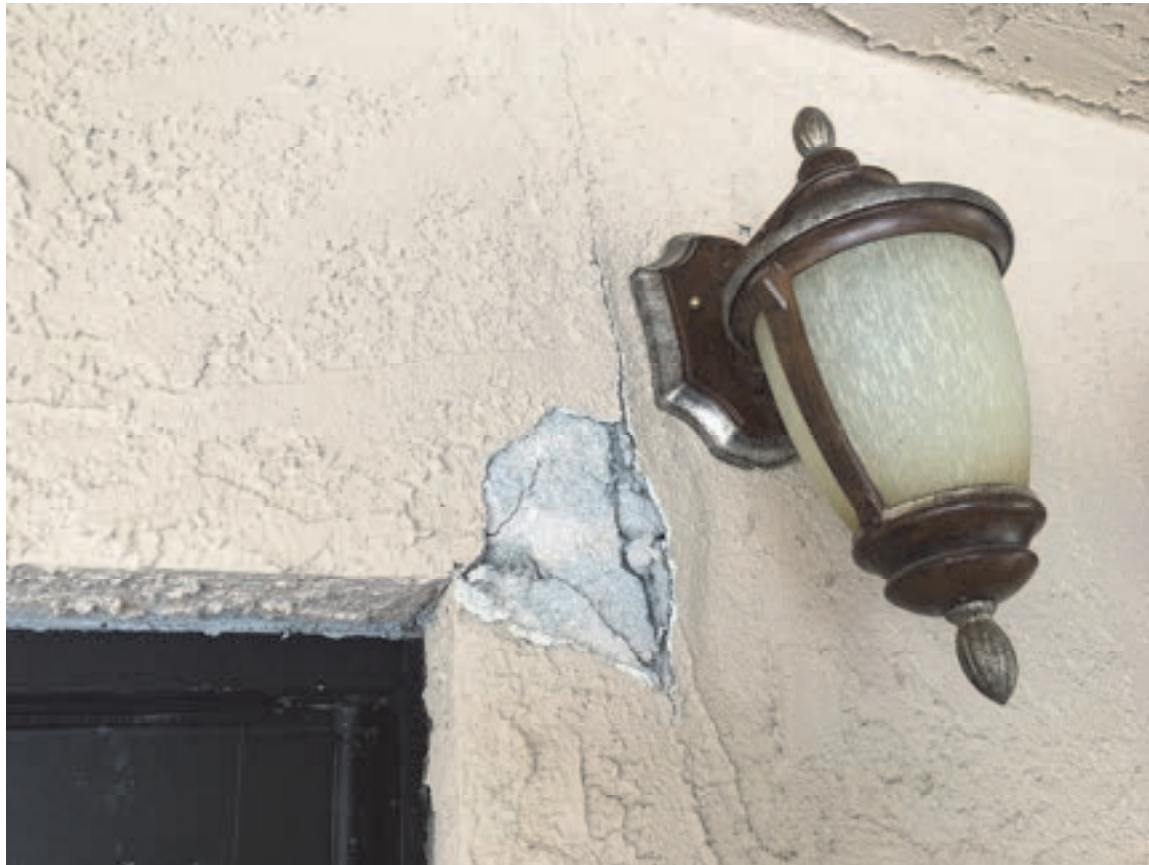
Figure 2-24 Stucco cracking and spalling at a door opening due to the 2019 Ridgecrest, California earthquake (photo credit: M. Ziemer).

The most common earthquake damage to stucco finishes includes diagonal cracking emanating from corners of door and window openings (Figure 2-24). As strong shaking continues, the cracks can extend from these openings, transitioning to longer horizontal cracks, and “X” cracks can form across a pier between openings. Spalling of the stucco along cracks can also occur. In more extreme cases, particularly where the lath connection is inadequate, large areas of stucco can detach from the wall framing. Earthquake damage to stucco can also manifest as a horizontal crack at the interface between the sill plate and foundation, associated either with in-plane sliding of the sill plate or out-of-plane deformation of the wall.

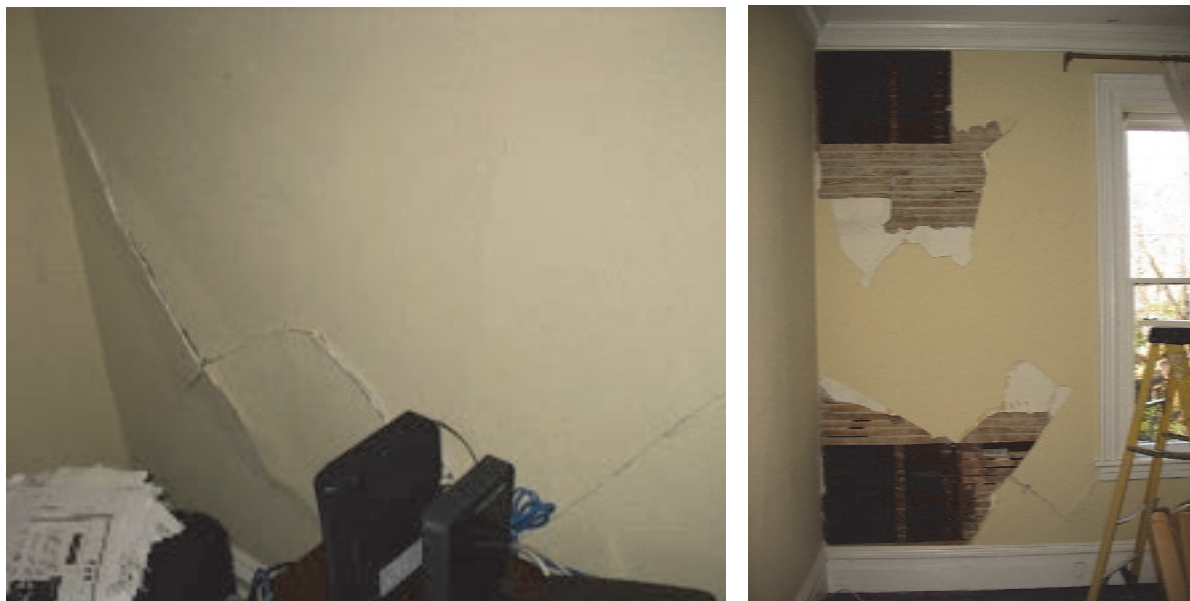
Figure 2-25 Detachment of plaster from wood lath (left) with destructive investigation (right) revealing that the wood framing had not sustained earthquake damage (photo credit: D. Bonowitz).

Plaster on wood lath is common in houses constructed prior to the 1940s. Its behavior during earthquakes is similar to that of weak stucco, including possible detachment of portions of the plaster from the lath during strong earthquakes (Figure 2-25). Plaster can provide significant bracing strength but often starts cracking and spalling at relatively low ground shaking and displacement levels.

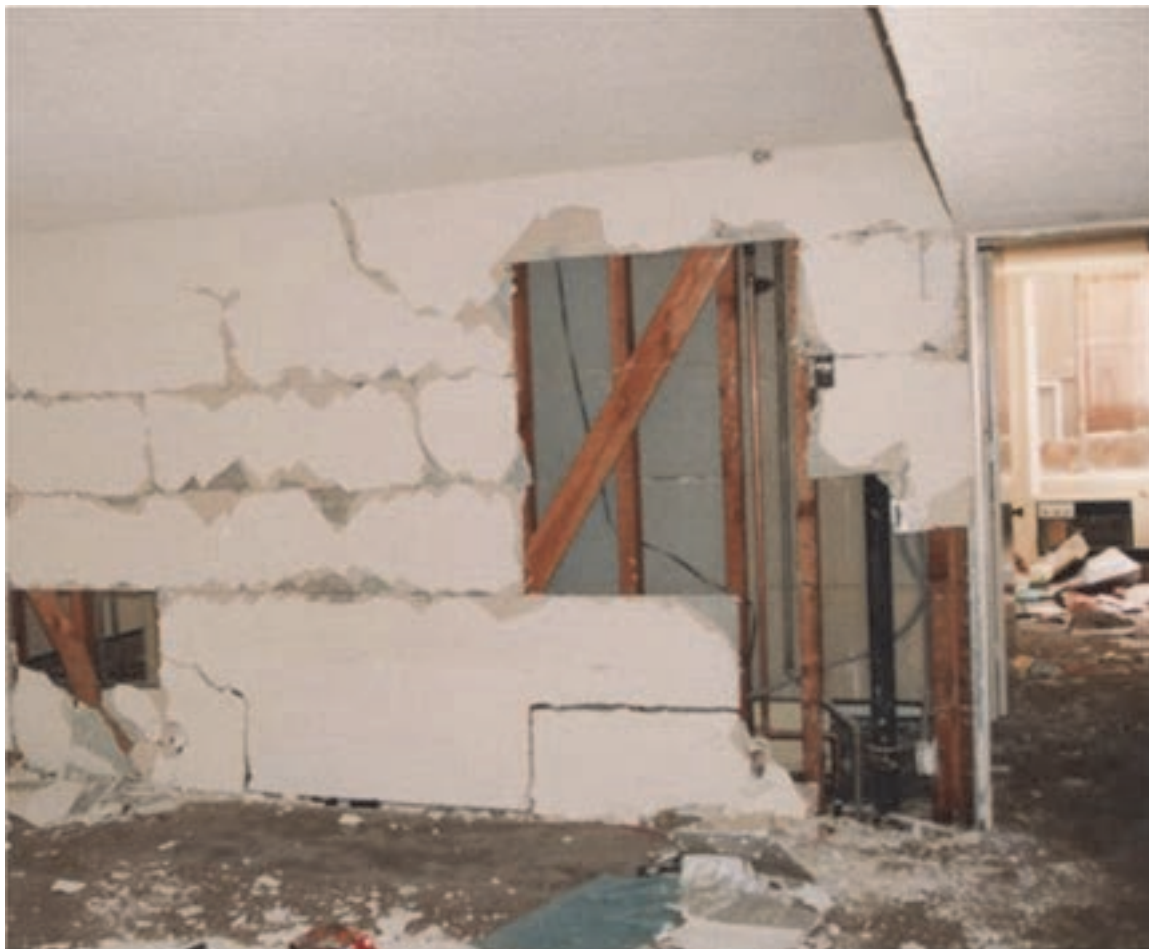
Figure 2-26 Earthquake-induced cracking and delamination of plaster on gypsum lath (photo credit: Exponent).

From the mid-1930s to the 1950s, interior wall finishes in houses transitioned from plaster on wood lath to gypsum wallboard. During that transition, many houses were built with plaster applied over gypsum lath panels. This wall finish system is sometimes called button board for the way the plaster is keyed to the gypsum panels with spaced round holes. Earthquake behavior at low displacement levels is similar to that of plaster on wood lath, including cracking. At higher displacement levels, behavior is more similar to that of gypsum wallboard (Figure 2-26).

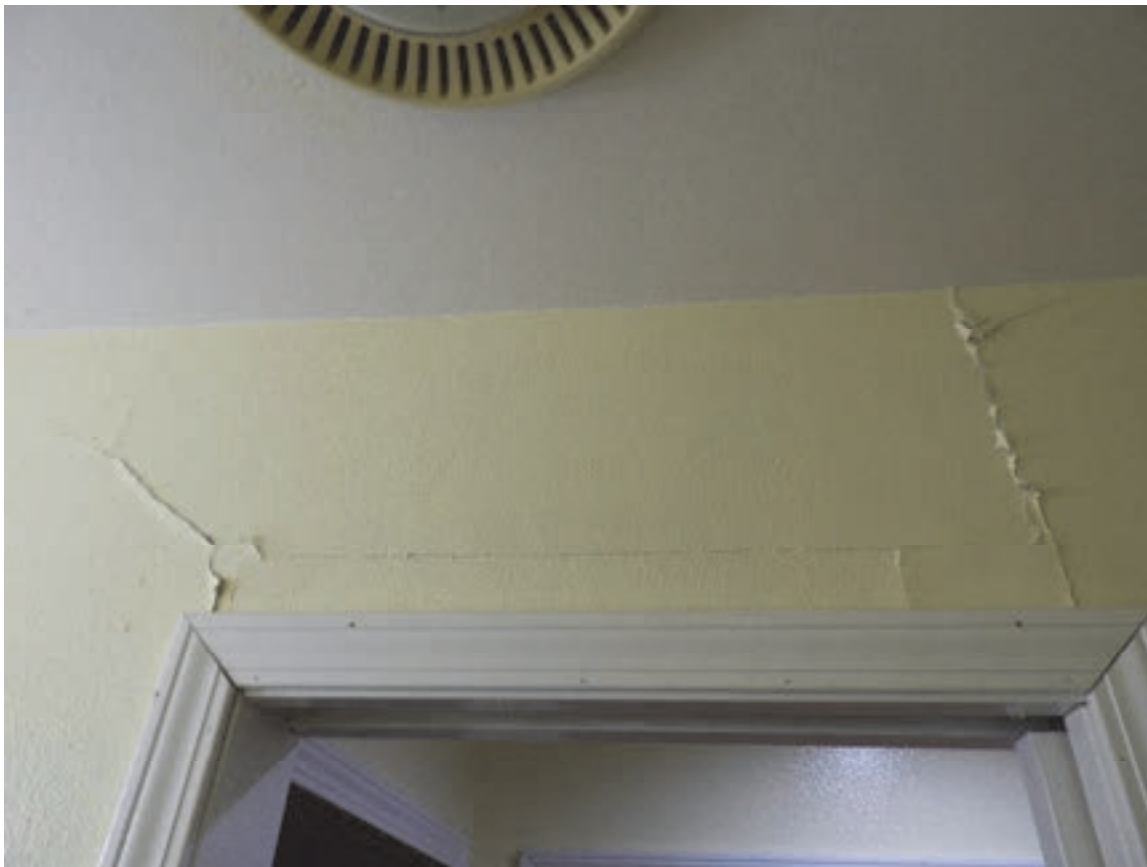
Figure 2-27 Cracking of gypsum wallboard at corners of door opening caused by the 2018 Anchorage, Alaska earthquake (photo credit: Z. Stutts).

Gypsum wallboard, also called drywall, is the most common interior wall finish material in houses built after the 1940s. Cracking of gypsum wallboard at corners of door and window openings is common in moderate-to-strong earthquakes, and cracking can also occur along taped joints between wallboard panels (Figure 2-27) and corner beads. Gypsum wallboard nails can work loose or pull out under earthquake shaking (or from other causes), leaving a pattern of raised nail heads discernible through the paint or taped finish. Where attached with screws, pullout is less likely, but with enough in-plane racking of the panel, the screws can gouge a slot in the drywall sheet not easily observed from the finished side. This “slotting” along the back sides of the panels reduces their stiffness in subsequent cycles of earthquake shaking. In more severe earthquakes, the panels may detach from the wall framing.

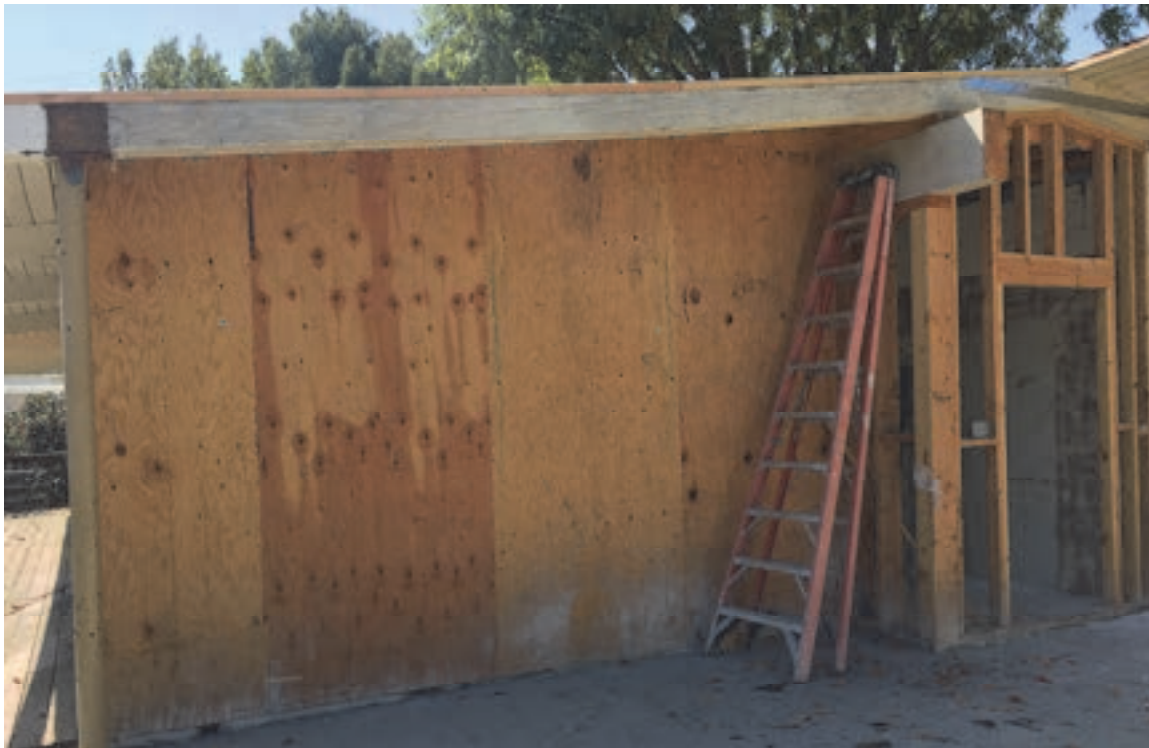
Figure 2-28 Wood structural panel (plywood) sheathing revealed by the removal of exterior finishes (photo credit: E. Mikailian).

Wood structural panel (WSP) sheathing is a general category that includes plywood (Figure 2-28) and oriented strand board. Particleboard and fiberboard sheathing, although less common in California, are grouped with WSP sheathing in these *Engineering Guidelines* because their use in seismic-force-resisting systems and their earthquake damage patterns are similar. A California house (or addition) built after about 1990 is likely to have a seismic-force-resisting system consisting of WSP-sheathed shear walls, although houses are still constructed without it. WSP sheathing is also found in retrofitted older houses, especially applied to the inside face of cripple wall studs.

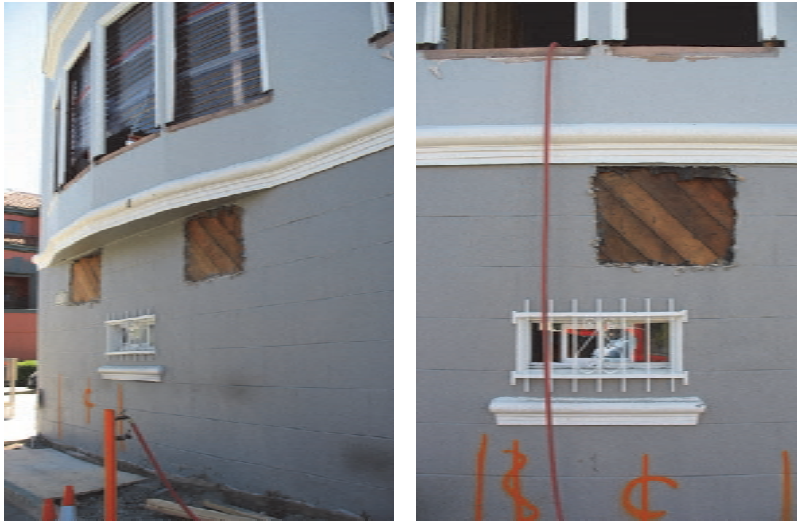
Figure 2-29 Diagonal lumber sheathing revealed by the removal of exterior finishes (photo credit: D. Bonowitz).

Prior to the mid-20th century, diagonal lumber sheathing (Figure 2-29) was used as a wall bracing system in many houses. Diagonal lumber sheathing typically consists of 1-inch thick boards laid diagonally across the wall framing and nailed to the studs and plates. Diagonal lumber sheathing is stiffer and stronger than horizontal lumber sheathing (discussed below). Earthquake damage to diagonal lumber sheathing includes splitting of the boards around nailed connections and, at higher shaking intensities, splitting of the wall framing to which the boards are attached.

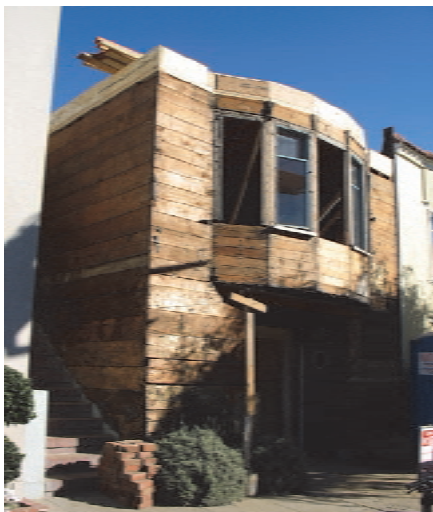
Figure 2-30 Horizontal lumber sheathing revealed by the removal of exterior finishes (photo credit: D. Bonowitz).

Horizontal lumber sheathing, particularly underlying the exterior wall finishes, is common in houses built before the mid-20th century (Figure 2-30). Behavior of horizontal lumber sheathing during earthquakes is similar to that of horizontal wood siding.

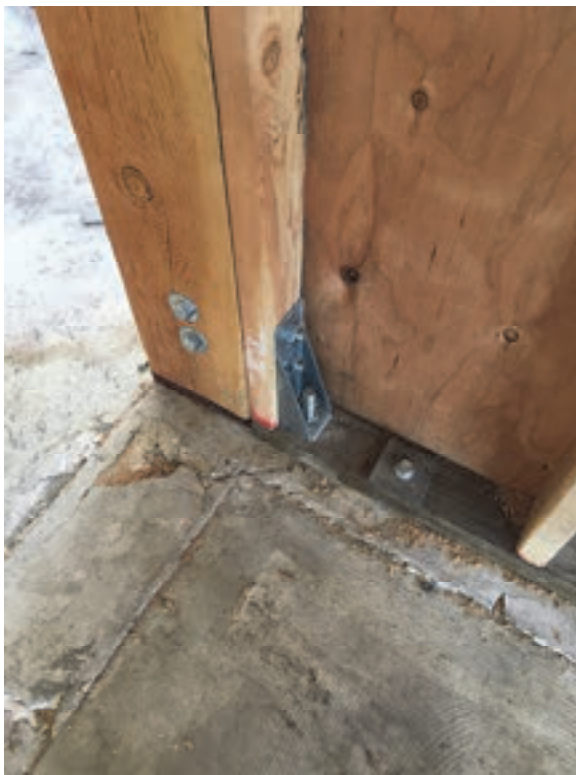
Figure 2-31 Tie-down at end of wood structural panel shear wall (photo credit: E. Mikailian).

Tie-down hardware is sometimes found in newer houses with an engineered design, particularly at the ends of narrow shear walls (Figure 2-31). Similar hardware is used in combination with posts to provide load paths for overturning effects between shear walls in successive stories. Common anchorage systems include proprietary bracket-type tie-down devices, light-gauge metal straps, and threaded rods used in stacked shear wall systems. All these devices are intended to resist tension forces associated with uplift of the shear walls.

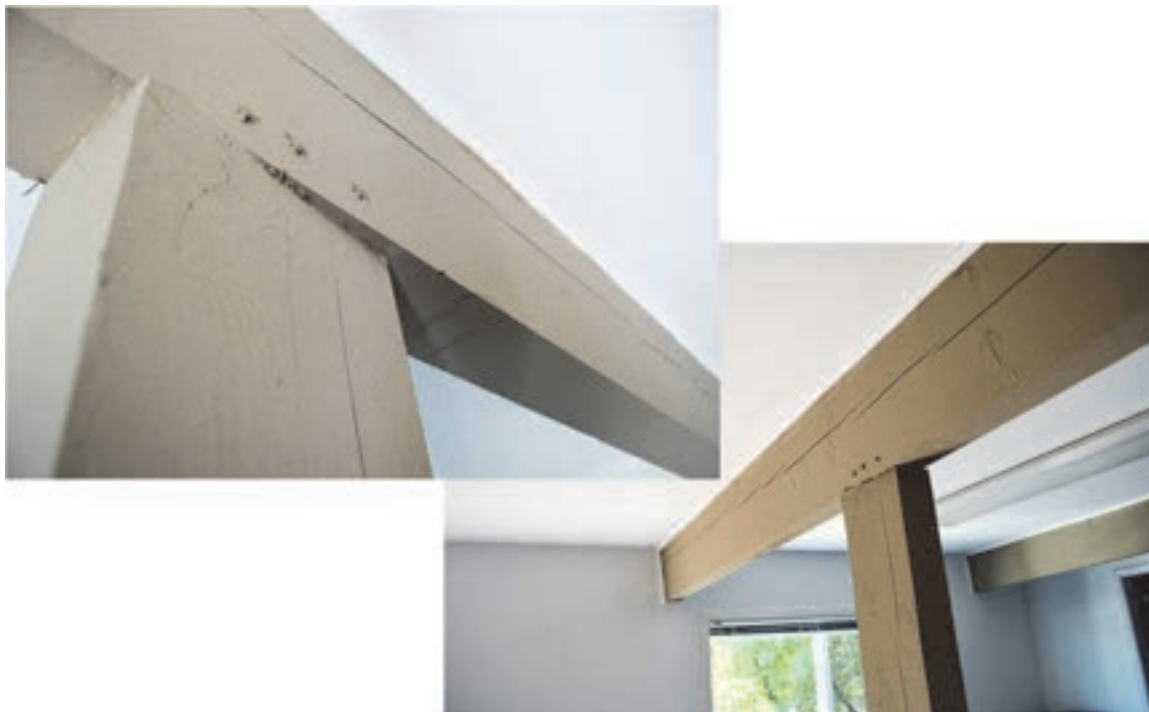
Figure 2-32 Gravity-load-carrying post supporting a beam. The two members, which are toe-nailed together, are misaligned, but lack of an unpainted surface indicates no recent relative movement (photo credit: Exponent).

Although generally not a part of seismic-force-resisting systems, gravity-load-carrying elements such as posts (Figure 2-32) can experience residual drift or shifting due to earthquakes. Posts with inadequate connections at the tops or bottoms are more susceptible to these damage mechanisms. Recent shifting at post connections is typically accompanied by freshly exposed wood surfaces along the connections and distress to connection fasteners, if present.

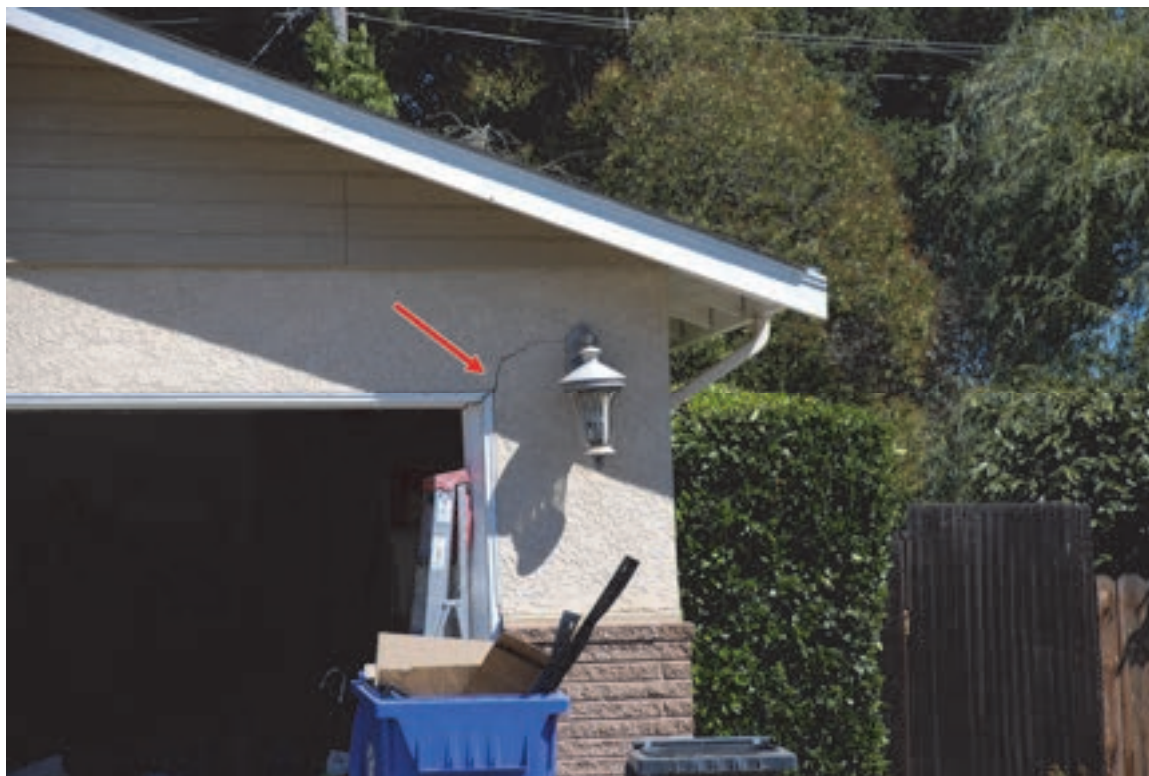
Figure 2-33 Concentrated earthquake damage to stucco at the top of a narrow wall segment adjacent to a garage door (photo credit: K. Cobeen).

Earthquake damage to portal frames can include concentrated damage to the sheathing or straps at the connections between the narrow wall piers and the beams (Figure 2-33). Concentrated damage to the sheathing and anchors may also occur at the bases of narrow wall piers, associated with rocking of the piers.

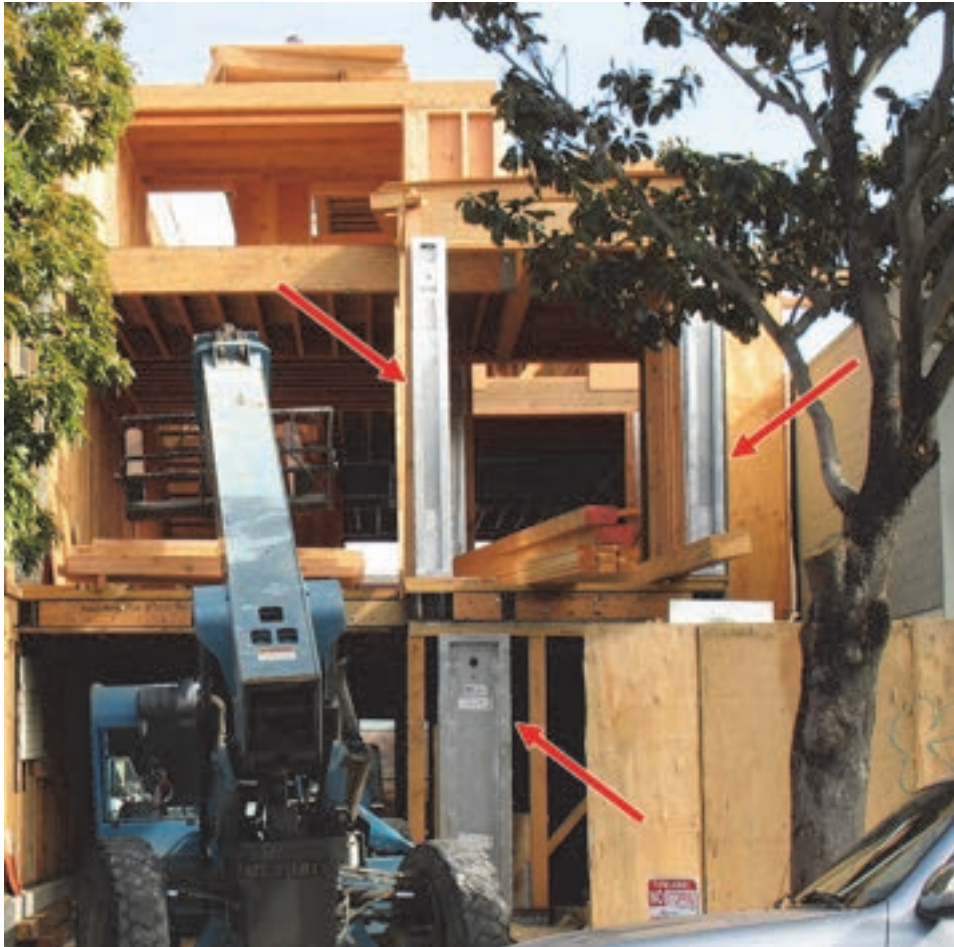
Figure 2-34 Proprietary shear walls at narrow wall piers between large window and door openings (photo credit: D. Bonowitz).

Pre-engineered, manufactured wall panels may be used on new houses or be used for retrofitting existing houses (Figure 2-34). These proprietary systems are typically used where the available wall length is narrow, for example on either side of a wide garage door. With typically high shear capacity and high aspect ratios, proprietary wall panels require careful detailing of boundary elements and base attachments. Earthquake damage to these panels includes separation of the panels from the surrounding wood framing and damage to the tie-downs.

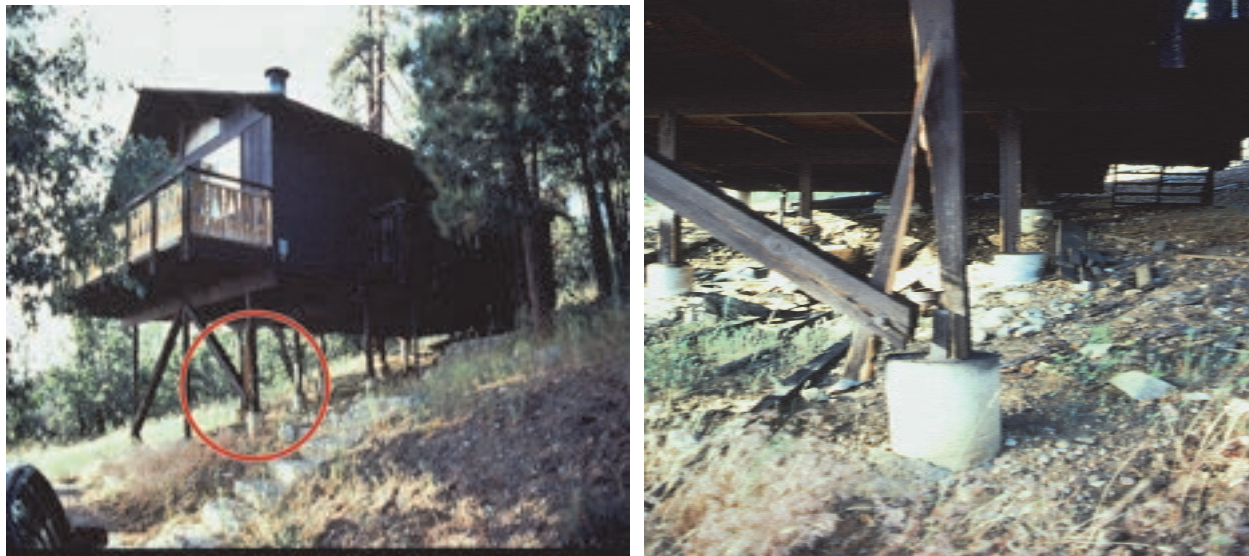
Figure 2-35 Damage at bolted connection of diagonal lumber bracing to post at hillside house. Damage at the connection includes splitting of the diagonal lumber brace and fracture of the post (photo credit: R. Gallagher).

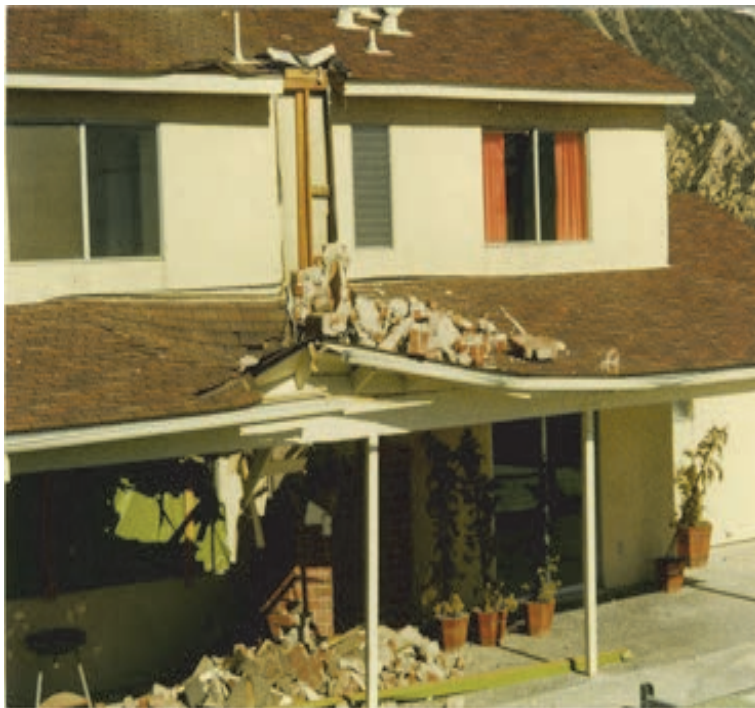
Figure 2-36 Damage to porch roof framing caused by chimney collapse (photo credit: R. Gallagher).

Damage to floor, ceiling, or roof framing in earthquakes is rare and is typically associated with forces imparted by adjacent chimneys (Figure 2-36) or other heavy elements attached to walls, separations at framing discontinuities, or loss of vertical supports due to damaged foundations, posts, or wall framing. Significant damage to floor, ceiling, or roof framing will typically be accompanied by conspicuous damage to their finishes.

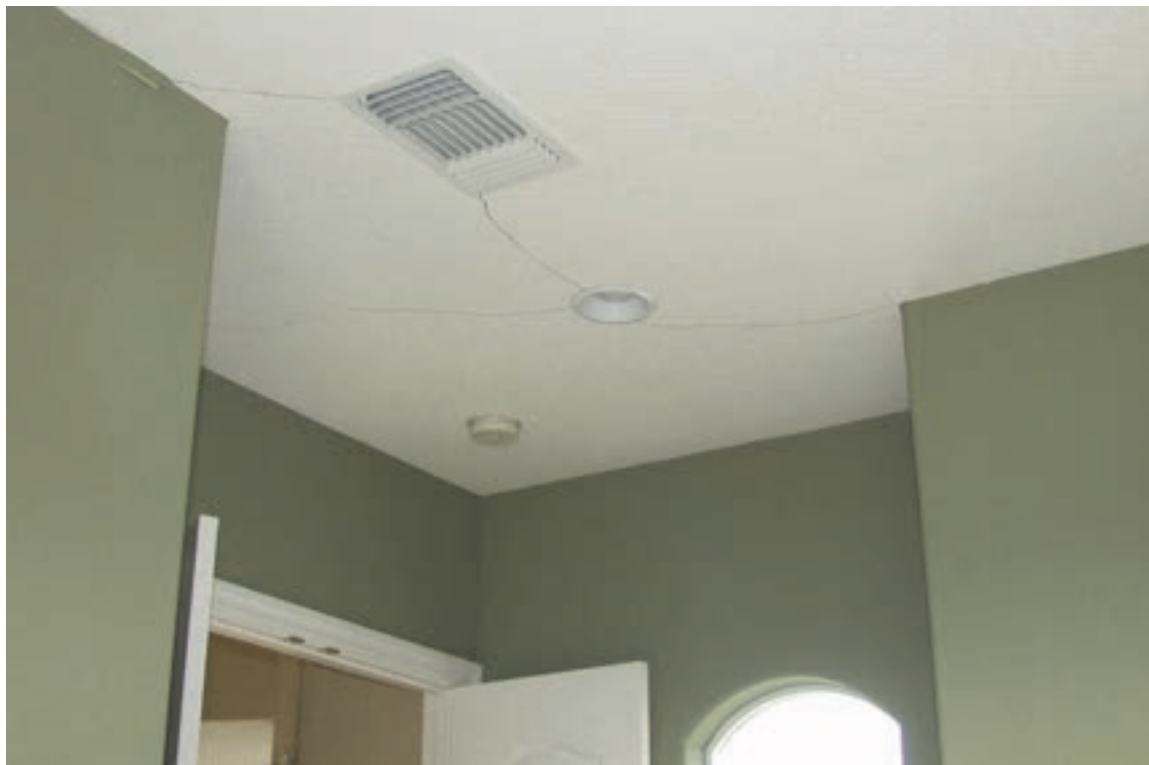
Figure 2-37 Cracking of ceiling finishes caused by the 2003 San Simeon, California earthquake (photo credit: Exponent).

Like floor diaphragms, structurally significant earthquake damage to ceiling diaphragms is rare. Cracking of brittle ceiling finishes, such as gypsum wallboard and plaster, can occur at relatively low intensity shaking but is usually not structurally significant (Figure 2-37). Damage patterns to these finishes are similar to those of similar materials used as wall finishes. Damage to ceiling diaphragms may also occur where the ceiling finishes are continuous across discontinuous framing, such as at split levels, stairwells, or where the joist directions change. In one-story houses or in the uppermost story of multi-story houses, ceiling finishes typically serve as the diaphragm sheathing for ceilings, except in cases of attics with floor systems.

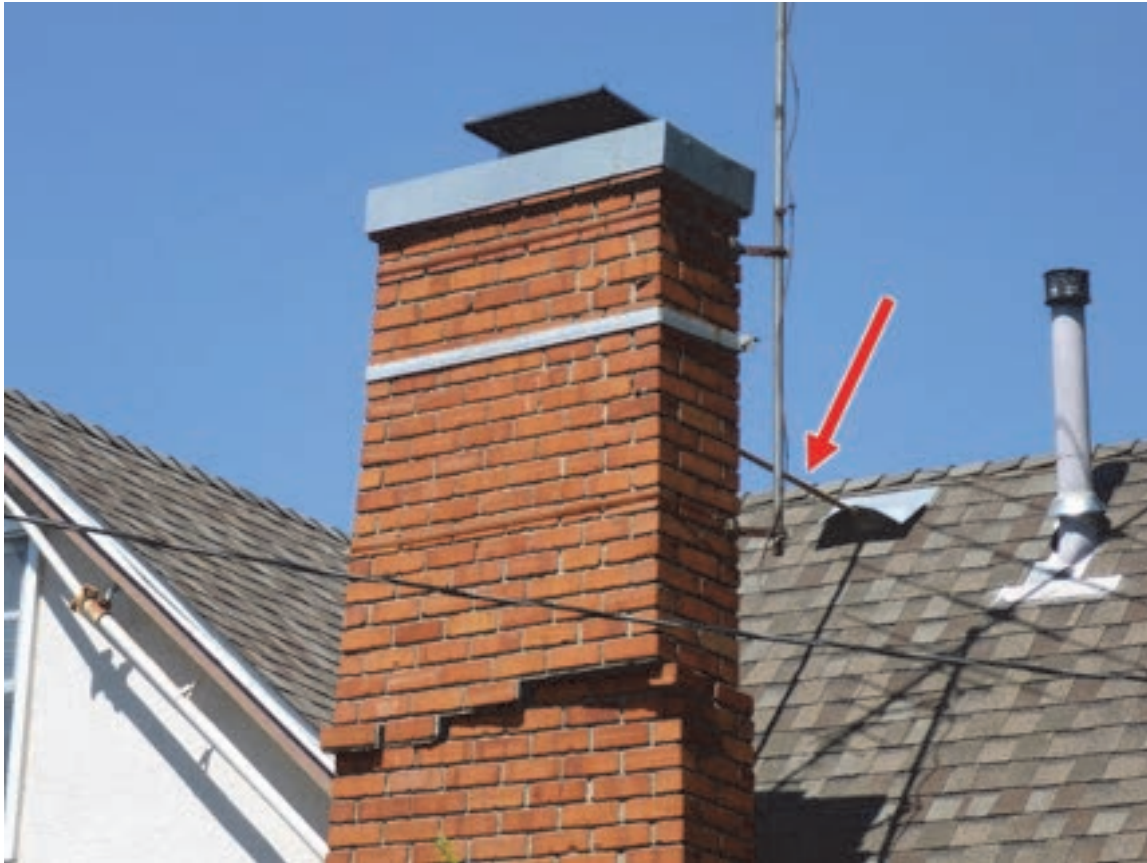
Figure 2-38 Earthquake-induced fractured chimney near the roof line. The brace between the chimney and roof, visible behind the chimney, was not adequate to prevent the damage (photo credit: Exponent).

Masonry chimneys are among the most vulnerable elements of houses. Unreinforced chimneys are vulnerable to cracking near rooflines (Figure 2-38), sometimes breaking away and falling. If the top portion of a chimney falls onto the roof, it can cause damage to the roofing and roof framing. Reinforced chimneys can separate from adjacent walls (Figure 2-39) and exhibit residual outward leaning following earthquakes. Many chimneys were built with steel straps embedded in the masonry and attached to floor or roof framing. Where inadequately connected, the straps can pull out, damaging the framing members or roof sheathing.

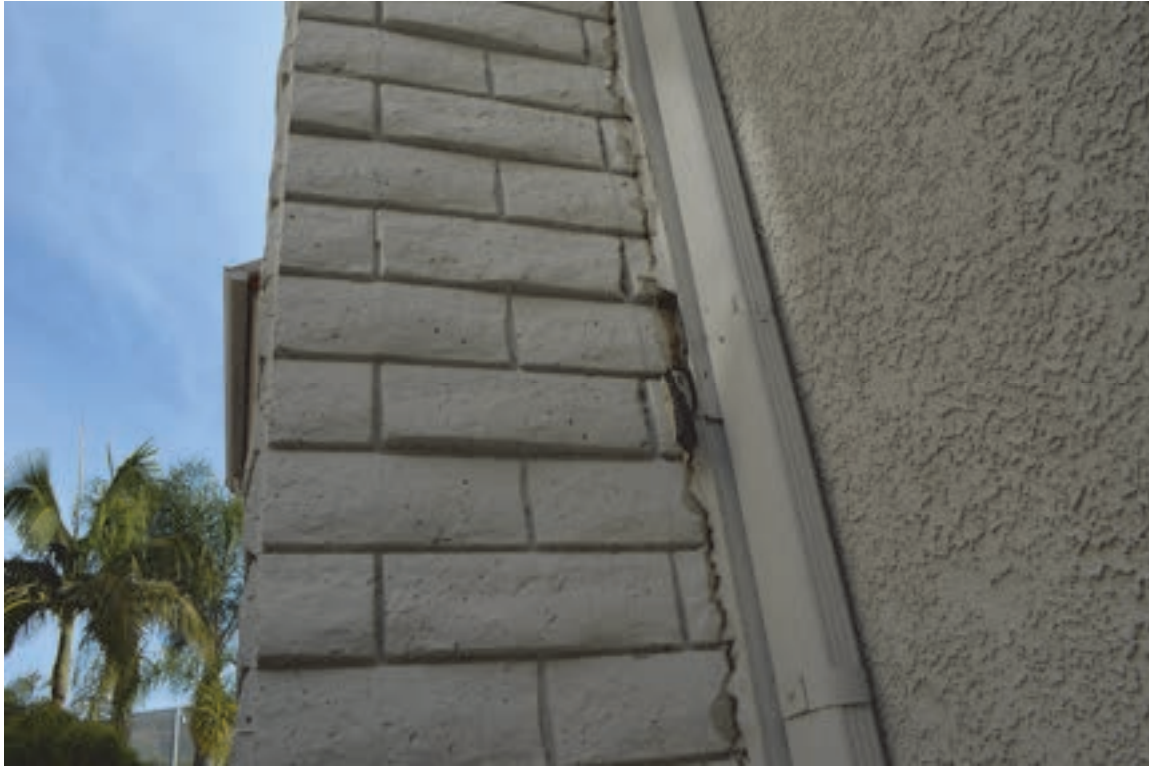
Figure 2-39 Separation of chimney from house caused by the 2014 La Habra, California earthquake. The separation was relatively minor, and the chimney remained attached to the house (photo credit: Exponent).

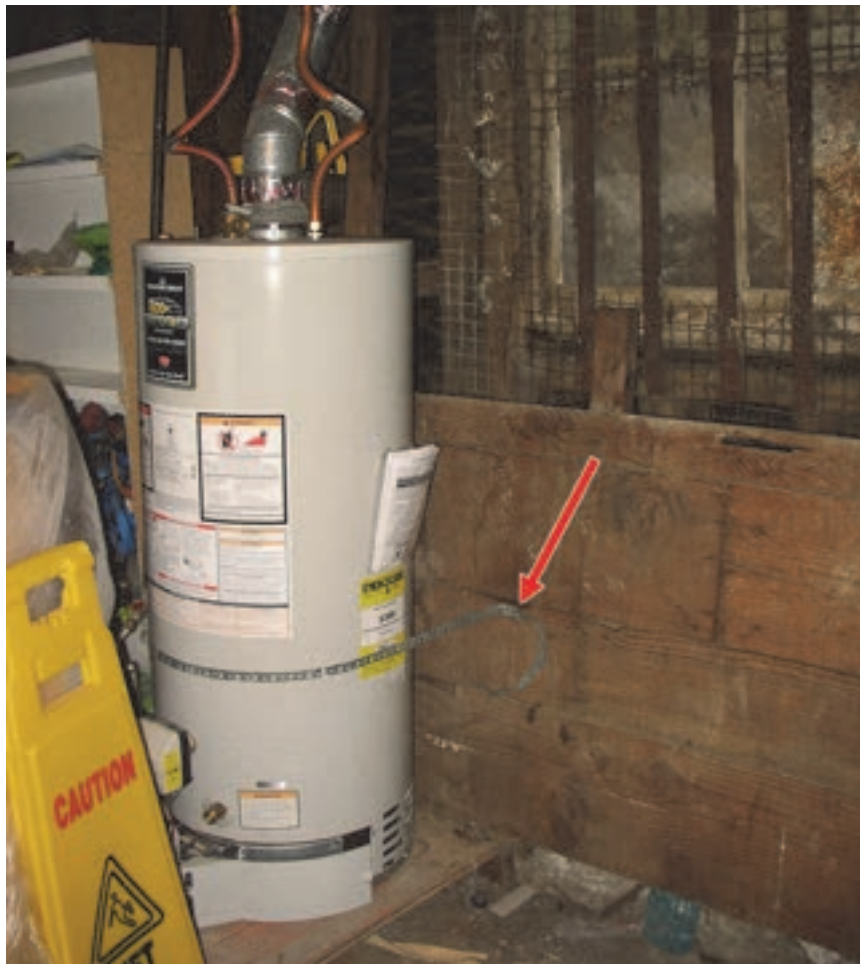
Figure 2-40 Inadequately strapped water heater (photo credit: D. Bonowitz).

Common MEP components of houses include water heaters, furnaces, air conditioning units, and pool or spa equipment, as well as their associated piping. Many of these MEP components in modern houses are anchored or braced; similar components in older houses are frequently unanchored and unbraced. Water heaters in older houses are likely to have been strapped to the adjacent wall if the water heaters have been recently replaced or if the properties have been recently purchased; however, poorly installed or anchored water heater straps are common (Figure 2-40).

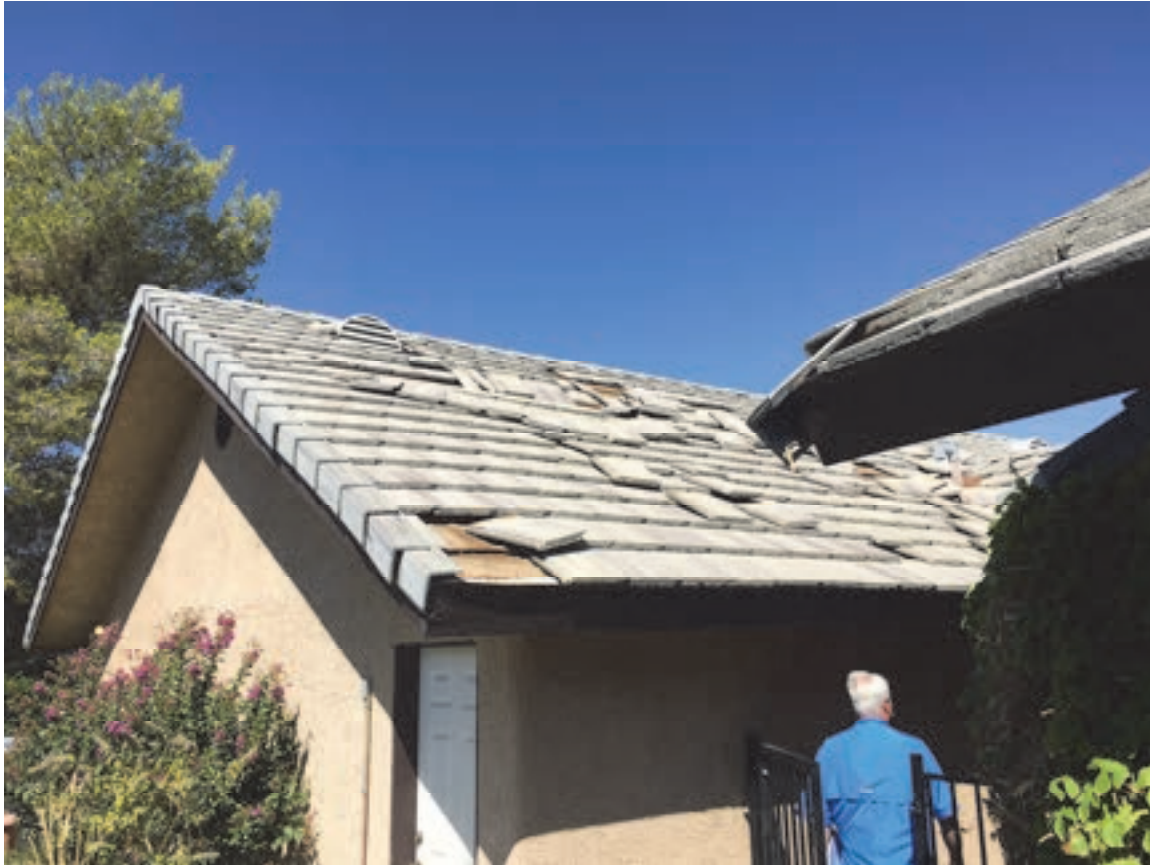
Figure 2-41 Displaced roof tiles caused by the 2019 Ridgecrest, California earthquake (photo credit: M. Ziemer).

Houses typically contain a wide variety of architectural components that can become damaged or dislodged during earthquakes. Common components include clay or concrete roof tiles and brick or stone veneer. Roof tiles can become loose and present falling hazards in the event of aftershocks (Figure 2-41). Brick or stone veneer that is inadequately anchored to walls may separate from the walls or collapse.

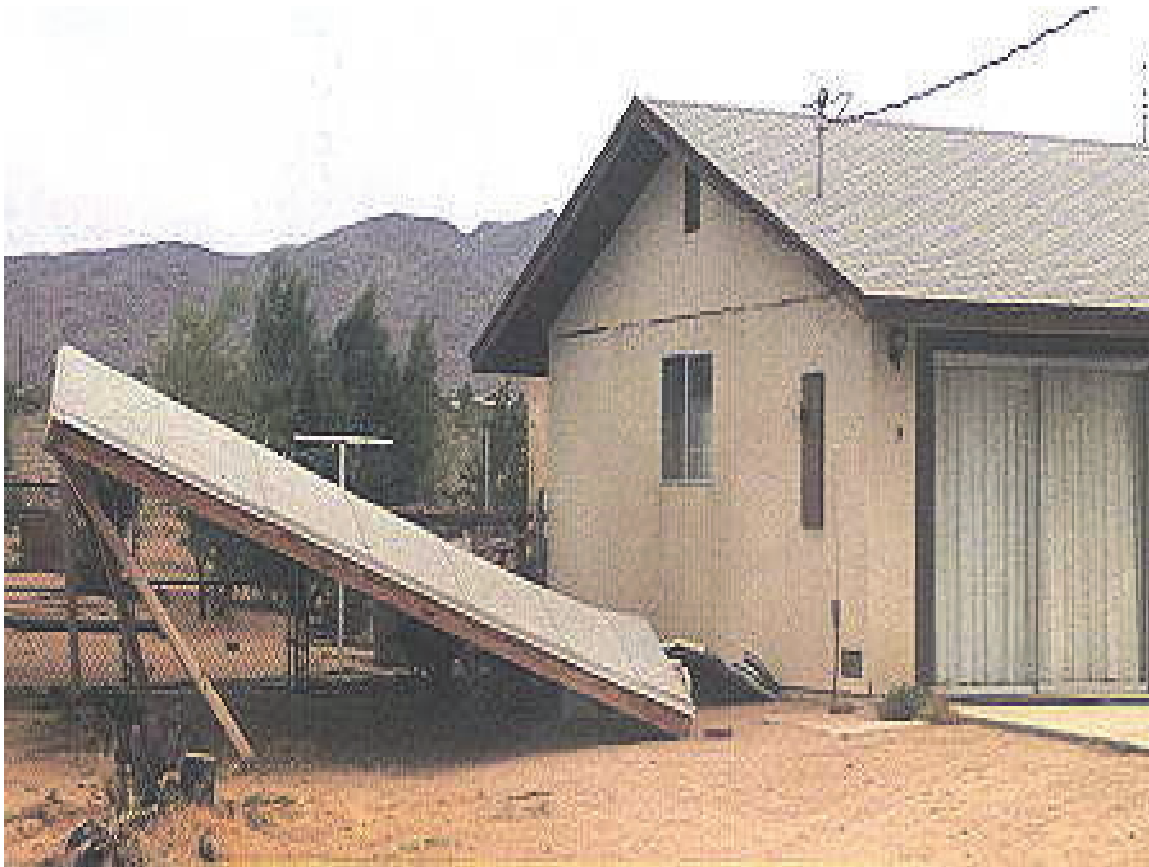
Figure 2-42 Earthquake-caused detachment of the carport from the house wall, resulting in collapse (photo credit: California Office of Emergency Services).

Earthquake damage tends to concentrate where parts of a house with different construction abut or attach to each other. This often occurs at appurtenances, such as exterior decks, porch roofs, carports, or patio covers, where the damage is likely to include cracked finishes, damage to ledgers or fasteners, and residual separations. An appurtenance with no seismic-force-resisting system of its own may be vulnerable to collapse if its attachment to the main structure is damaged (Figure 2-42). Damage to an appurtenance, such as a deck at an entry door, can block ingress and egress to a house

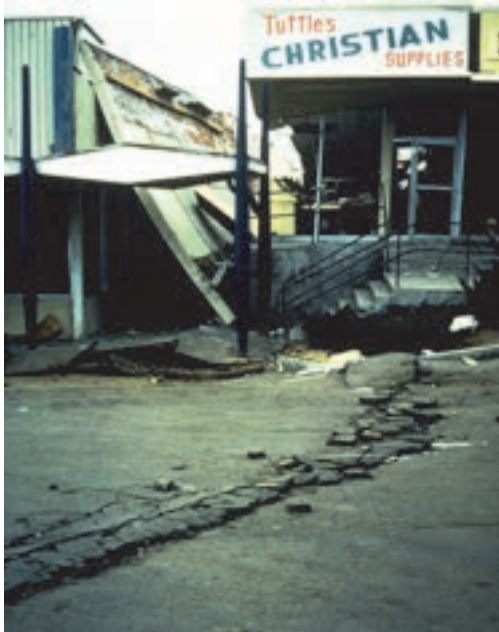
Figure 5-1 Surface fault rupture from the 1971 San Fernando, California earthquake and associated damage to pavement and structures in the Sylmar area (photo credit: National Information Service for Earthquake Engineering, or NISEE).

When fault slip extends to the ground surface, the resulting ground displacements are termed “surface fault rupture” (Figure 5-1). Examples from California with surface fault rupture include the 1906 San Francisco, 1971 San Fernando, 1992 Landers, and 1999 Hector Mine earthquakes.

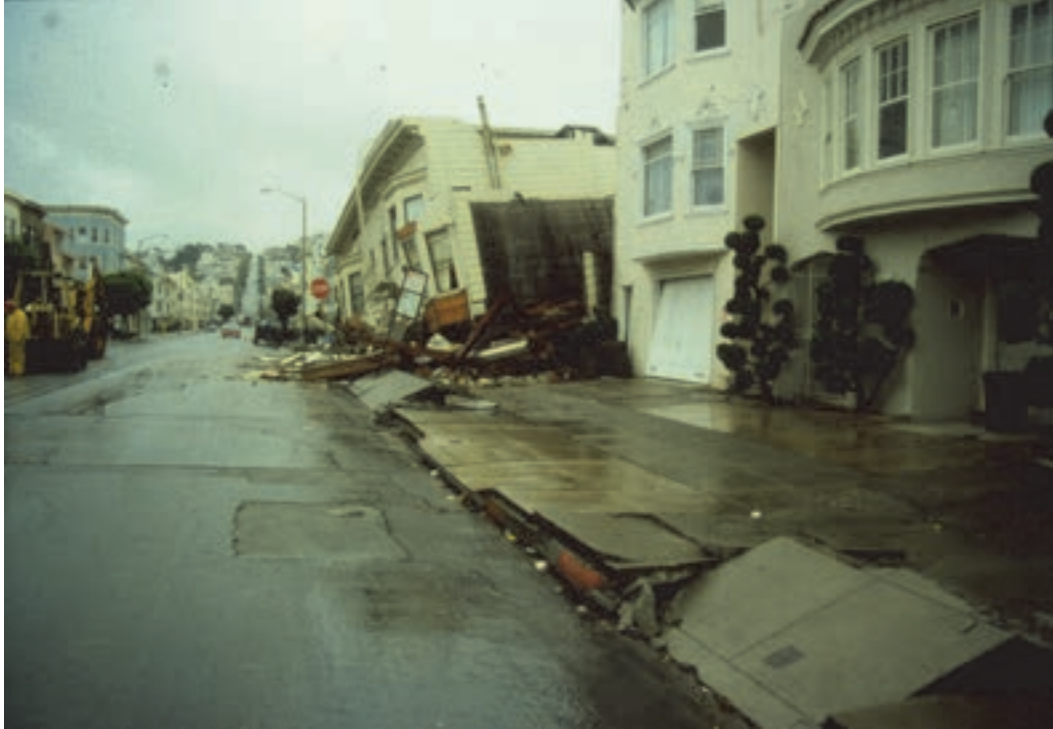
Figure 5-7 Buckled pavement from liquefaction-induced ground oscillations, San Francisco Marina District, 1989 Loma Prieta, California earthquake (Seed et al., 1990).

When liquefaction effects are manifest at the ground surface, such effects may take the form of sand boils and ejecta, settlement, ground fissures, lateral spreads, and landslides (e.g., flow failures). In the absence of driving static shear stresses, liquefaction can result in large transient ground oscillations that can lead to buckled or cracked pavements and curbs and broken pipelines (Figure 5-7). Such damage will typically not have a consistent pattern of lateral displacements.
