Earthquake Damage Assessment and Repair Guidelines for Residential Wood-Frame Buildings

Volume 2 | ENGINEERING GUIDELINES

CEA-EDA-02 2020

Earthquake Damage Assessment and Repair Guidelines for Residential Wood-Frame Buildings, Volume 2 – Engineering Guidelines

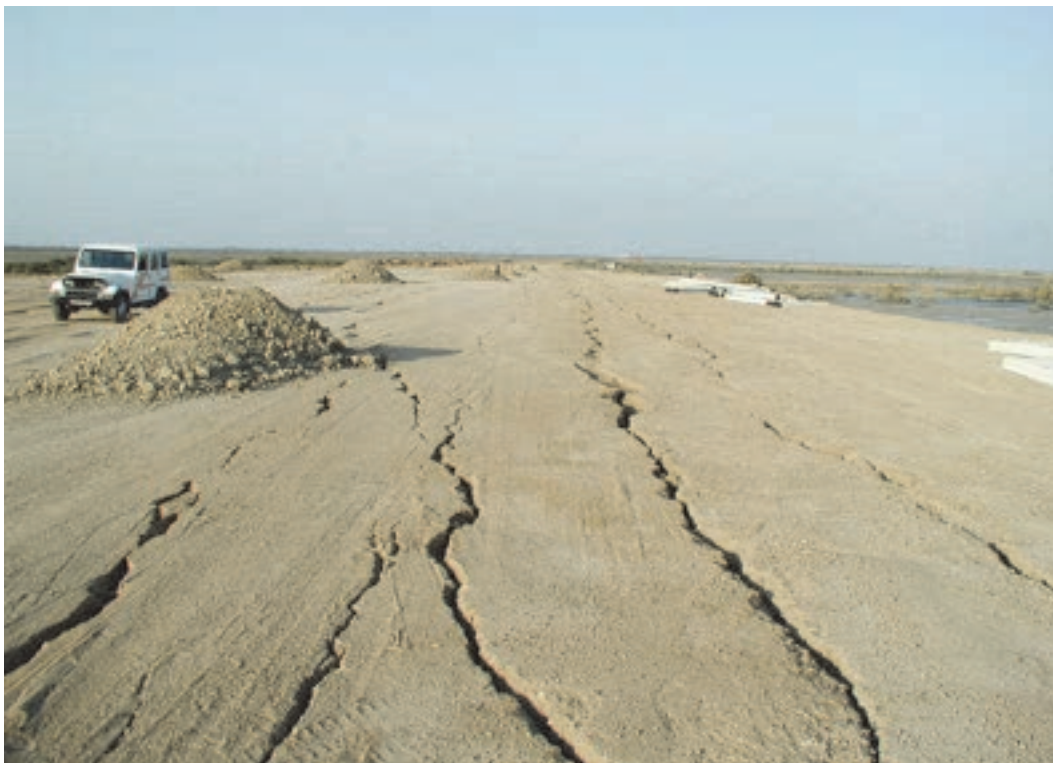
Figure 5-8 Ground cracking of fill from liquefaction-induced cyclic mobility of foundation soils during 2001 Gujarat, India earthquake (photo credit: J. P. Stewart).

When driving static shear stresses are present, liquefaction can lead to lateral spreading from cyclic mobility or a flow slide (Figure 5-8 and Figure 5-9). Surface effects generated by lateral spreads will involve a consistent pattern of lateral ground movement and surface cracking (Youd and Garris, 1995). Post-liquefaction re-consolidation will occur regardless of the static shear stress condition and can result in relatively uniform settlement (Figure 5-10) or can produce differential settlements (Figure 5-11). Liquefaction at shallow depths can cause sand boils to form (Figure 5-12), which occurs when excess pore pressures in a liquefiable strata vent through cracks or openings in overlying non-liquefied layers.

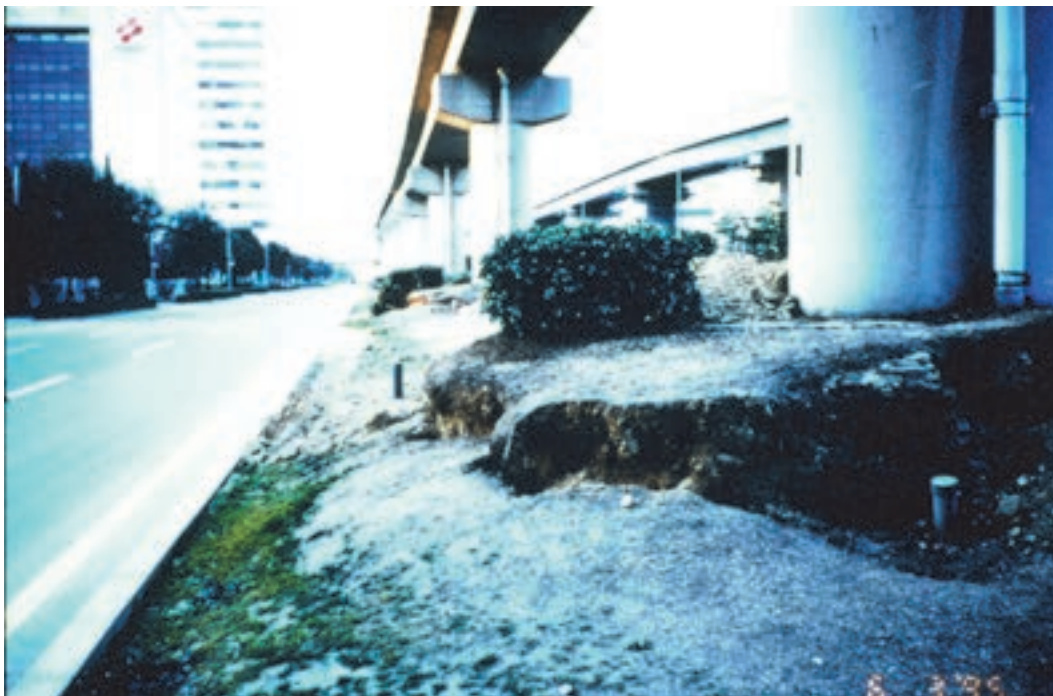
Figure 5-10 Uniform settlement of liquefied fill soils, 1995 Kobe, Japan earthquake. The amount of settlement is shown by the difference between the unsettled pile-supported bridge bent and the surrounding ground. The uniformity of the settlement is shown by the lack of cracking in the pavement (Sitar et al., 1995).

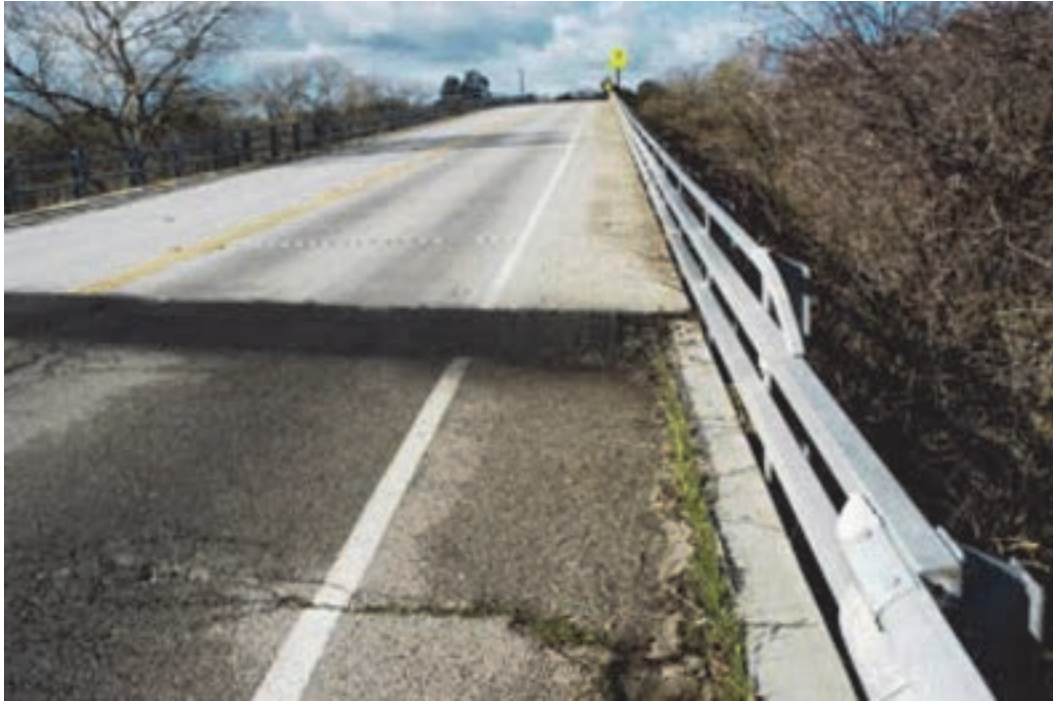
Figure 5-11 Templeton Road Bridge settlement following the 2003 San Simeon, California earthquake. The settlement of approximately 5 inches was a result of liquefaction beneath the bridge abutment foundation (EERI, 2004).

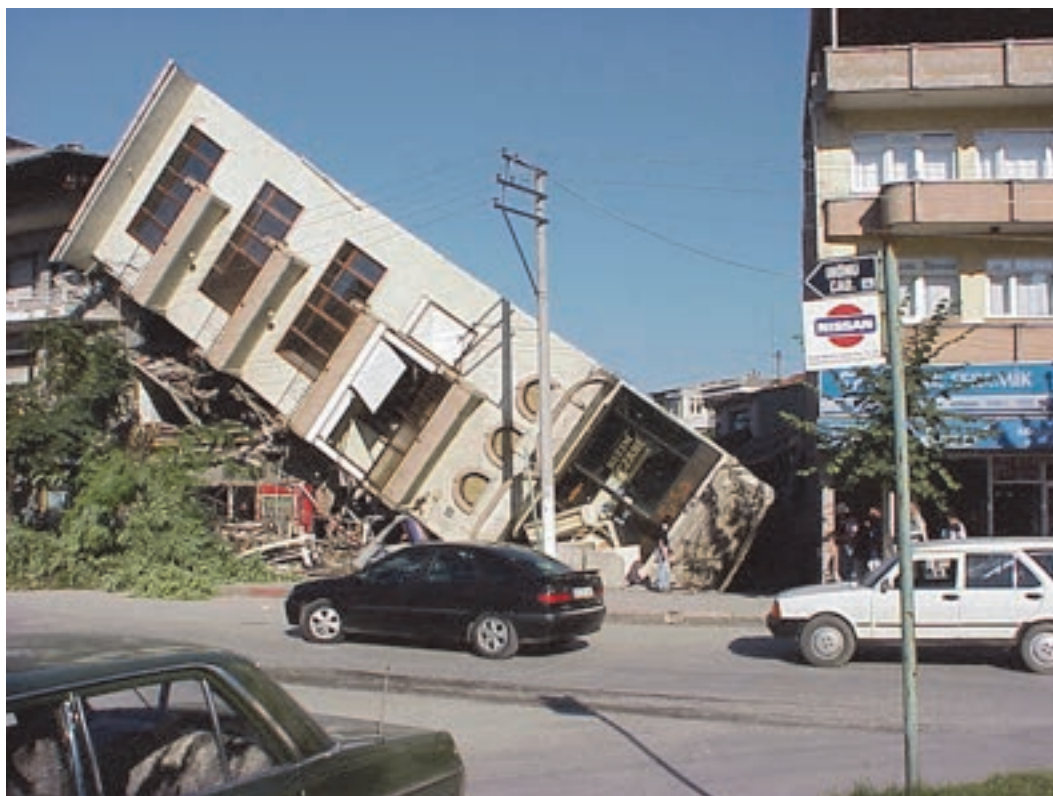
Figure 5-13 Foundation bearing failure of shallow foundation in Adapazari from the 1999 Kocaeli, Turkey earthquake (photo credit: J. P. Stewart).

For structures supported on shallow foundations, liquefaction effects can include foundation bearing failures (Figure 5-13), foundation settlement or tilting or both (Figure 5-14), and lateral translations of foundations (Figure 5-15). Depending on their stiffness and strength and the magnitude of deformations, the foundation elements themselves may or may not be structurally damaged as these deformations occur.

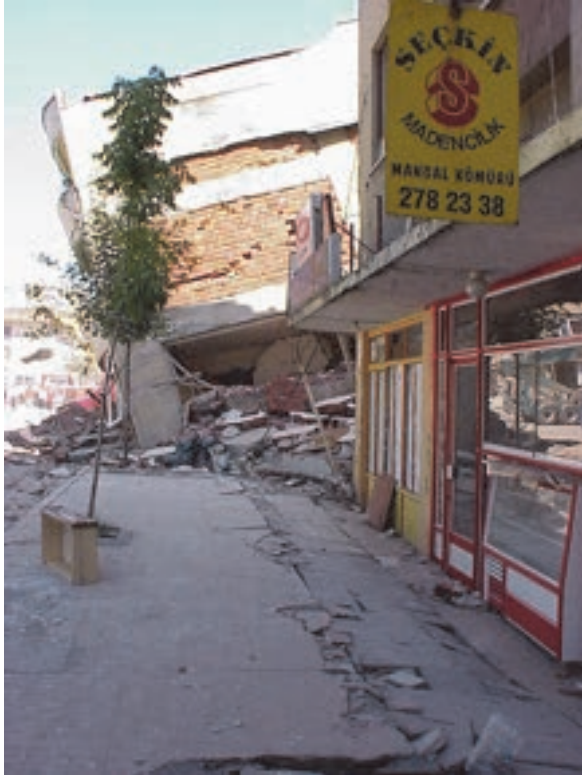
Figure 5-14 Settlement relative to surrounding ground (foreground) of mat foundation in Adapazari from the 1999 Kocaeli, Turkey earthquake (photo credit: J. P. Stewart).

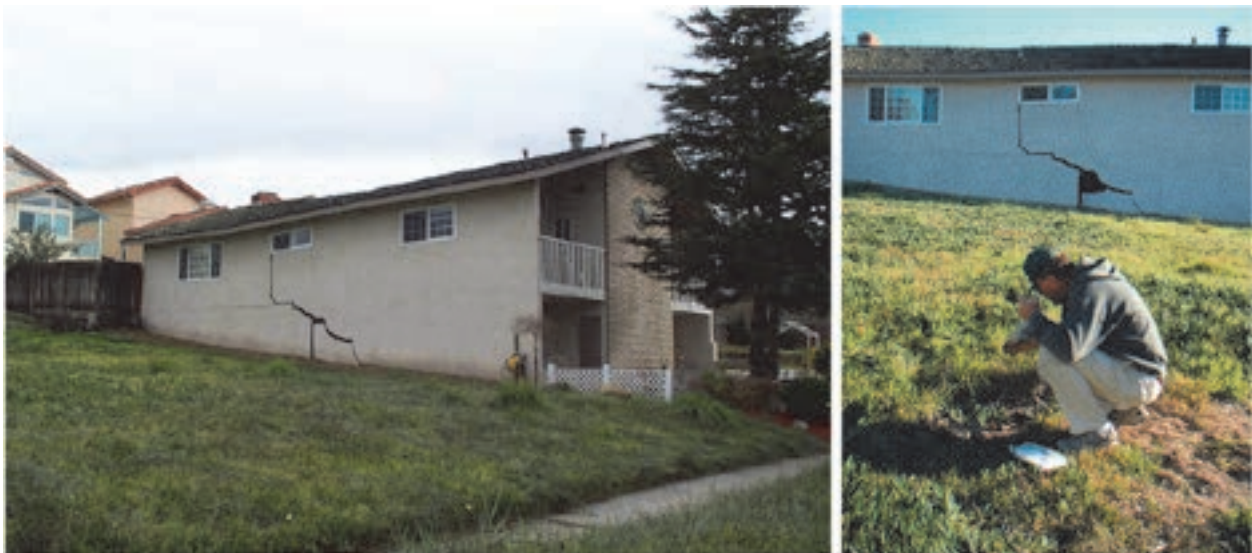
Figure 5-15 Damage to a residence in Oceano, California from lateral spreading following the 2003 San Simeon earthquake. Photo (right) taken along head scarp offset and its intersection with residence foundation (photo credits: San Luis Obispo County Department of Planning & Building, left; Holzer et al., 2004, right).

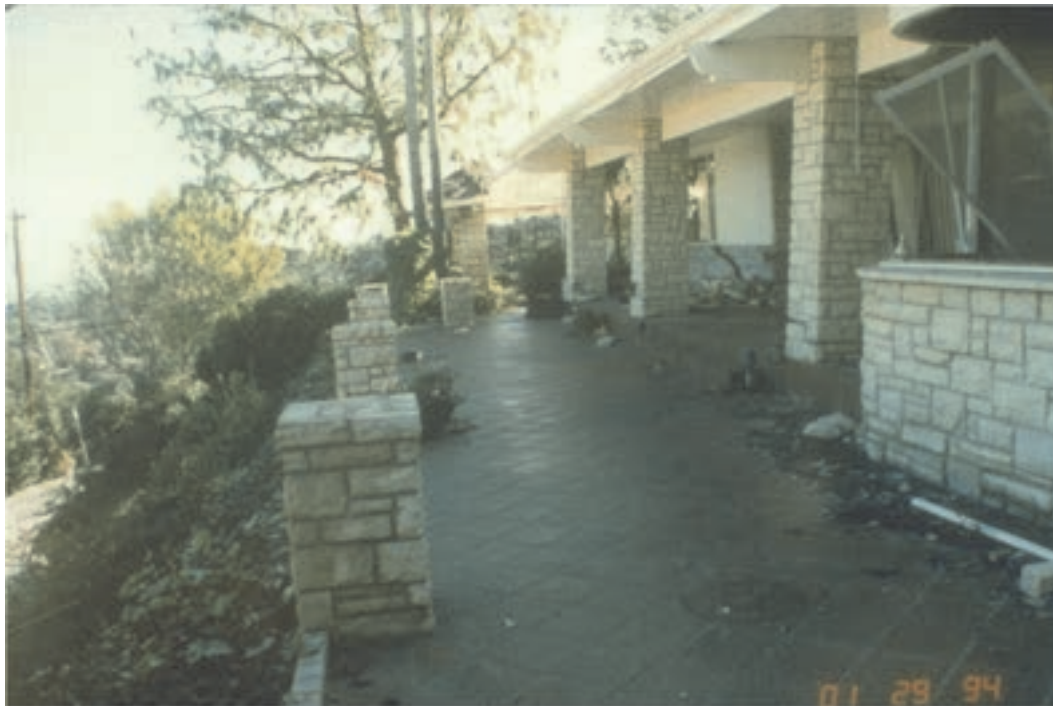
Figure 5-16 Structure damaged by movements in wedge fill from the 1994 Northridge, California earthquake (photo credit: NISEE).

Seismic compression is defined as the accrual of contractive volumetric strains in unsaturated soil during strong shaking from earthquakes. Such strains may result in ground surface settlements and potential lateral movements near slopes (Figure 5-16). This process has been observed to be especially prevalent in artificial fill soils. Ground deformations in compacted fill slopes from seismic compression are well documented in the literature (Pyke et al., 1975; Stewart et al., 2001; Stewart et al., 2004a) and are recognized as representing a significant hazard with respect to collateral loss during earthquakes (SSC, 1995).

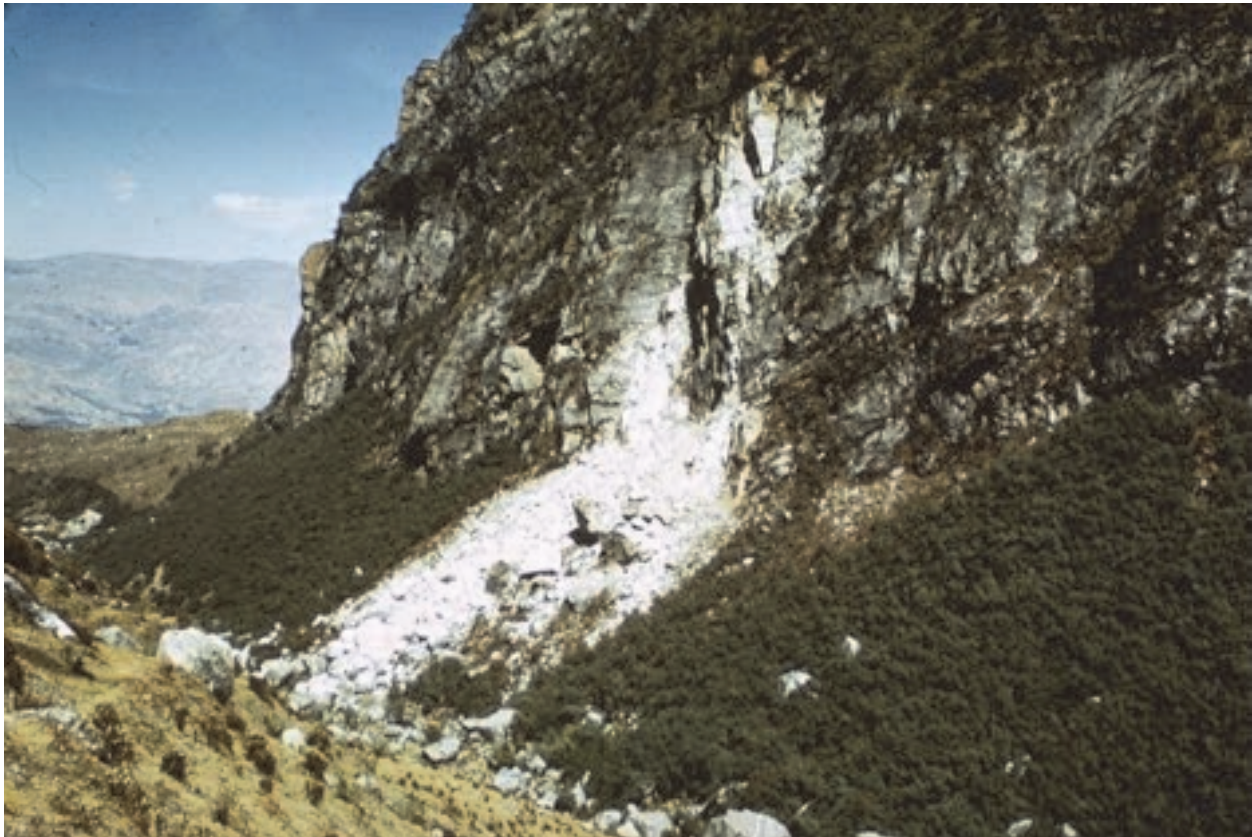
Figure 5-18 Rockfall from the 1970 Peru earthquake (photo credit: NISEE).

- masses of disrupted slide material, such as rock falls or avalanches (Figure 5-18)
- relatively coherent slide masses whose displacement is accommodated along well-defined slip surfaces or across relatively broad, distributed shear zones
- lateral spreads and flows associated with soil strength loss due to pore pressure increase

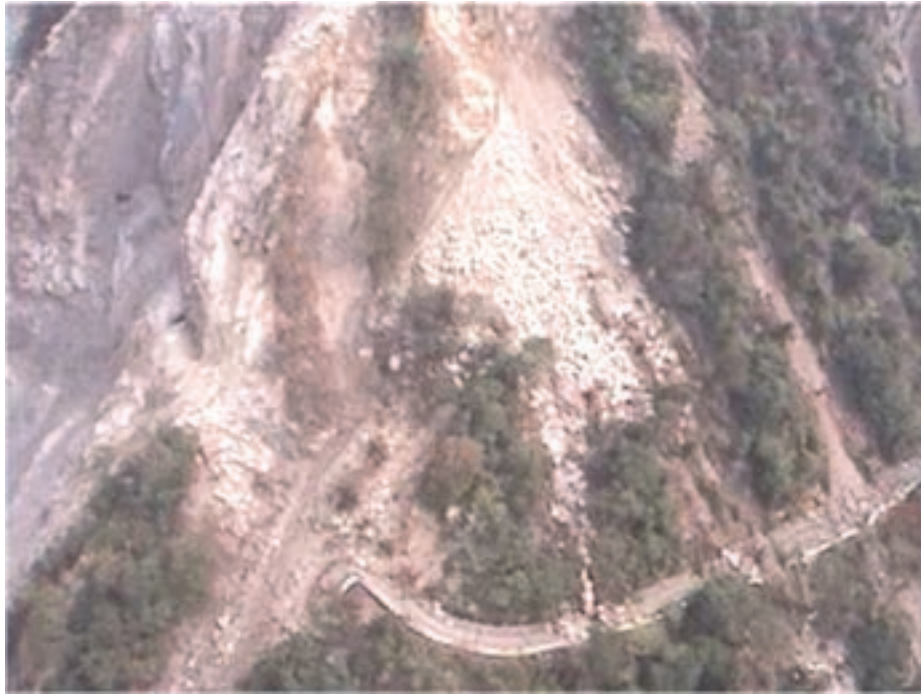
Figure 5-19 Example of disrupted landslide—rockfall in central Taiwan from 1999 Chi Chi, Taiwan earthquake (photo credit: J. P. Bardet).

Disrupted slides and falls, as described by Keefer (1984), occur in areas of high topographic relief (slopes steeper than 35 degrees to 40 degrees) and tend to involve closely jointed or weakly cemented materials (Figure 5-19). Rock avalanches are a particularly damaging type of disrupted slide, involving slide masses that originate in steep terrain and disintegrate into streams of rock that can travel large

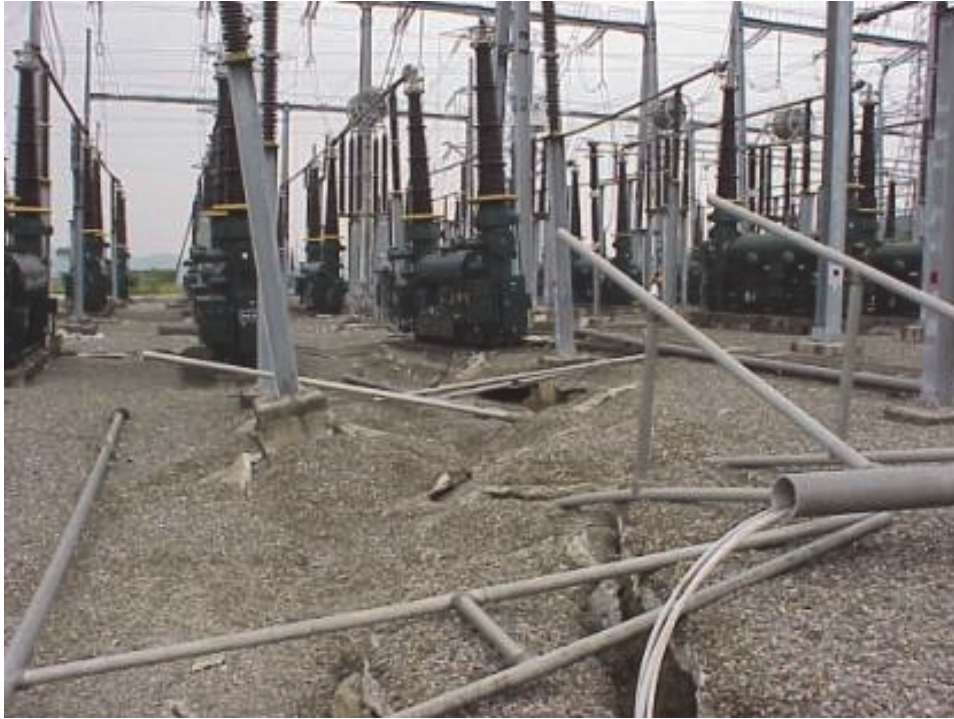
Figure 5-20 Head scarp of coherent landslide at Junliau Switching Station, Taiwan, induced by 1999 Chi Chi, Taiwan earthquake. Slide movements of approximately 3 feet to 4 feet occurred along a bedding plane in rock (photo credit: J. P. Stewart).

Coherent slides can occur in rock or soil materials and at slope angles much lower than those for disrupted slides and falls (Figure 5-20). Coherent slides in rock typically involve slip along basal surfaces weakened by weathering, jointing, or prior shearing, or along bedding planes and other discontinuities that dip out of slope. Keefer (1984) reports that coherent slides in rock masses have occurred on slopes as shallow as 15 degrees. Coherent slides in soil can occur along basal slip surfaces or relatively distributed shear zones. These slides most commonly involve fill embankments (i.e., sliding occurring within the embankment materials or in relatively soft foundation soils) (Rogers, 1992; Bardet et al., 2002) but have also been widely documented in natural alluvial soils (Keefer, 1984).

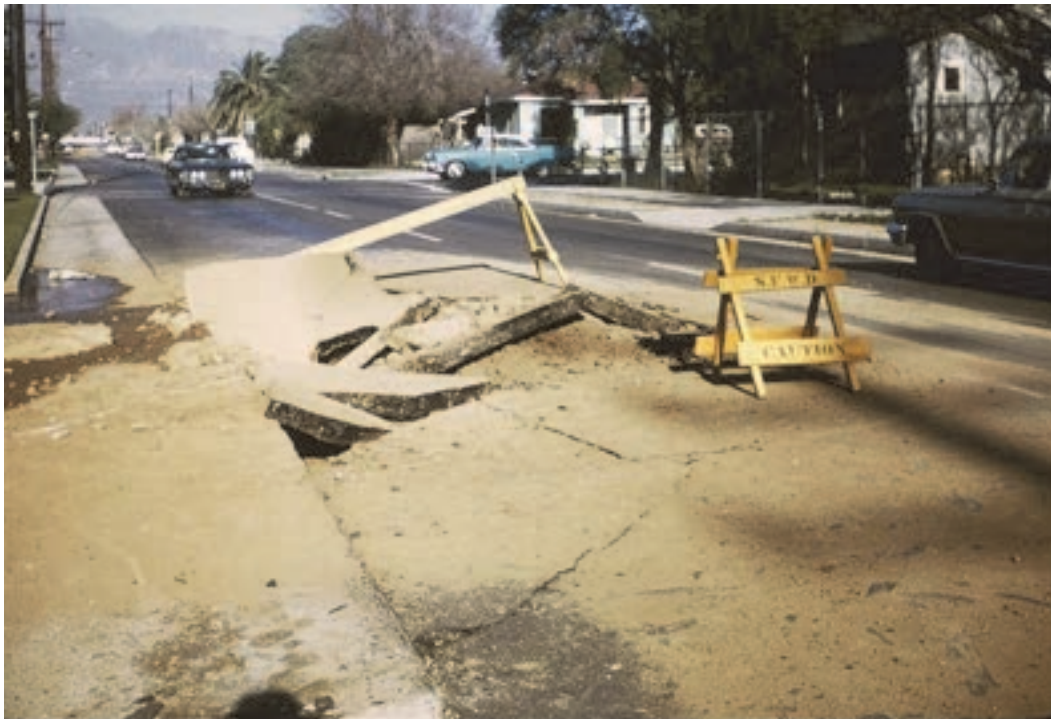
Figure 6-2 Pipe failures and resulting pavement distress and settlement from the 1971 San Fernando, California earthquake (photo credit: NISEE).

- **Utility lines.** Utility lines can be sensitive to ground deformations and breaks in these lines can be a good indicator of permanent ground deformation. Examples of these utilities include water service pipes, water mains, sanitary sewer pipes, and gas pipes (Figure 6-2). If possible, modes of pipe failure should be noted (e.g., extension, shear, compression). When the reconnaissance is performed after an earthquake, repairs of underground utilities by municipalities may have already occurred; hence, recently patched areas of streets may be evidence of underground utility repair (i.e., water or sewer pipe breaks).

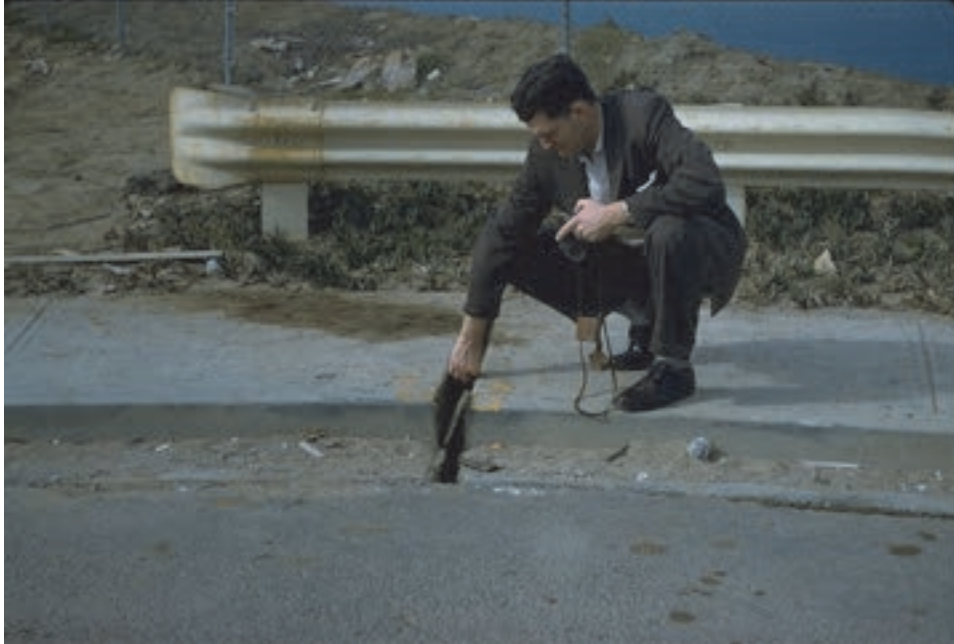
Figure 6-3 Separation in sidewalk from 1957 Daly City, California earthquake (photo credit: NISEE).

- **Nearby houses.** Damages to nearby properties are good indicators of the intensity of shaking experienced at a house. The condition of improvements with different vulnerabilities to earthquake damage should be noted. For example, damage to utility lines, flatwork (Figure 6-3), or foundations (Figure 6-4) at nearby houses are indicators of permanent ground deformation that warrant consideration at the subject site. However, block wall damage is common even at low intensity of earthquake shaking and is not a good indicator of earthquake-induced permanent ground deformation if the crack pattern in the wall is inconsistent with a prevailing pattern of ground deformation.

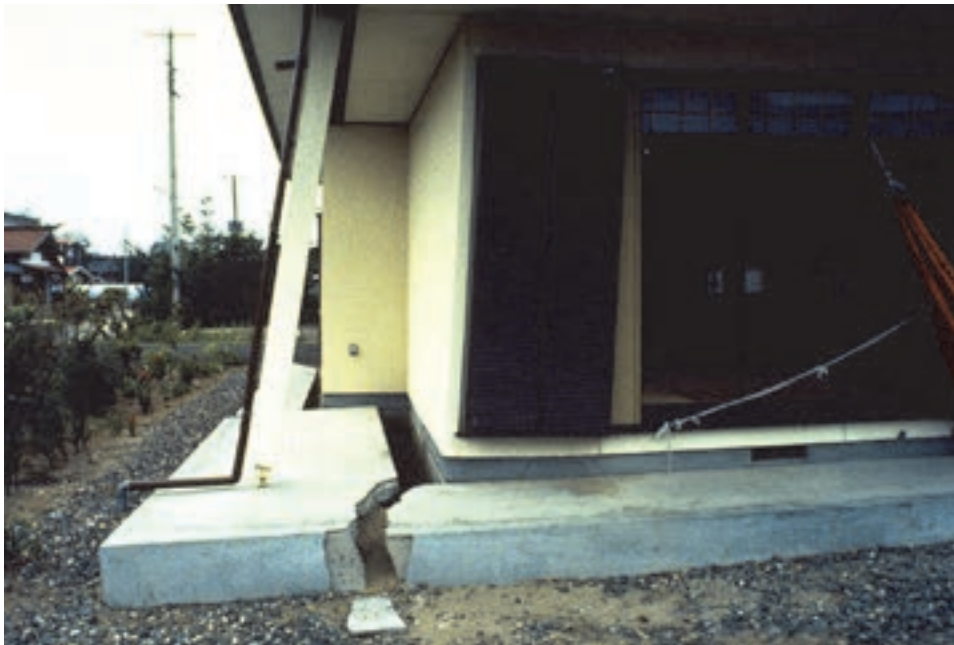
Figure 6-4 Damage to house foundation in Wakami, Japan, caused by lateral spreading following the 1983 Nihonkai-Chubu, Japan earthquake (photo credit: NISEE).

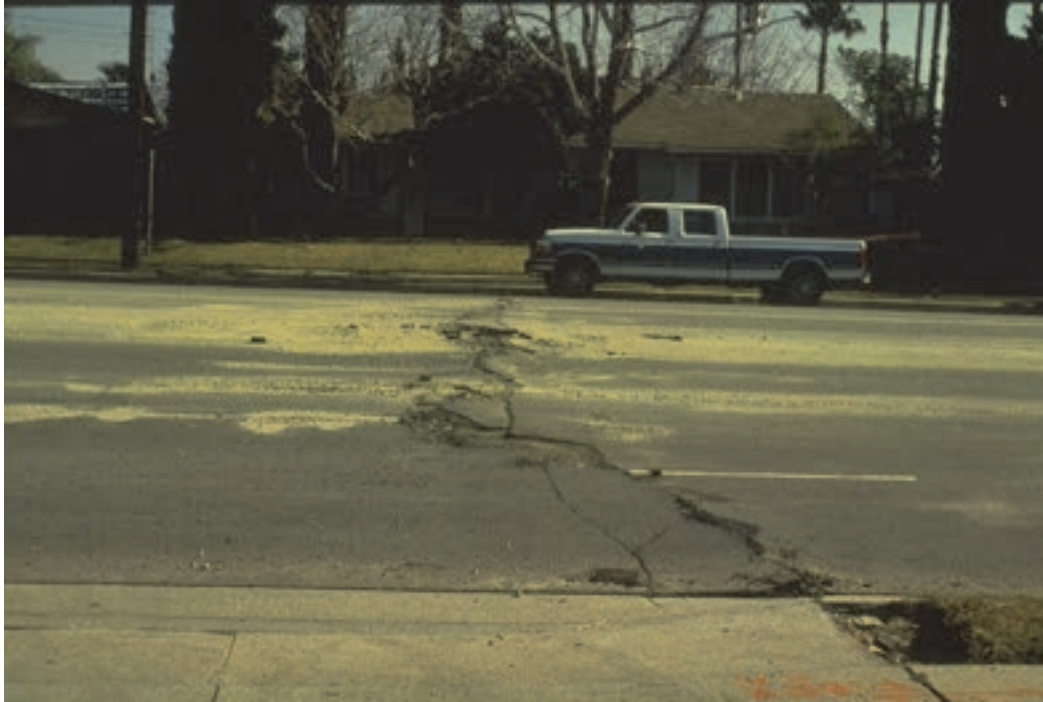
Figure 6-6 Localized compression feature and pavement damage from the 1994 Northridge, California earthquake (photo credit: NISEE).

- **Hardscape and flatwork.** Fresh cracks in hardscape or flatwork (e.g., driveways, patios, sidewalks) or the opening of construction joints are good indicators of earthquake-induced permanent ground deformation, especially if the cracking pattern is consistent with a prevailing pattern of ground deformation. Also, fresh-appearing out-of-levelness in patios, decks, or other hardscape or flatwork inconsistent with normal construction practices (e.g., patios adjacent to structures are sloped away from the building for drainage) are indicators of potential earthquake-induced permanent ground deformation. However, fresh cracks that form a random pattern may represent pre-earthquake damage that was worsened by the earthquake shaking. Indicators such as paint or debris within cracks, previous patching of cracks, and previous releveling are good indicators of pre-earthquake damage possibly associated with static ground deformation (see Figure 6-6, Figure 6-7, Figure 6-8, and Figure 6-9).

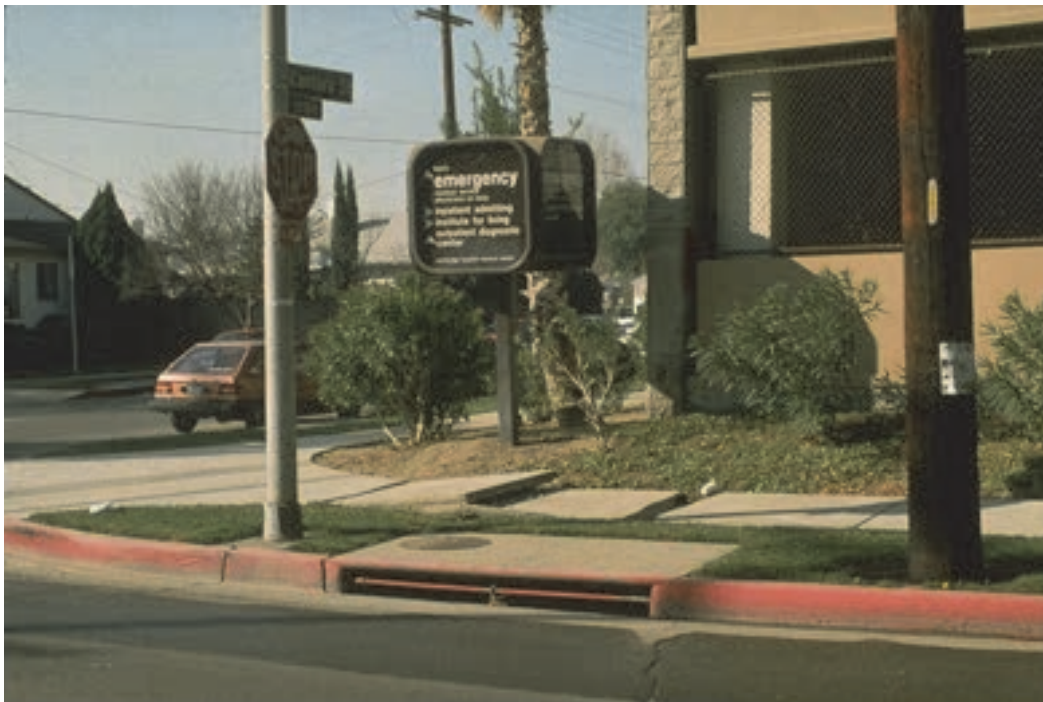
Figure 6-7 Sidewalk buckled from lateral compression by the Northridge Hospital Medical Center from the 1994 Northridge, California earthquake (photo credit: NISEE).

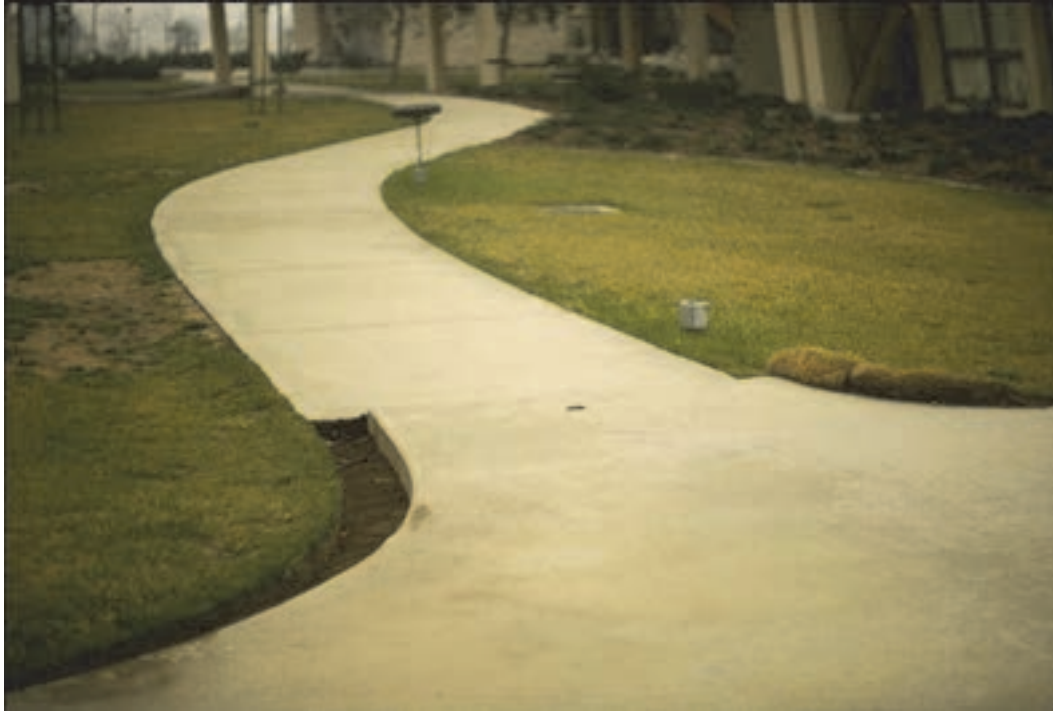
Figure 6-8 Offset sidewalk from the 1971 San Fernando, California earthquake (photo credit: NISEE).

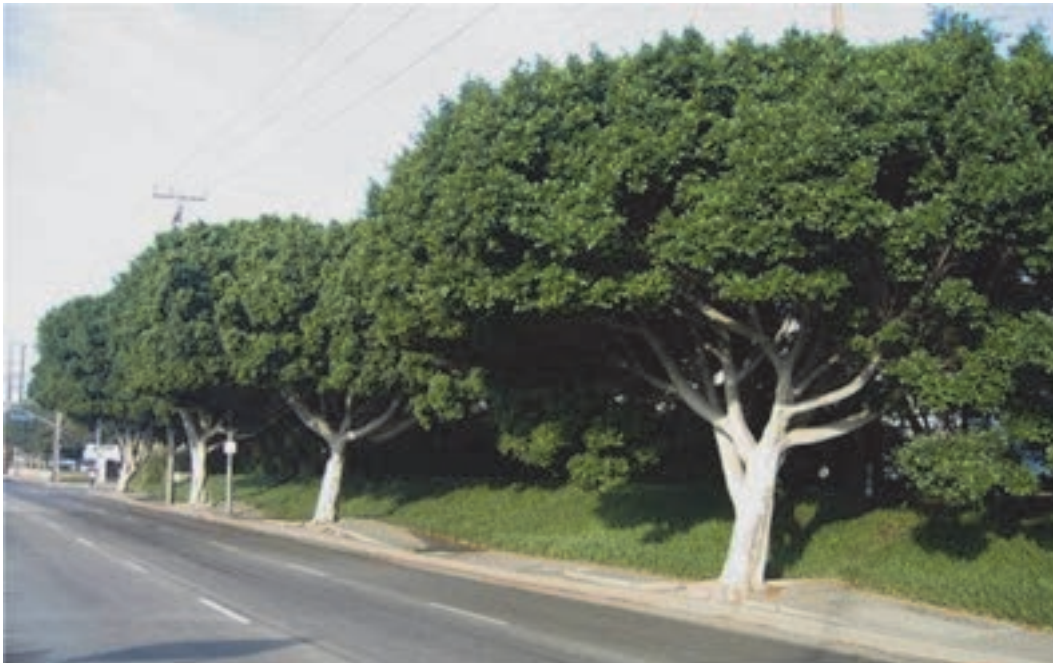
Figure 6-9 Tree root damage to sidewalks and other surface improvements is common and not associated with earthquake damage (photo credit: Exponent).

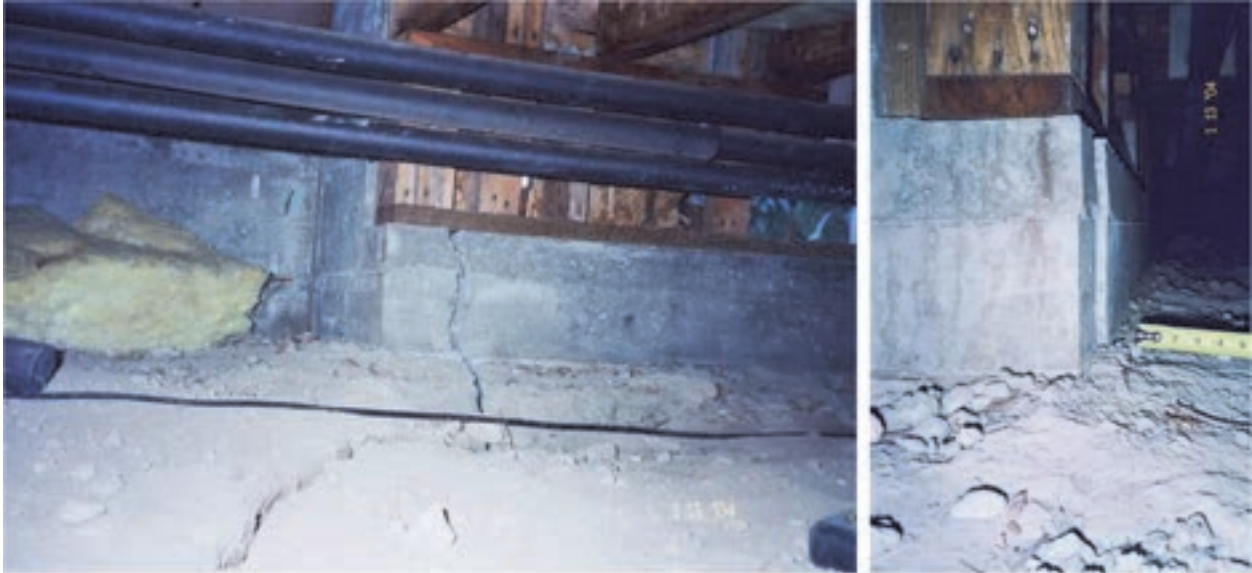
Figure 6-11 Foundation and ground cracking following the 2003 San Simeon, California earthquake, where the photo on the right shows the offset present across foundation crack (photo credits: Exponent).

- **Foundations.** Indicators of earthquake-induced permanent ground deformation related to foundation performance include: (a) fresh cracking in concrete foundation elements; (b) soil deformations adjacent to foundations (e.g., bulging or tension cracks); and (c) out-of-levelness consistent with conspicuous earthquake damage to adjacent house walls (Figure 6-11).

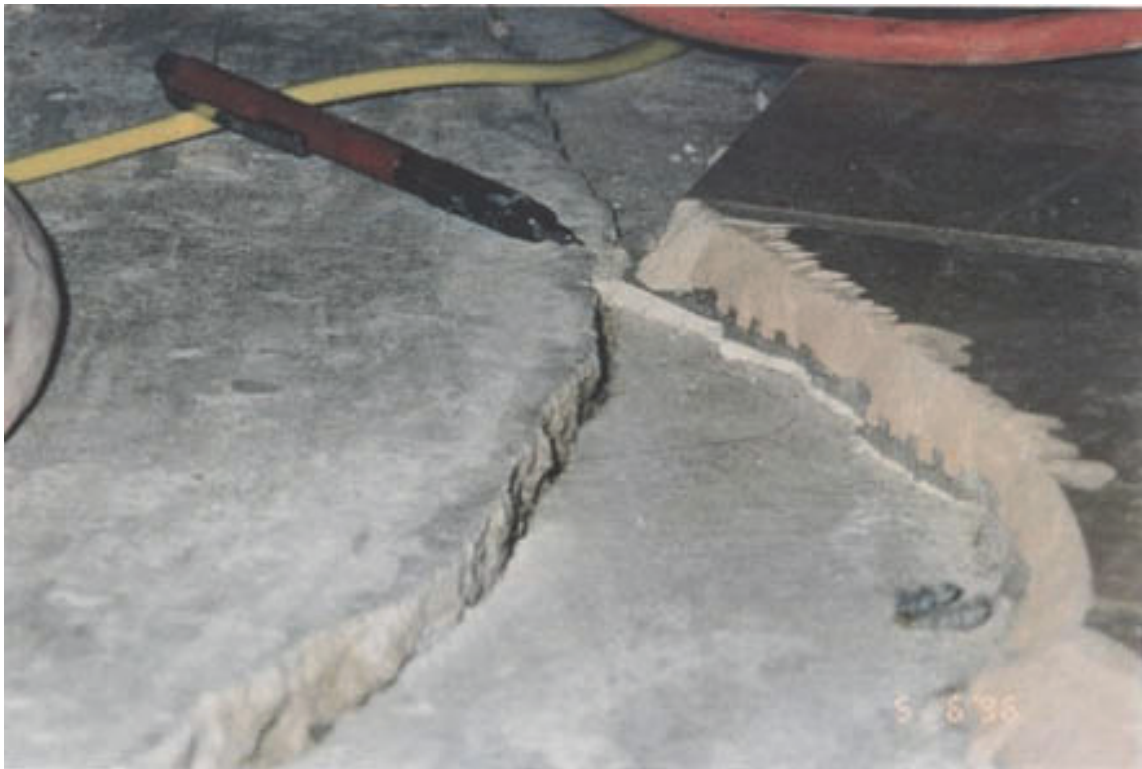
Figure 6-12 Grout completely filling the slab-on-grade crack (indicated by pencil) indicates that slab crack was present at the time of the tile installation and has not experienced movement since tile installation (photo credit: Exponent).

- **Fresh cracking in concrete foundation elements** requires direct inspection of the foundation elements. This inspection can be performed along the sides of a structure, from direct inspection of interior floor slabs (which may require rolling back carpet), or from crawlspace inspections. If foundation concrete is not directly visible, geotechnical consultants can look for fresh cracks in tiles applied to slab-on-grade surfaces or in wall finishes (e.g., stucco) above the foundation elements. Fresh cracking in any of these elements indicates potential earthquake-induced permanent ground deformation. Conversely, patching of cracks, debris within cracks, or evidence of previous releveling are indicators of long-term, re-occurring ground movement unrelated to earthquake shaking (Figure 6-12, Figure 6-13, and Figure 6-14).

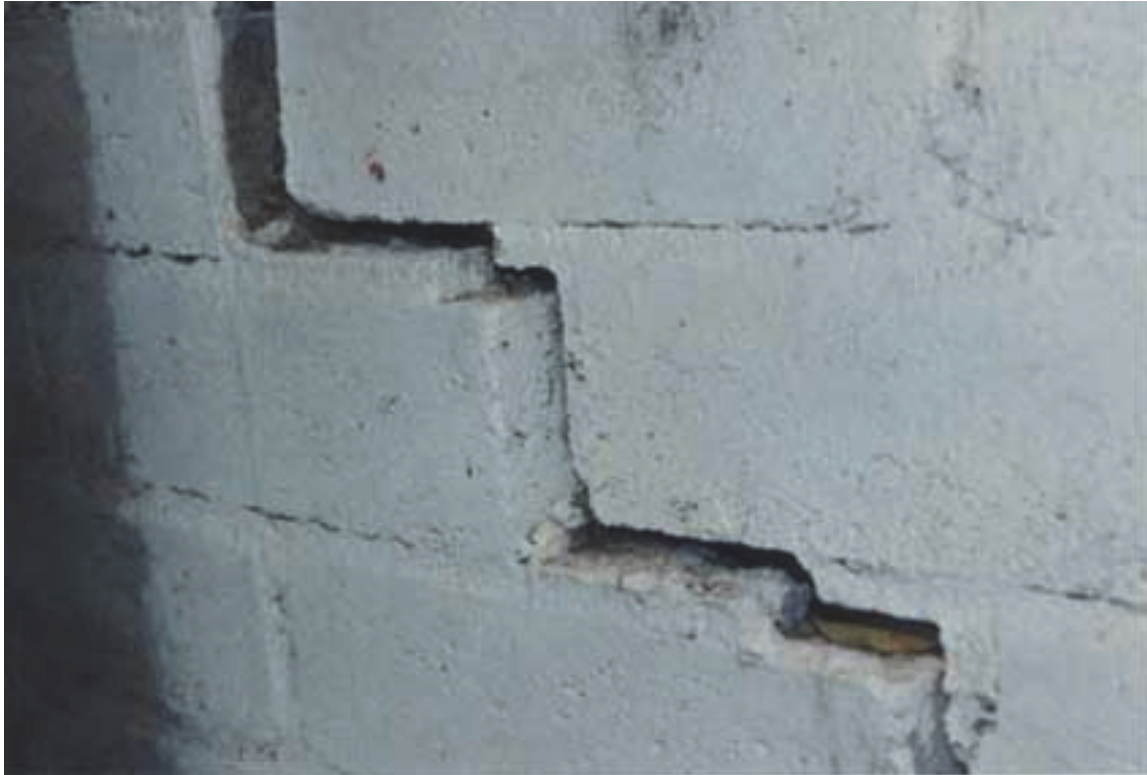
Figure 6-13 Paint within concrete block wall crack indicates that the crack was present at the time of last painting (photo credit: Exponent).

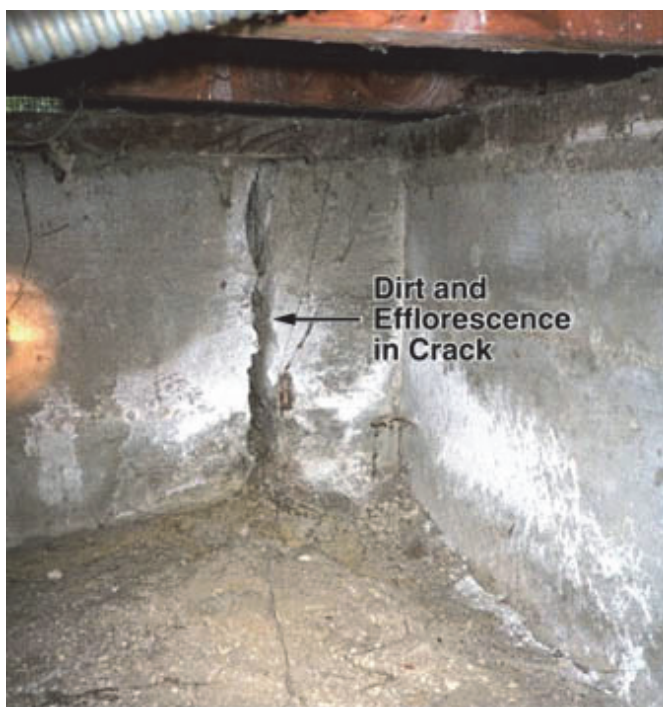
Figure 6-14 Dirt and efflorescence indicates age of foundation wall crack is not recent (photo credit: Exponent).

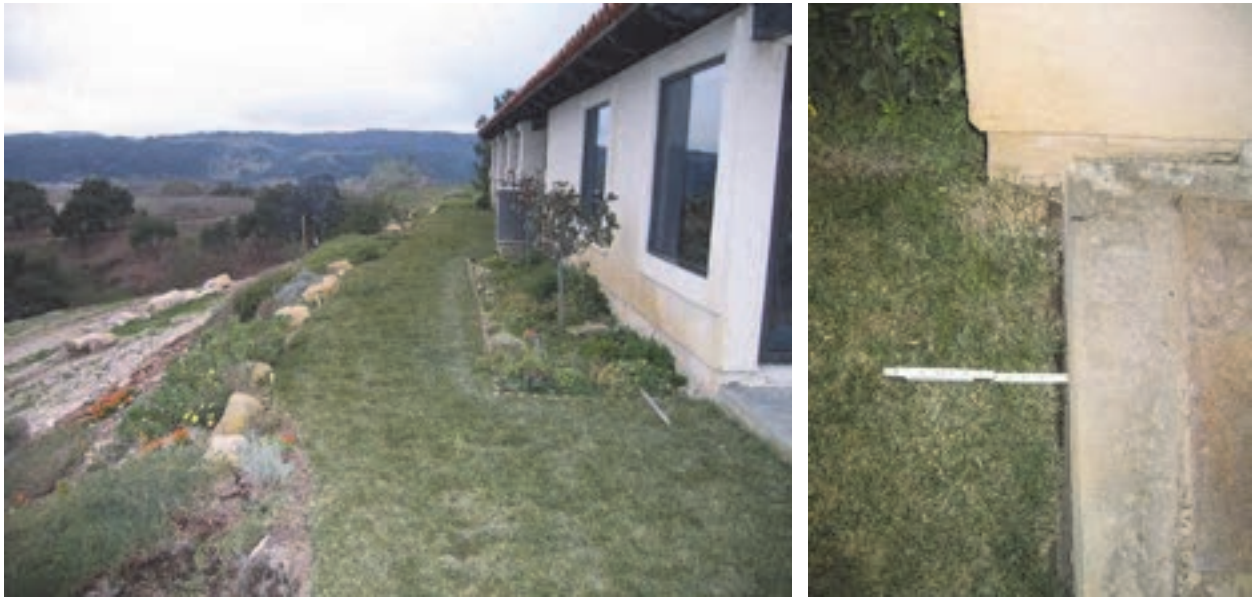
Figure 6-15 Ground separation from residence along slope side of structure following the 2003 San Simeon, California earthquake (image credit: Exponent).

- **Soil deformation near the foundation** involves permanent ground deformation that is localized around foundations, indicating full or partial bearing failure or foundation sliding (Figure 6-15). This mode of permanent ground deformation usually results from seismic pore-pressure induced strength loss in foundation soils (i.e., liquefaction), and in past earthquakes has generally only been observed in structures with significant bearing loads (typically 3 stories or more in height).

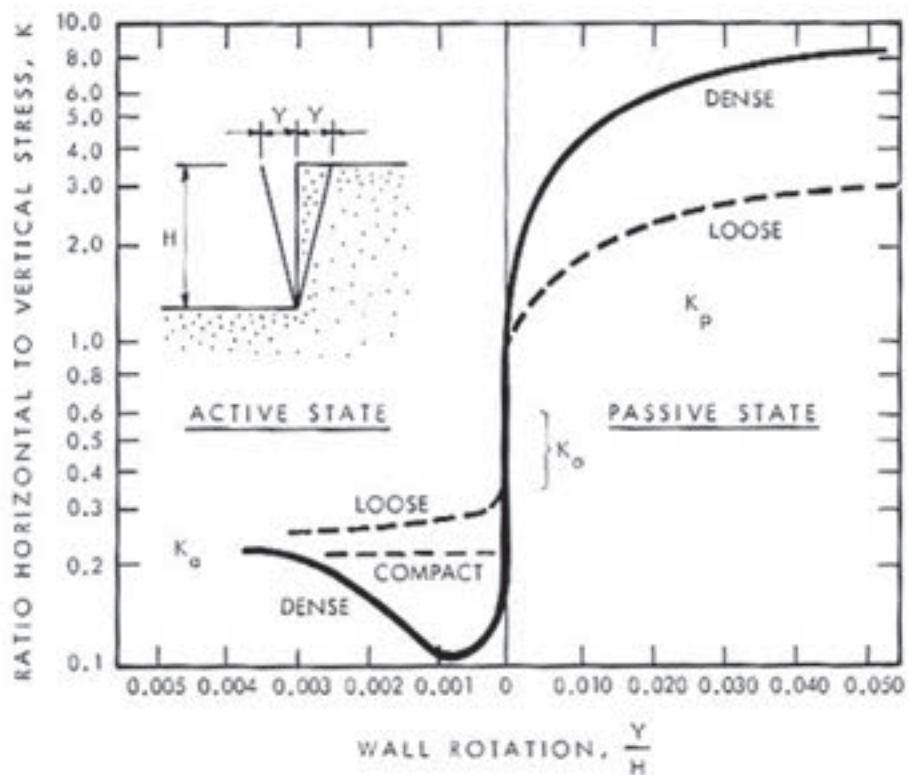
Figure 6-16 Magnitude of wall rotation to reach failure in retained soil and effect of wall rotation on earth pressures. K_0 , K_a , and K_p are the at-rest, active, and passive earth pressure coefficients, respectively (Canadian Geotechnical Society, 1992).

Detailed investigations involving subsurface exploration, laboratory testing, and engineering analyses may need to be performed when field indicators of potential earthquake-induced wall movement are present (e.g., rotation in excess of that required to mobilize active and passive earth pressures as delineated in Figure 6-16), unusual cracking of the wall is observed, or distress to the flatwork behind the wall is present. The purpose of these investigations is to identify the cause of the retaining wall damage and to facilitate the design of repairs. Detailed investigations and analysis may also be required to help distinguish between wall damage caused by long-term static processes and seismic loading (see Chapter 7).

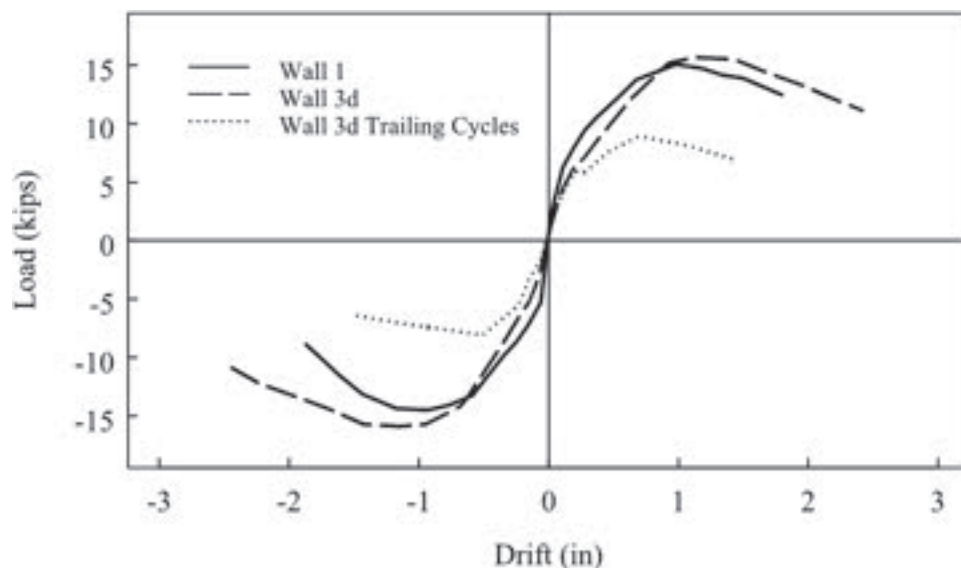
Figure D-1 CUREE EDA-03 Figure 6.46 showing global wall response comparison at failure for Wall 1 and Wall 3d, where Wall 3d was the repaired wall specimen.

CUREE EDA-03 also evaluated the effectiveness of various repair methodologies to restore the strength and stiffness of wall specimens. Wall 3 and Wall 4 in the study were tested and repaired, with re-testing of repaired walls to four target drift ratios. Repairs to stucco and gypsum wallboard cracks were performed using the repair methodologies recommended in these *Engineering Guidelines*, including routing and filling cracks, resetting fasteners, installation of new fasteners, and other techniques. The repair methods were found to substantially restore the strength and stiffness of damaged walls. Figure D-1 shows the global wall response comparison at failure for Wall 1 and Wall 3d, with the latter specimen being a repaired wall specimen.

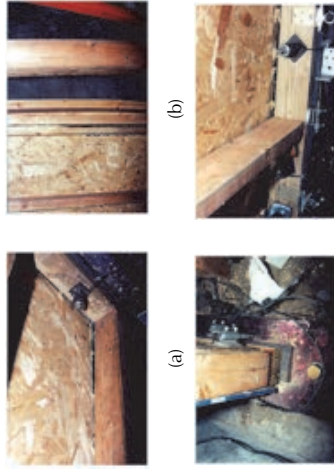
Wall behavior at failure included: damage to edge nailing, sheathing separation from framing, sheathing separation at joints, splitting of framing, bowing of framing, and separation of framing members

<p>Group 8A Specimen: (a) OSB pulled away from frame, (b) exterior post stud bowed, (c) sill plate split, and (d) separation of OSB from sill</p>	> 3%

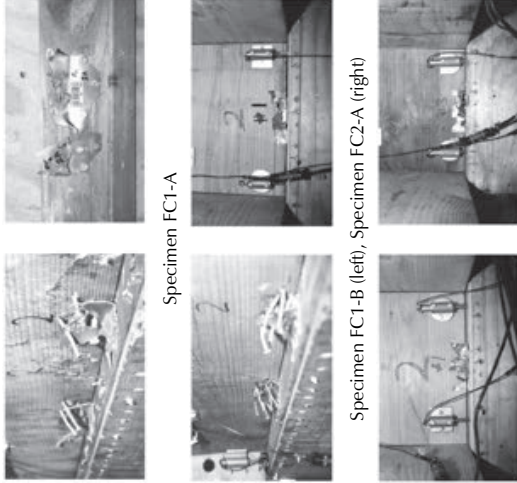
<i>Specimen</i>	<i>Damage Description</i>	<i>Damage Appearance</i>	<i>Shear Transfer Connection Displacement at Ultimate</i>	<i>Hysteresis Curve (load vs. connection displacement)</i>
Proprietary framing clip connections for unblocked diaphragms to shear walls	<p>Shear transfer connection behavior at failure was typically characterized by buckling of the framing clip followed by the withdrawal of nails at the connection. Tested in-plane shear capacities ranged between 750 plf to 850 plf and shear connection displacements at ultimate ranged from 0.3 inches to 0.75 inches</p>

<p>Specimen FC1-A</p> <p>Specimen FC1-B (left), Specimen FC2-A (right)</p> <p>Specimen FC2-B</p>	<p>0.3 inches to 0.75 inches</p>
