Corrosion of Steel Hardware Caused by Pressure-Treated Lumber

This handout is from Earthquake Strengthening for Vulnerable Homes—a Practical Guide for Engineers, Contractors, Inspectors, and Homeowners, by Thor Matteson, Structural Engineer. Mr. Matteson has been concerned with fastener corrosion since 2004, when the wood-treating industry began using new preservative formulations that aggressively attack steel hardware.

8.5 <u>Pressure-treated lumber:</u> <u>a ticking time-bomb since... 2004?</u>

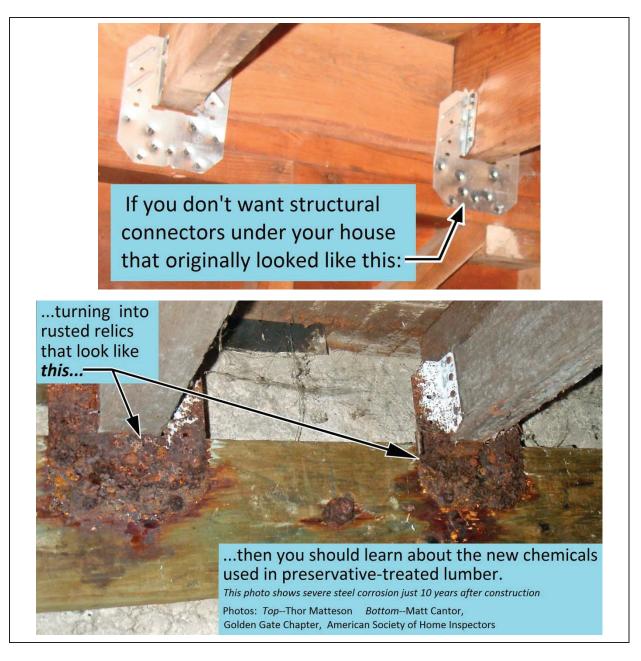
Figure 8-1 Most wood now sold to resist decay also attacks steel connectors. The red circle shows a rusted concrete anchor. At center is a severely corroded H10A (compare to Figure 6-34). This installation was about 10 years old when photographed. Photo: Matt Cantor, GGASHI

Imagine constructing a house using building materials that will quietly destroy each other. Millions of homes have been built using such materials; the hardware pictured in Figure 8-1 shows severe corrosion of steel connectors in contact with chemically treated lumber. Rust weakens connectors, making them more likely to fail during an earthquake. Future failures of structural connections will surprise a lot of building professionals and homeowners; if you have this material in your home you still have time to avert disaster.

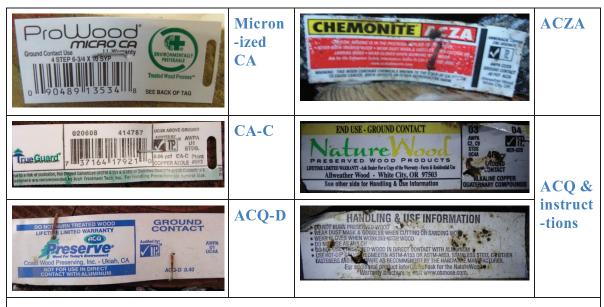
Figure 8-2 Tags from several varieties of pressure-treated lumber found on jobsites; all of them are rated "ground-contact," which has higher chemical content than the minimum needed to protect lumber used as mudsills.

the wood cells, giving a "waterproof" treatment suitable for fence-posts, decks, etc. Figure 8-2 shows several labels from PT lumber.
